NATIONAL TRANSPORTATION SAFETY BOARD

HIGHWAY ACCIDENT REPORT

CHARTERED INTERSTATE BUS CRASH
INTERSTATE ROUTE I-80S
NEAR BEAVER FALLS, PENNSYLVANIA
DECEMBER 26, 1968

SS-H-5

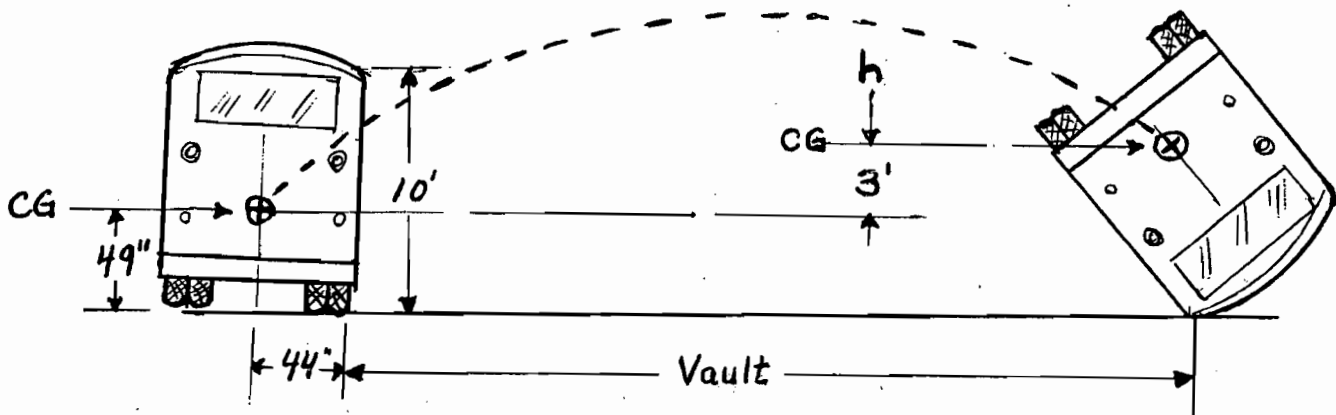
ATTACHMENT 6

ESTIMATION OF VAULT SPEED

VEHICLE DATA: Center of Gravity (CG), loaded, is:

- 49" above ground
- 44" inboard of outer wheel rims (or 3.7')
- 62.5% of Wheelbase length back of Front Axle

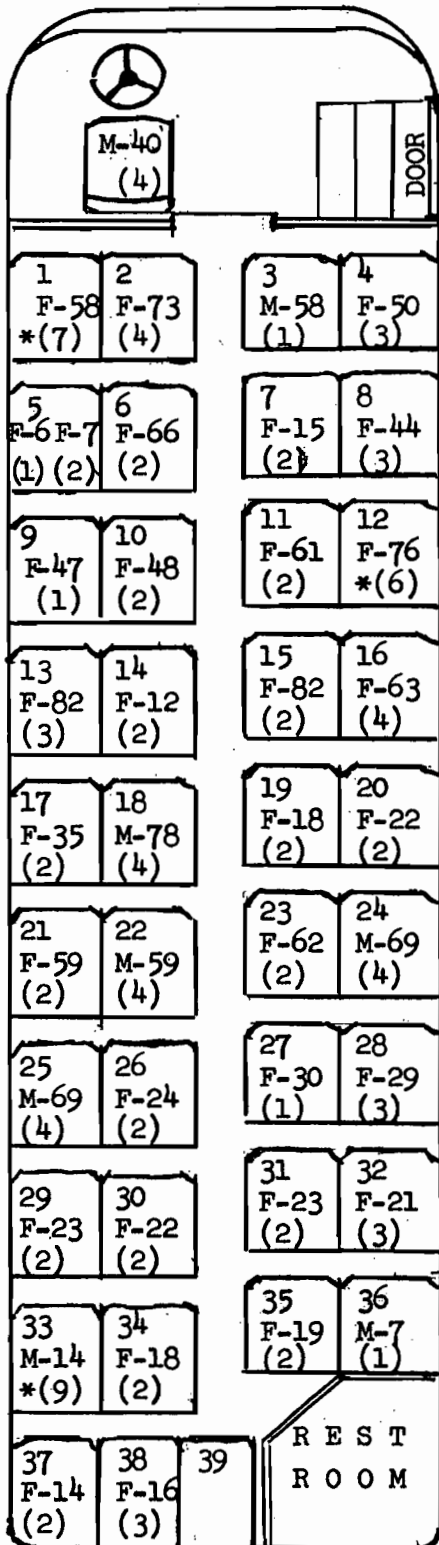
ATTACHMENT 8

SEAT LOCATION OF PASSENGERS

Seat locations shown represent a composite of information, based on patient statements when interviewed by the Rochester Accident Investigation Group, and information supplied by the Pennsylvania State Police and the Bureau of Motor Carrier Safety (FHWA).

The only significant uncertainty concerns occupancy of Seats 1 and 2. The survivor, Seat 2, said she was sitting by the window, but this was not substantiated by the State Police or BMCS. Further, she said she fell into the doorway and that the fatally injured passenger fell on top of her.
