HIGHWAY ACCIDENT REPORT

INTERSTATE BUS-AUTOMOBILE
COLLISION AND ROLLOVER
ON INDIANA ROUTE 57, SOUTH
OF PETERSBURG, INDIANA
NOVEMBER 24, 1969

REPORT NUMBER: NTSB-HAR-71-4

ADOPTED: FEBRUARY 10, 1971

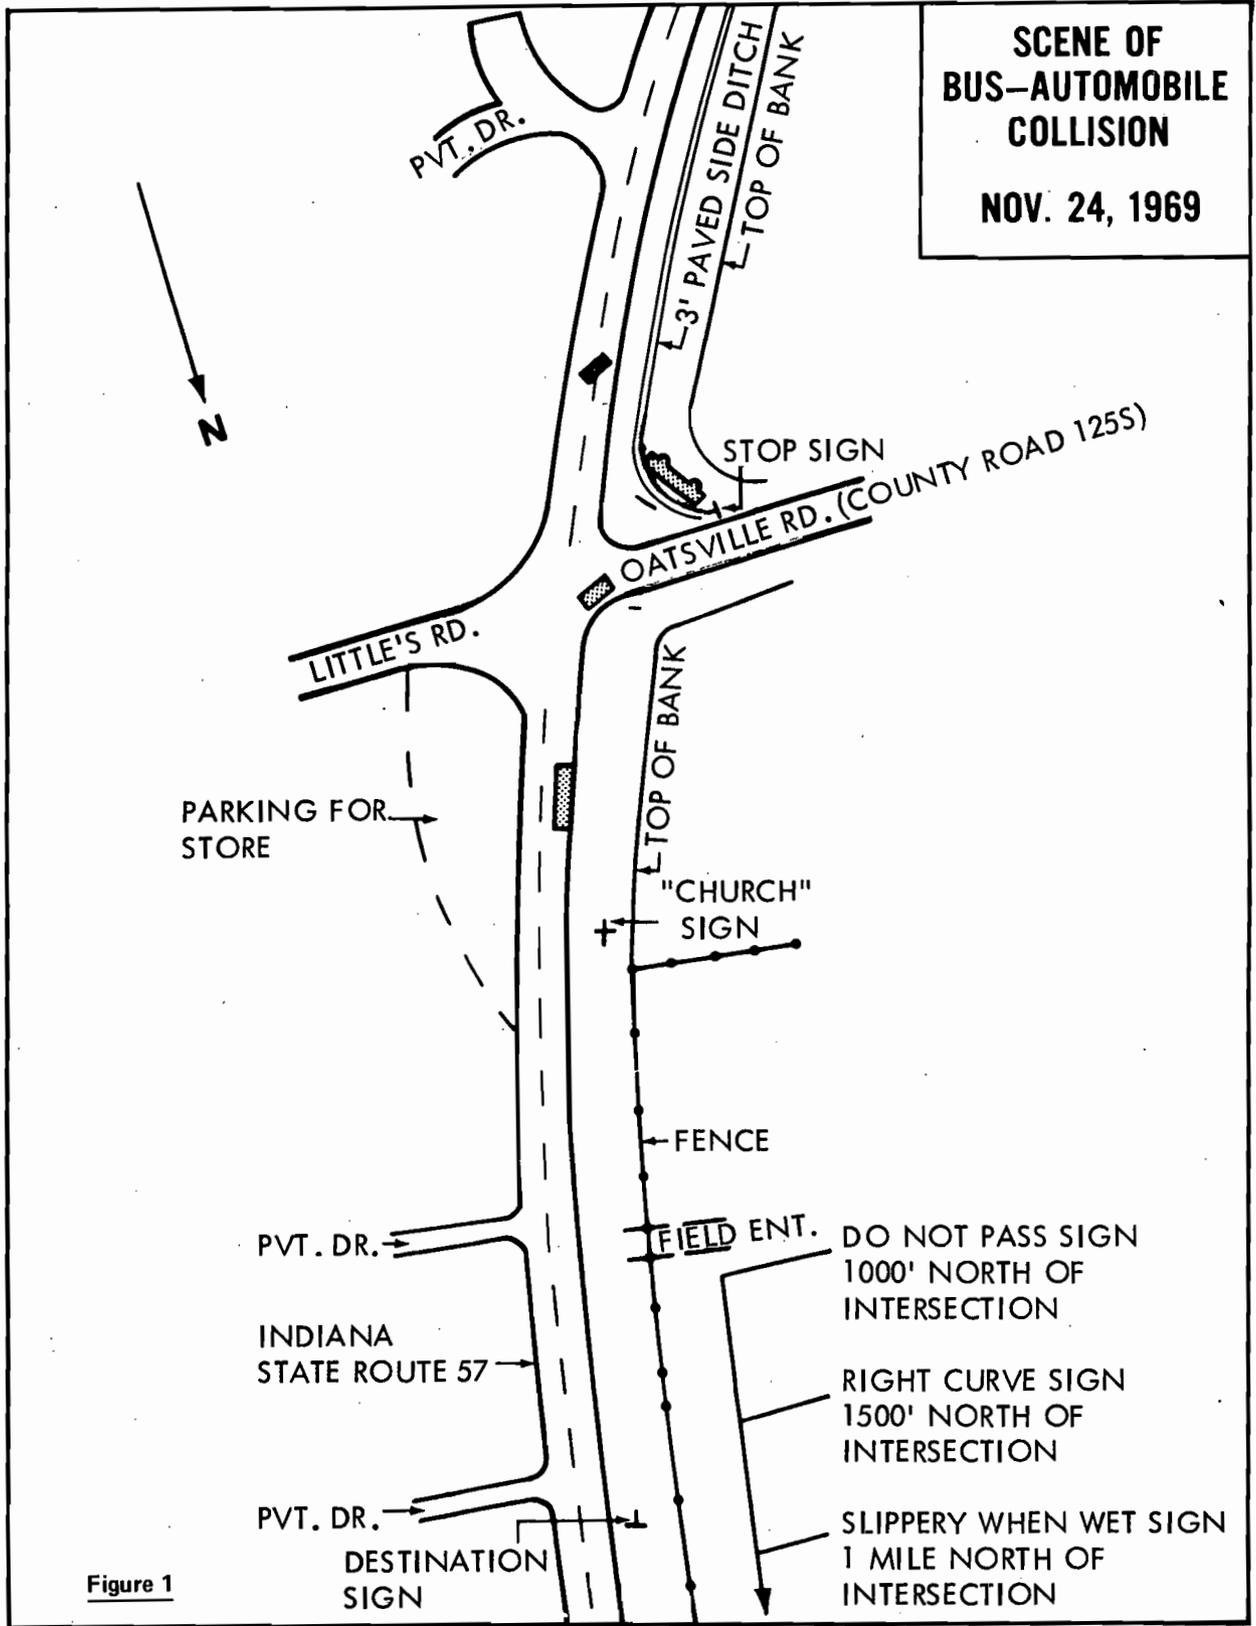
Figure 1

The accident occurred at 5:15 a.m., c.s.t.,¹ on November 24, 1969, on Indiana Route 57, at the intersection of county road 125-S (Oatsville Road), 5.6 miles south of Petersburg, Indiana. This is a moderately built up area of residences and small businesses, with some four accesses per quarter mile. At this point, Route 57 enters gently rolling hills. On the northeast corner of the intersection is a store set back 50 feet from the highway, and on the other three corners are residences some 60 to 100 feet back from the highway. (Figure 1 and Appendix 3.)

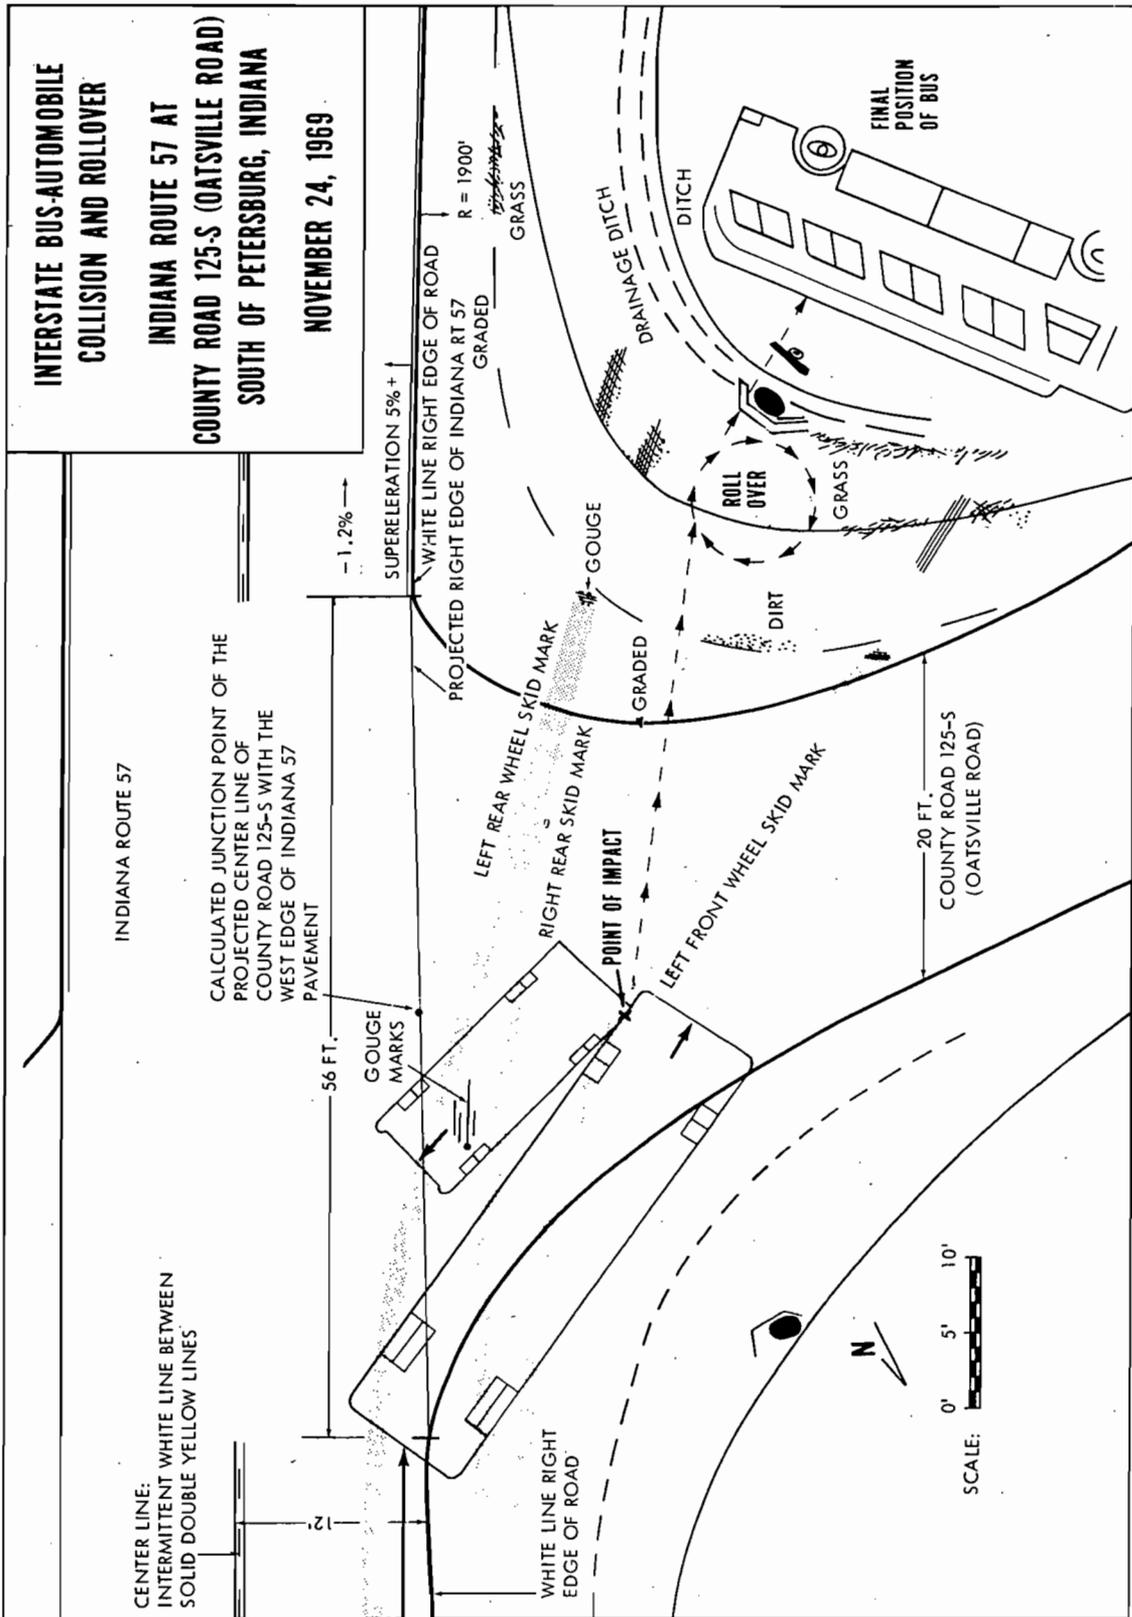
The point of impact was identified by gouge marks in the pavement on the north side of Oatsville Road, west of its intersection with Indiana Route 57. (Figure 2 and Appendix 4.)

- As the two vehicles were momentarily locked and sliding south, the left suspension and bumper support bracket of the automobile scraped the pavement, leaving the gouge marks shown in Figure 2 and Appendix 4.

Following the reasoning set forth in the analysis of the impact marks on the bus and automobile and the skid and gouge marks on the road, scale outlines of the bus and automobile were superimposed onto the diagram in Figure 2. The results show the probable relation of the two vehicles at the moment of first impact, and the probable position of the automobile as it stood on Oatsville Road just before the collision.

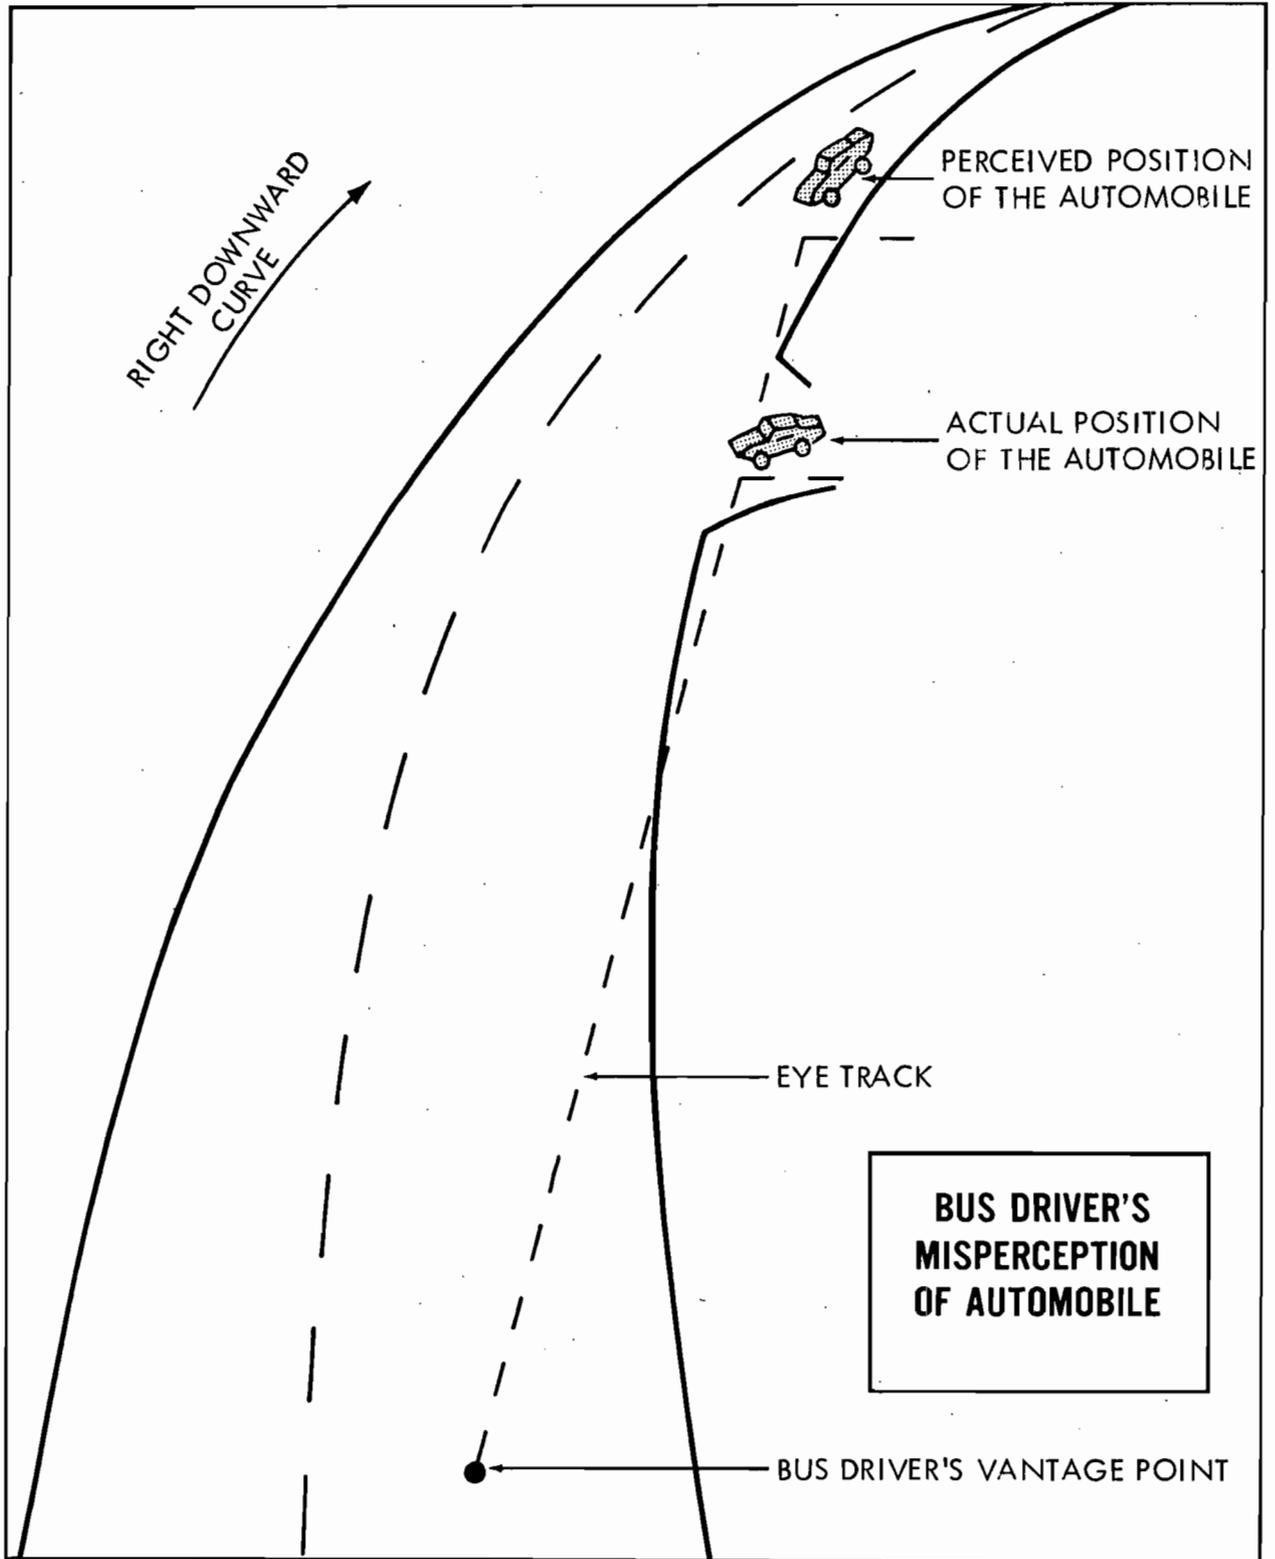
Figure 5

than it was in fact, this would tend to make the automobile appear to be out in his roadway in the manner indicated above (Figure 5). Several factors may have tended to make the busdriver perceive the automobile as being farther away than it was in fact. First, he was not viewing the automobile's headlamps head-on, although he assumed he was. When viewed from an angle, the distance separating the headlamps would be the same as for a more distant vehicle viewed head-on. Also, the intensity of the lights viewed from an angle (especially from the left) would be the same as for lights viewed head-on from some greater distance. Finally, Dr. Allen reports that under foggy conditions, people generally err on the side of perceiving things to be farther away than they actually are. There are, no doubt, other possible explanations for the busdriver's misperception of the automobile, but the above is submitted as the most probable.
