# NATIONAL TRANSPORTATION SAFETY BOARD

## HIGHWAY ACCIDENT REPORT

COLLAPSE OF  
NEW YORK THRUWAY (I-90) BRIDGE  
OVER THE SCHOHARIE CREEK,  
NEAR AMSTERDAM, NEW YORK  
APRIL 5, 1987

NTSB/HAR-88/02

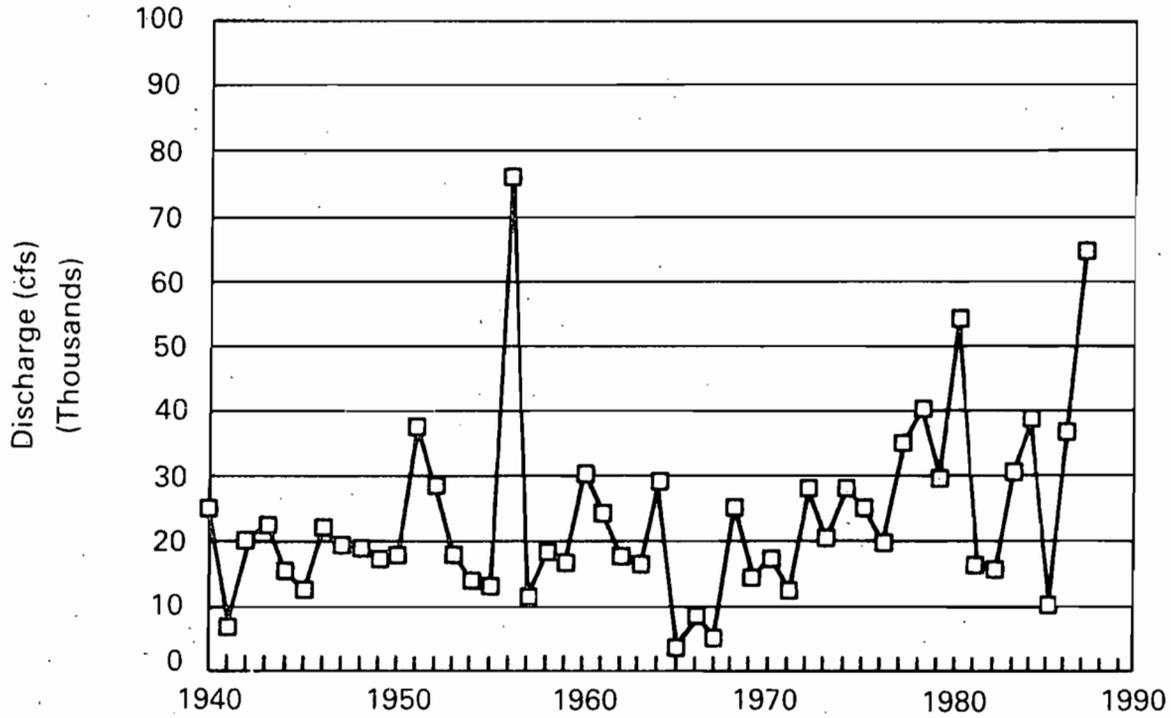
Figure 3.--Annual peak discharges at Burtonsville Gage.

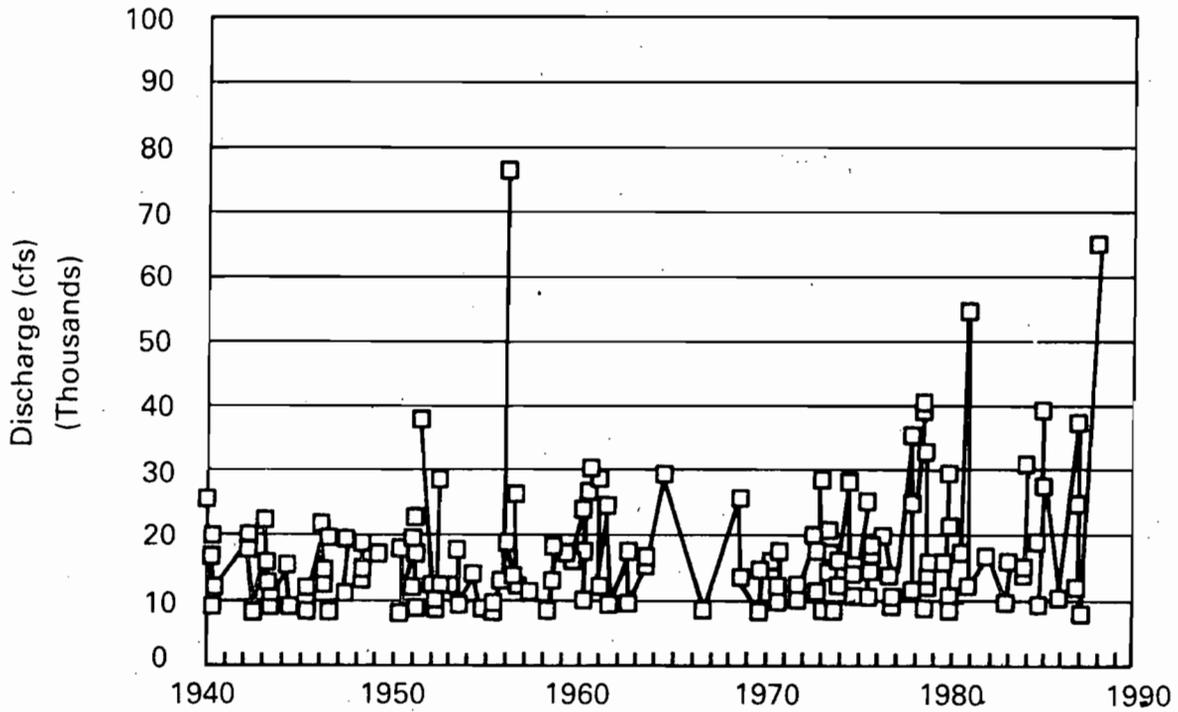
Figure 4.--All floods greater than 8,000 cfs at Burtonsville Gage.

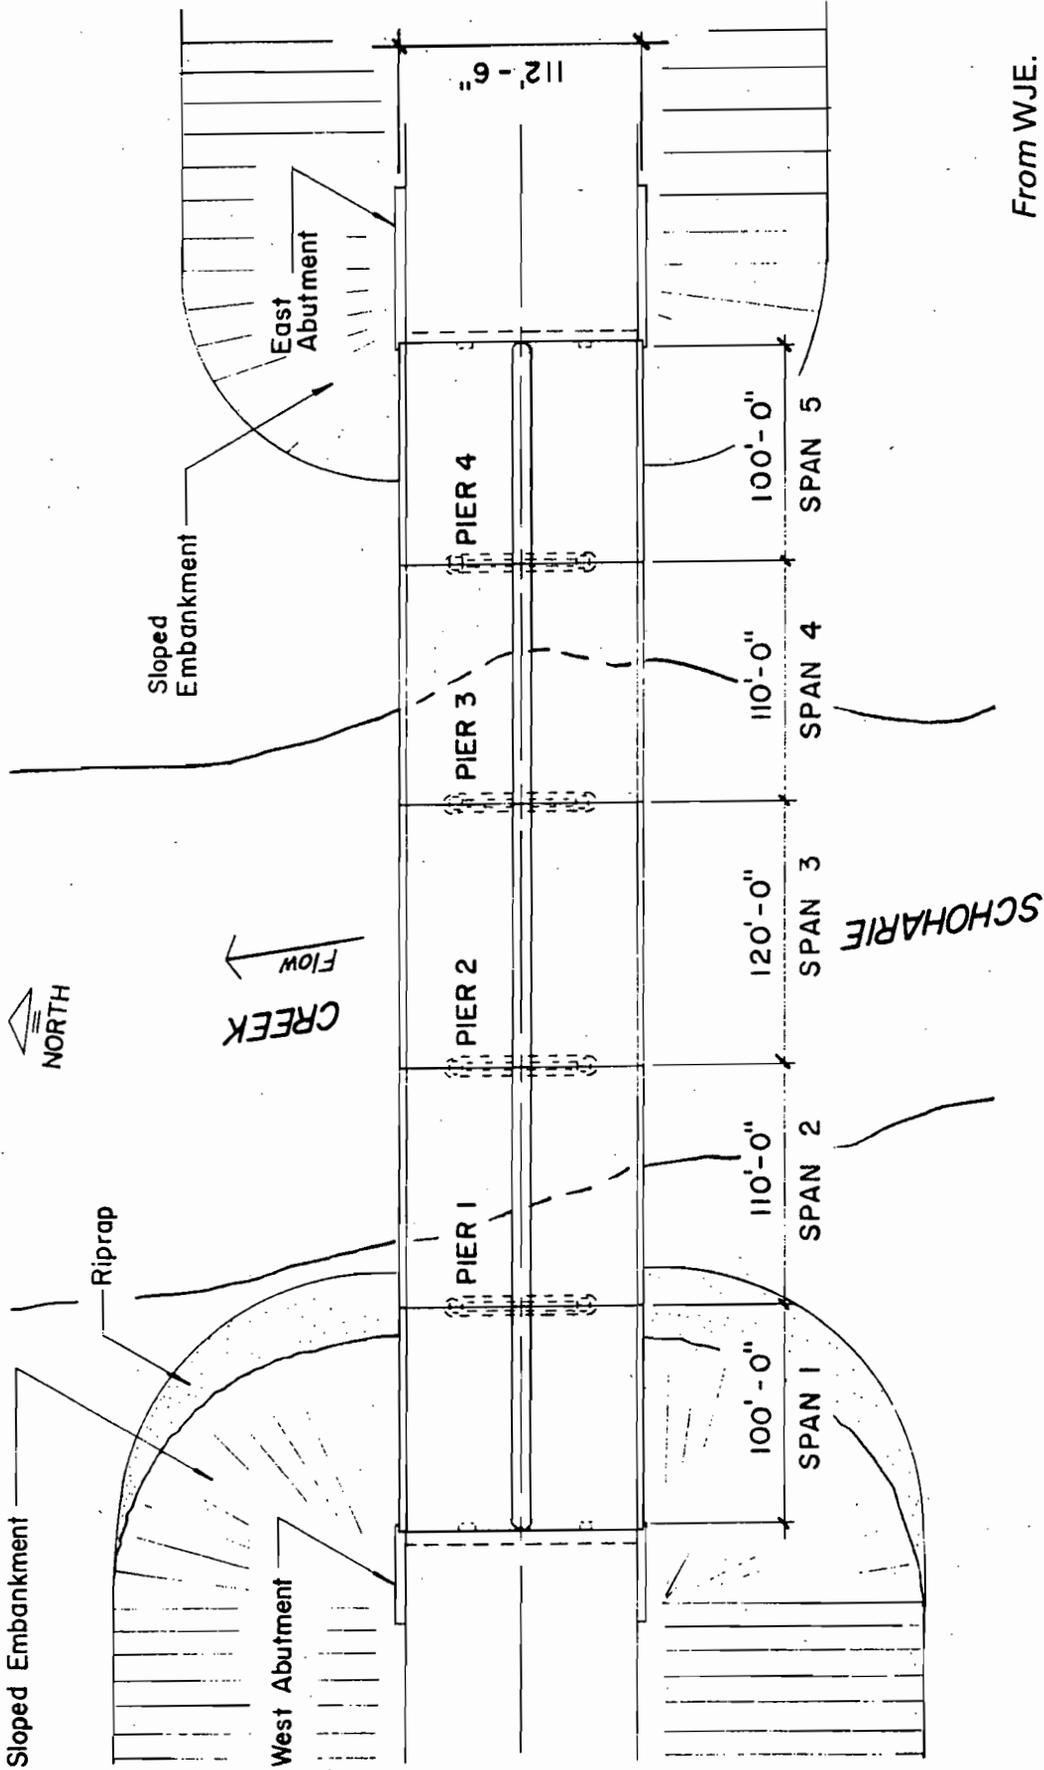
The Schoharie Creek Bridge consisted of five spans with nominal lengths of 100, 110, 120, 110, and 100 feet, for a total length between abutments of 540 feet. A schematic plan, developed by Wiss, Janney, Elstner Associates, Inc. (WJE), 19/ from the original drawings is shown in figure 7. The profile drawing from the original design plans is shown in figure 8. Figure 9 shows the pier details based on a WJE drawing.

Figure 7.--Schematic plan of bridge.

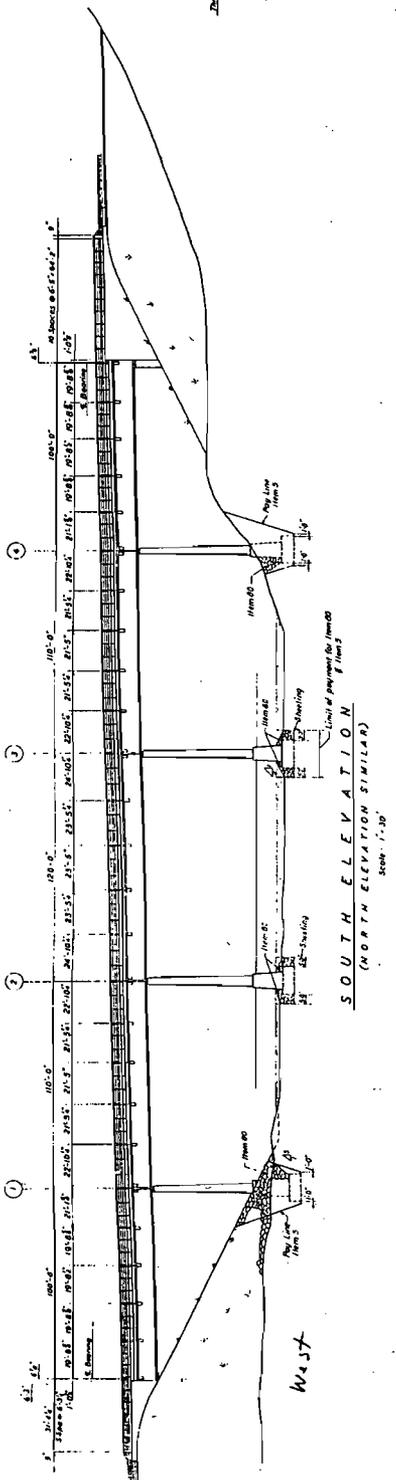
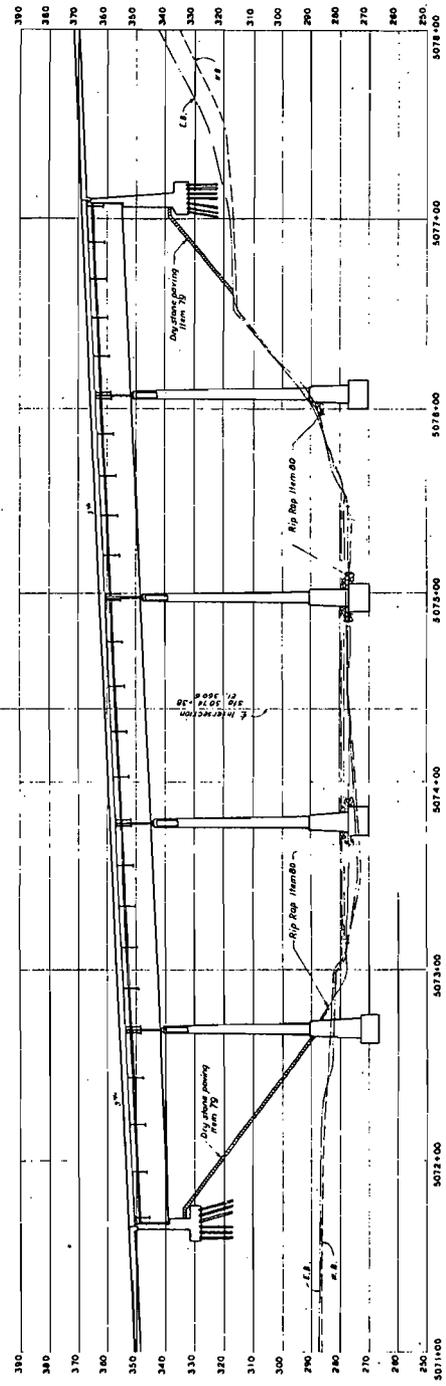
FIGURE 8. - - ORIGINAL DESIGN PLAN.

Pavlo's design plans (figure 8) showed steel sheeting in the top view at piers 2 and 3 and not the other materials permitted by the Item 82 specification. No sheeting was shown at piers 1 and 4. The bottom view of the design plans did not show sheeting at any of the piers.

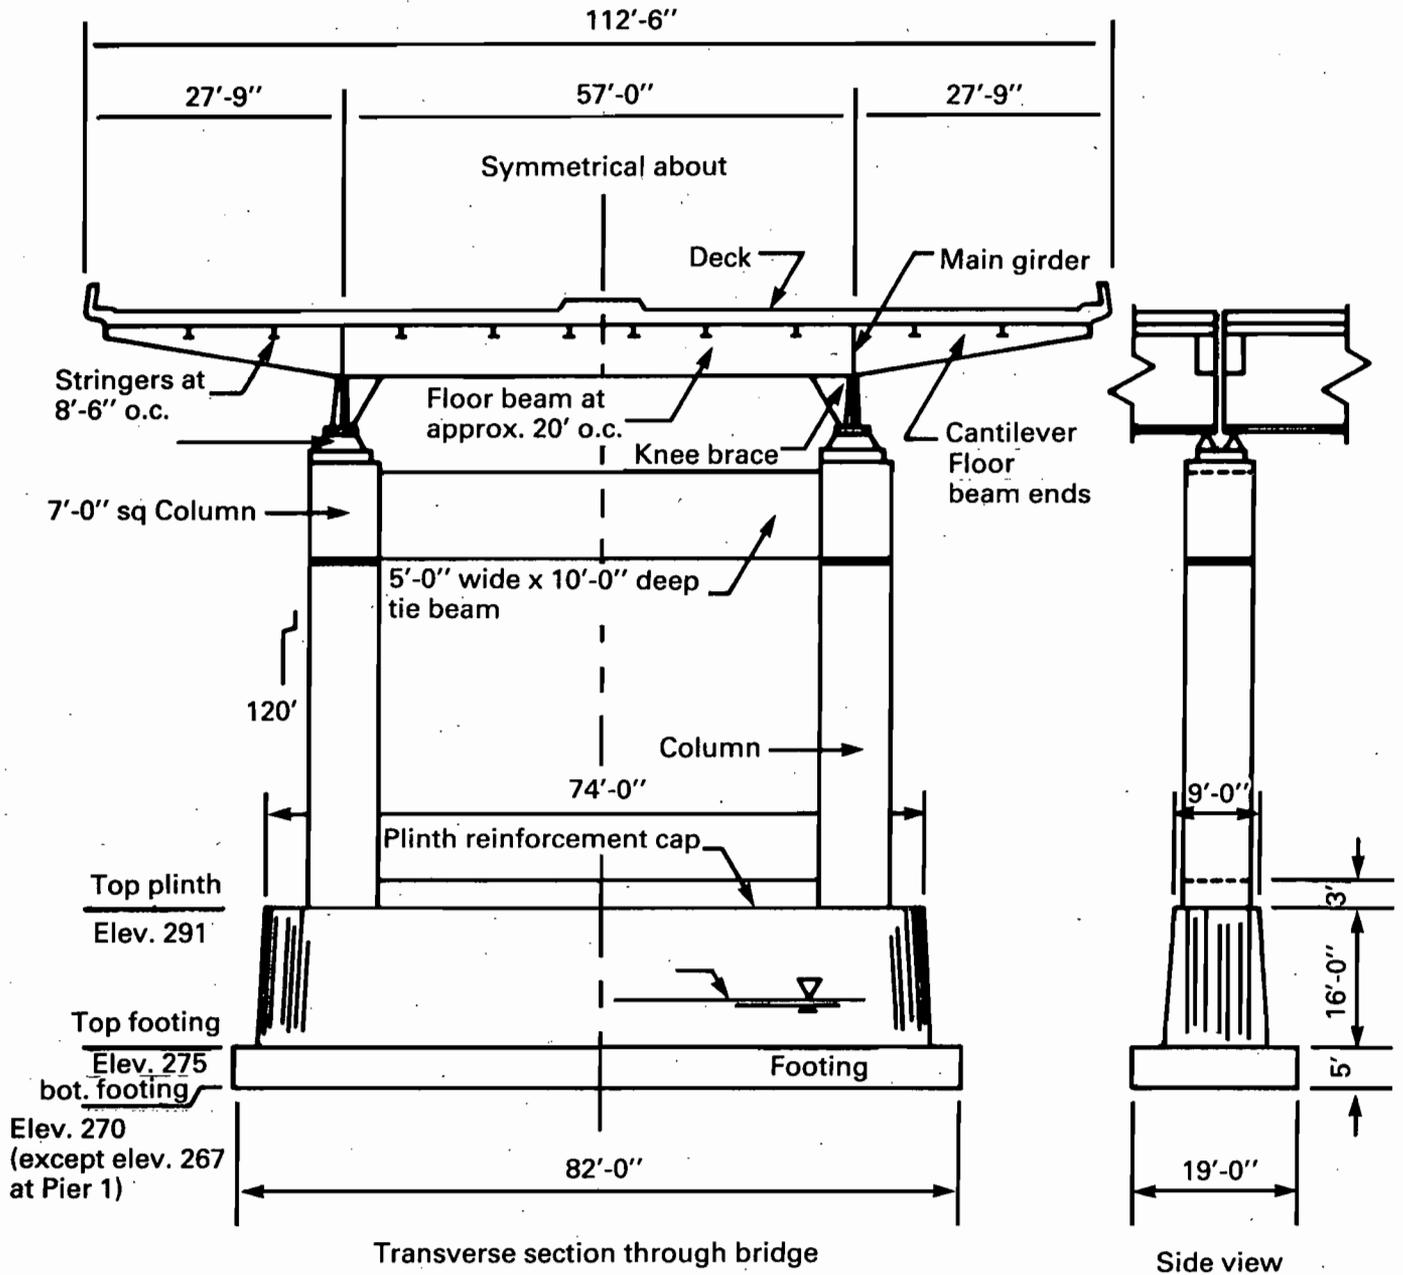
Figure 9.--Sections of the bridge pier.

The piers were designed as rigid concrete frames, each consisting of two columns connected by a tie beam near the column tops and supported on a plinth and spread footing. (See figure 9.) Because of the vertical grade of the bridge, height of the columns varied, from about 50 feet for pier 1 to about 60 feet for pier 4. The bottoms of the footings of piers 2, 3, and 4 were placed at an elevation of 270 feet; the bottom of pier 1 was placed at an elevation of 267 feet based on the results of the boring tests.

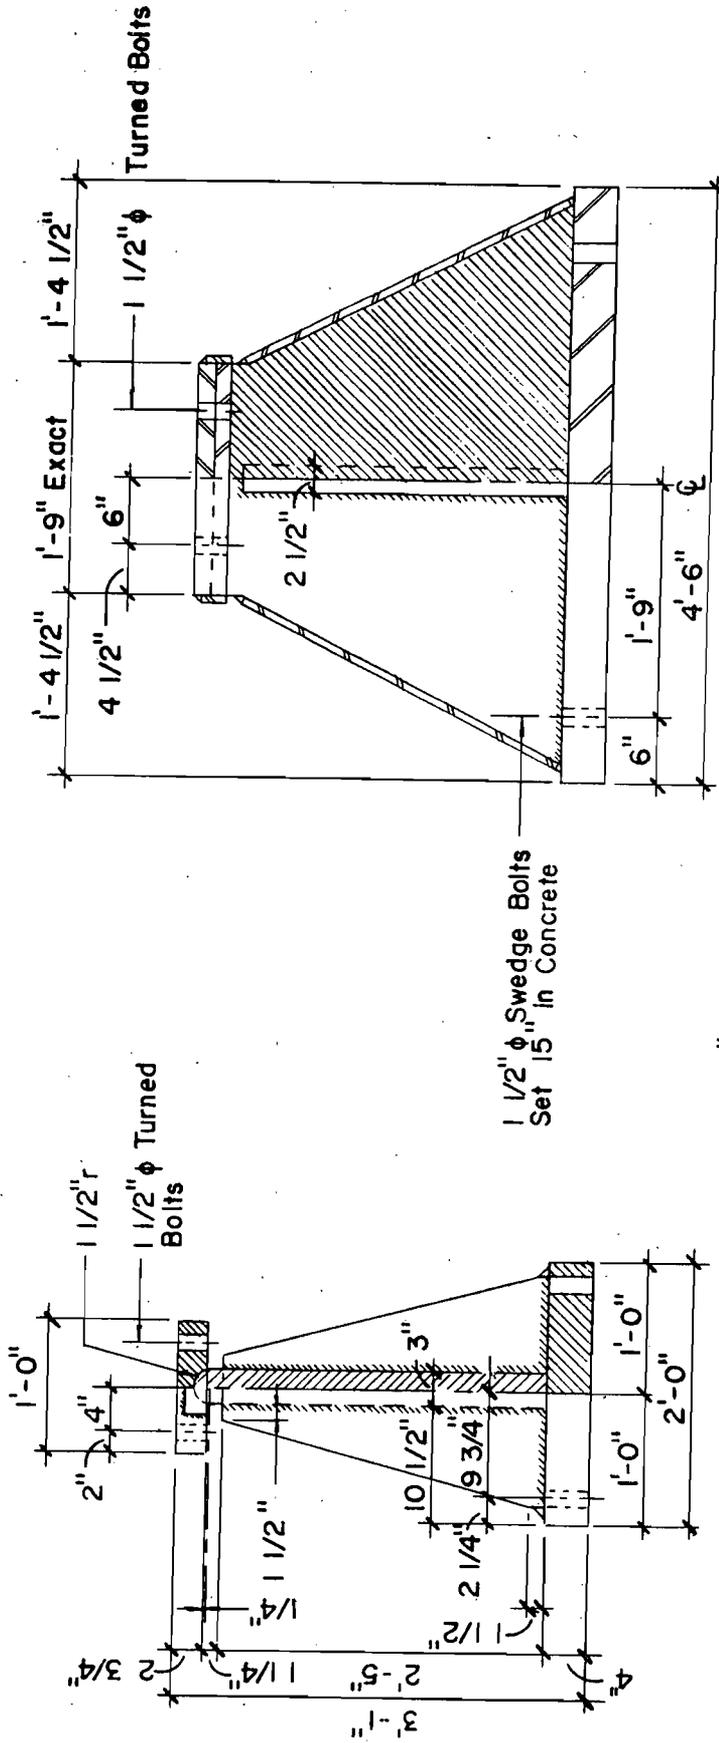
Figure 15.--Fixed bearing details.

Expansion joints separated the spans. The east end of each main girder was supported by a fixed bearing, anchored either to the concrete piers or to an abutment. The west end of each main girder was supported by a rocker (expansion) bearing. (See figures 15 and 16.)

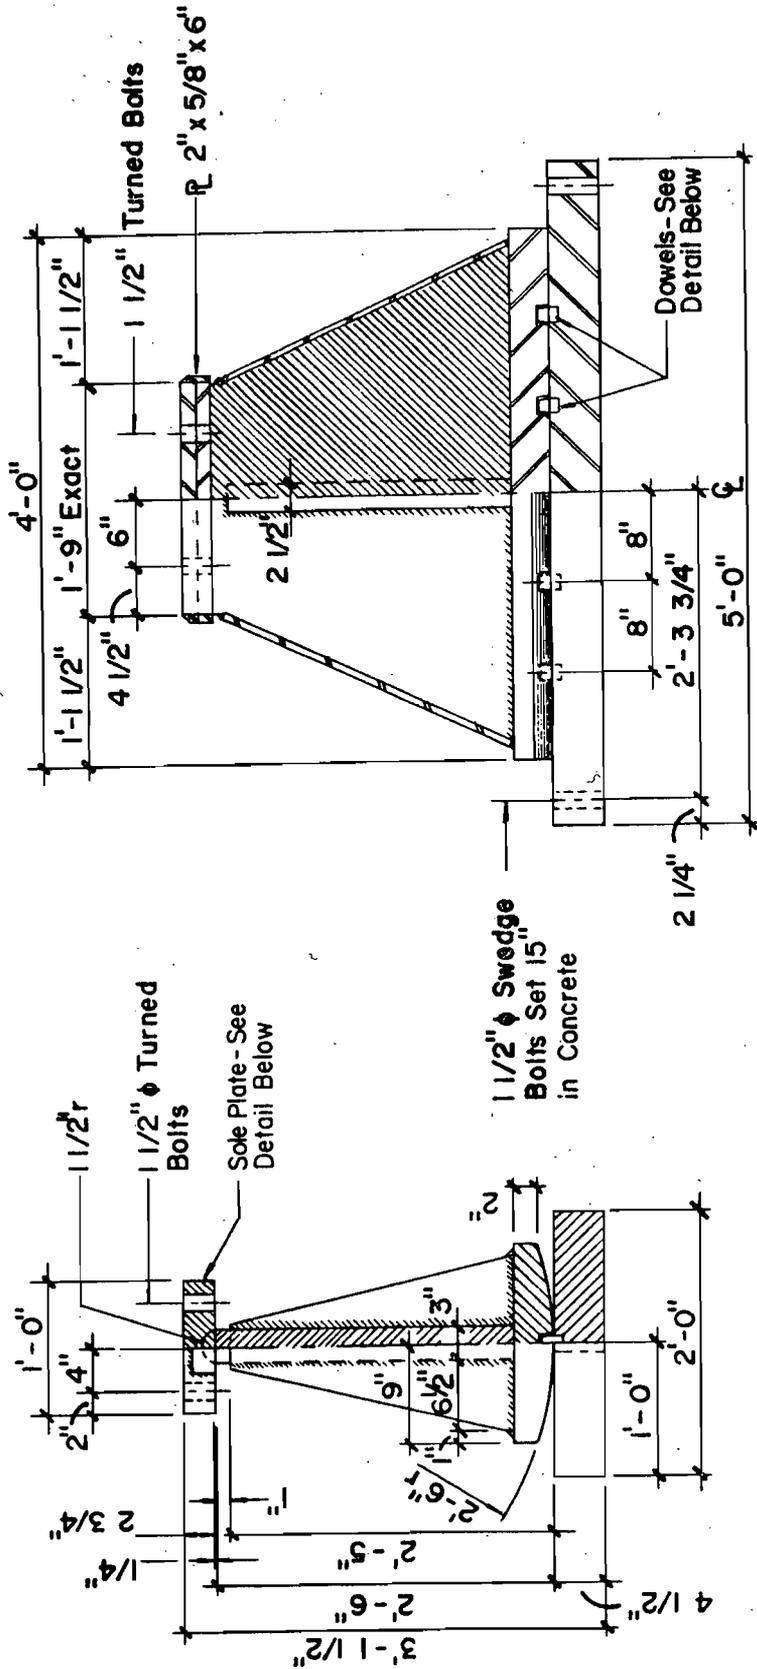
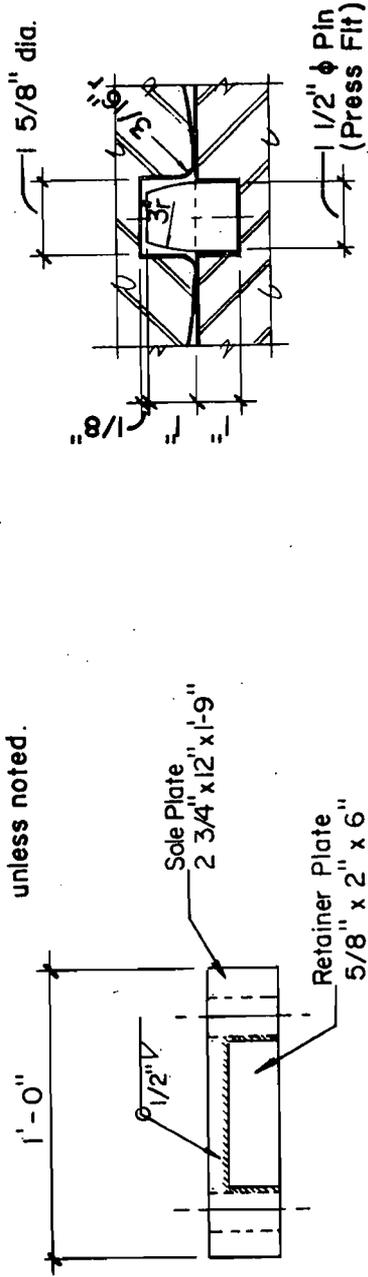
Figure 16.--Expansion bearing details.

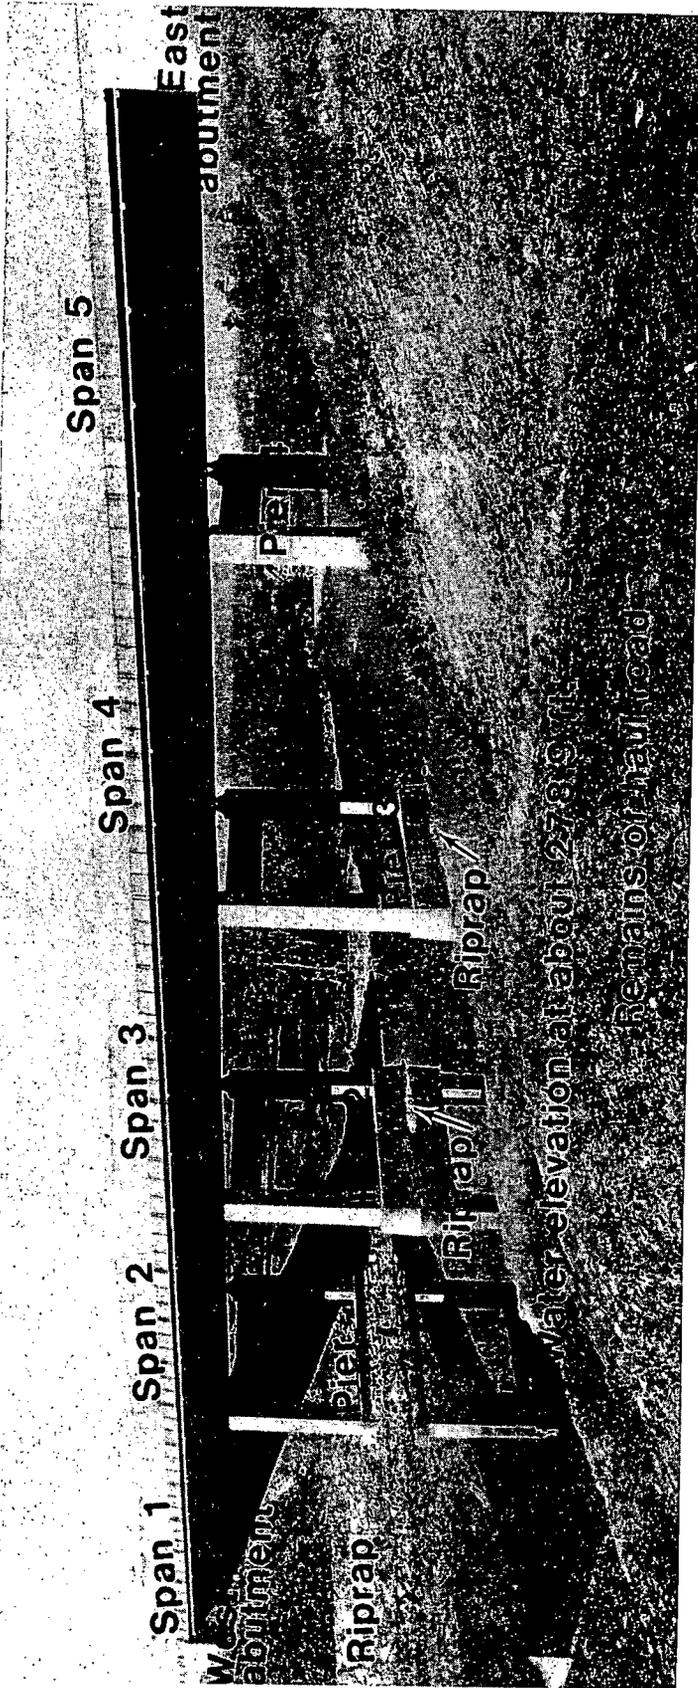
Three photographs taken on October 30, 1956, show riprap at the bridge piers. These photographs show that the water level was between elevation 278 and 279 feet, which is about 1 foot below the top of the riprap as called for in the design plans. In one photograph (figure 21), very little riprap was visible on the southeast side of pier 2, while a slight mound of riprap visible on the northeast corner extends upward to an elevation of about 281 feet. The second photograph (figure 22) shows a water elevation of about 279 feet, with only a few pieces of riprap visible on the west side of pier 3. On the west side of pier 2, some riprap is visible to an elevation of about 281 feet. In the last photograph (figure 23), between the columns of pier 3 on the east side, riprap is visible at an elevation of 283, which was 3.5 feet above the height called for.

Figure 21.--Photographs of the Schoharie Creek Bridge  
Looking northwest on October 30, 1956.

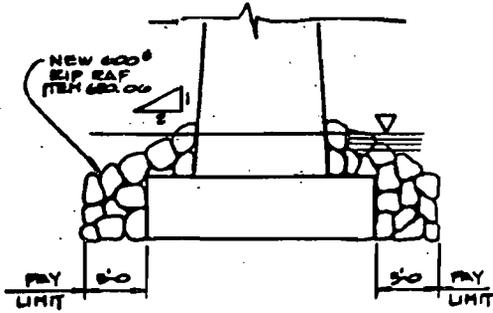
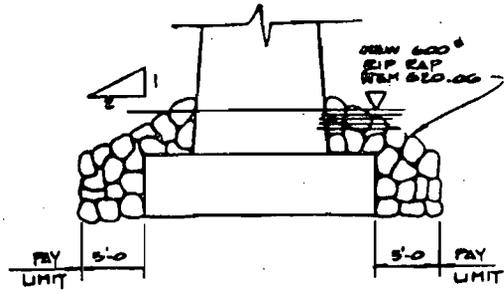
Pier #2

During testimony given at the Safety Board's public hearing, the project manager for the firm stated that in August 1977, they took some drop line readings around the plinth. The water level was extremely low and the water was clear. They compared the readings with original as-built drawings and determined that some of the riprap was no longer present. The firm could not find the actual drop line readings in their files, but the project manager stated that the profile and elevation drawings, dated December 28, 1979, were prepared for the NYSTA based on drop line measurements. The drawings show both the firm's and the NYSTA's logos. Copies of a photograph and drawings from the design plans are shown in figures 26 and 27.

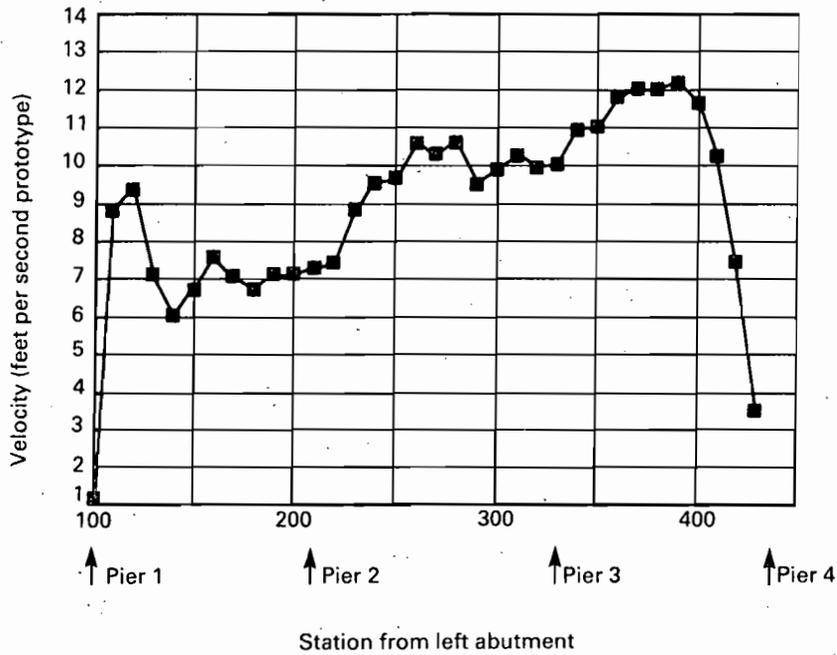
The velocity distribution across the creek at the bridge for the flood of 1987 (with a tailwater elevation of 294 feet) is shown in figure 30. The greatest velocity, 12.5 fps, occurred in the channel between piers 3 and 4. Directly upstream of pier 3, the velocity was about 10.8 to 11.2 fps. The surface flow upstream of pier 3 was aligned with the pier. However, the bottom flow approached the pier from the east about 5 degrees out of alignment. At pier 2, the velocity was 7.5 fps. The velocity at pier 2 was aligned with the pier on both the surface and at the bottom, even though the flow coming from the cornfield had a dramatic appearance on the surface when re-entering the main flow.

Figure 30.--Velocity profile upstream of the bridge for the 1987 flood condition.

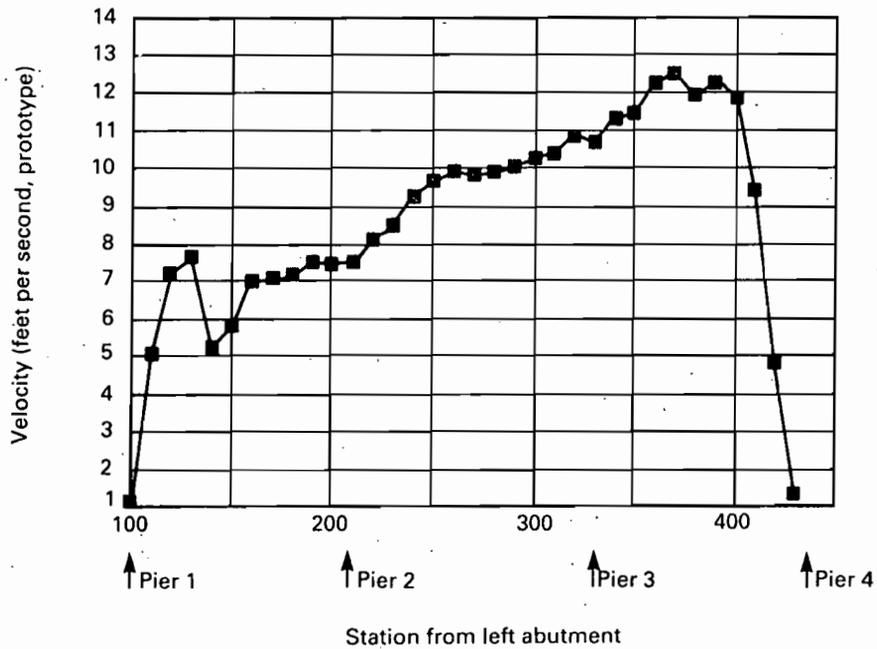
Figure 31.--Velocity profile upstream of the bridge for the 1955 flood condition.

The velocity distribution across the creek for the flood of 1955 (with a tailwater elevation of 296 feet) is shown in figure 31. Again, in this test run, the greatest velocity, this time 12.1 fps, occurred in the channel between piers 3 and 4. Directly upstream of pier 3, the velocity was 10.0 fps.

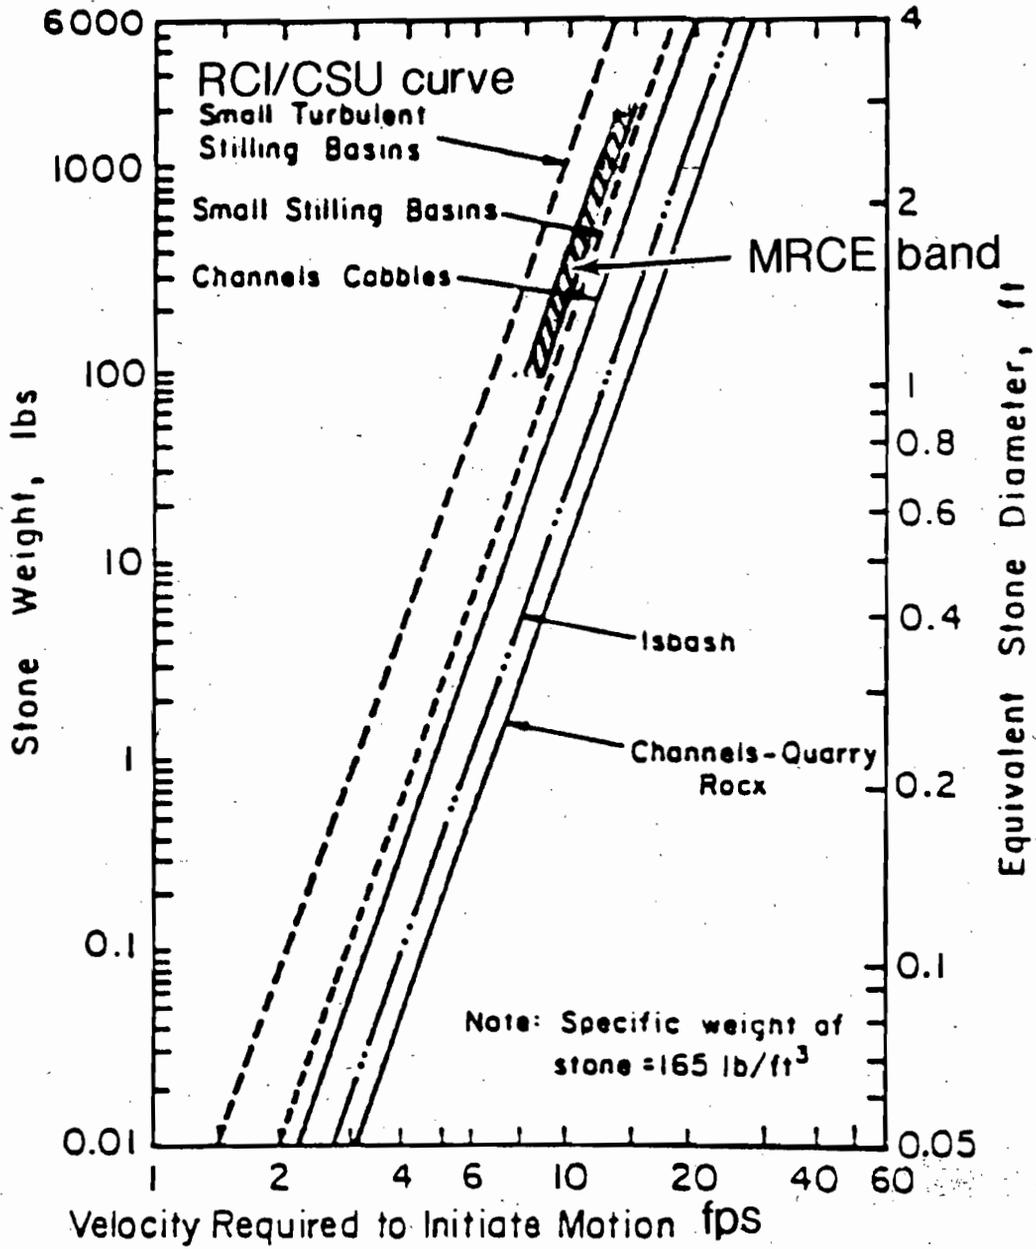
The RCI/CSU study also addressed the magnitude of water velocity that would move rocks of given sizes. Their analysis is based on the implicit assumption that the density of all rocks is the same and therefore the weight of all rocks of concern is proportional to the cube of their diameter. Based on their experience, RCI/CSU concluded that the water conditions at the base of pier 3 during flood conditions are most closely represented by studies done in a small turbulent stilling basin to determine the velocities needed to move various size rocks. WJE's hydraulic consultant (Modjeski and Master (M&M)) concluded that conditions somewhere between those encountered in a small turbulent stilling basin and in a non-turbulent stilling basin best represented the conditions that existed at pier 3 at the time of the bridge collapse. Two values were presented in the WJE report, one for a safe weight for placement in the bottom of a channel with turbulent flow and one that was 1.5 times heavier than the other value to account for factors that might allow easier movement, such as exposed placement and rounded shape. Table 7 presents the weight of stone that can be moved by given velocities based on each consultant's experience. Figure 37 is a plot of the velocities as a function of stone size by weight based on RCI/CSU analysis, WJE analysis, and data compiled by the Army Corp of Engineers (Isbash 1932 to 1936).

Figure 37.--Critical velocity as a function of stone size.

The variations in the data provided by MRCE and CSU on the magnitude of stream velocities needed to move riprap of given weight are an indication of the uncertainty that now exists in specifying the size of riprap needed for scour protection. (See table 7 and figure 37.) The median weight of the item 80 riprap at the bridge was to have been 300 pounds. CSU concluded that the conditions in a turbulent stilling basin best represented conditions at pier 3. CSU found that a 300-pound rock would move in water with a velocity of 7.9 fps. However, CSU also stated that this velocity could vary by as much as 25 percent, which indicates a 300-pound rock could move in water at a velocity of from 6 to 10 fps. MRCE data indicate that a 300-pound rock would move in water at 10.1 to 10.8 fps.

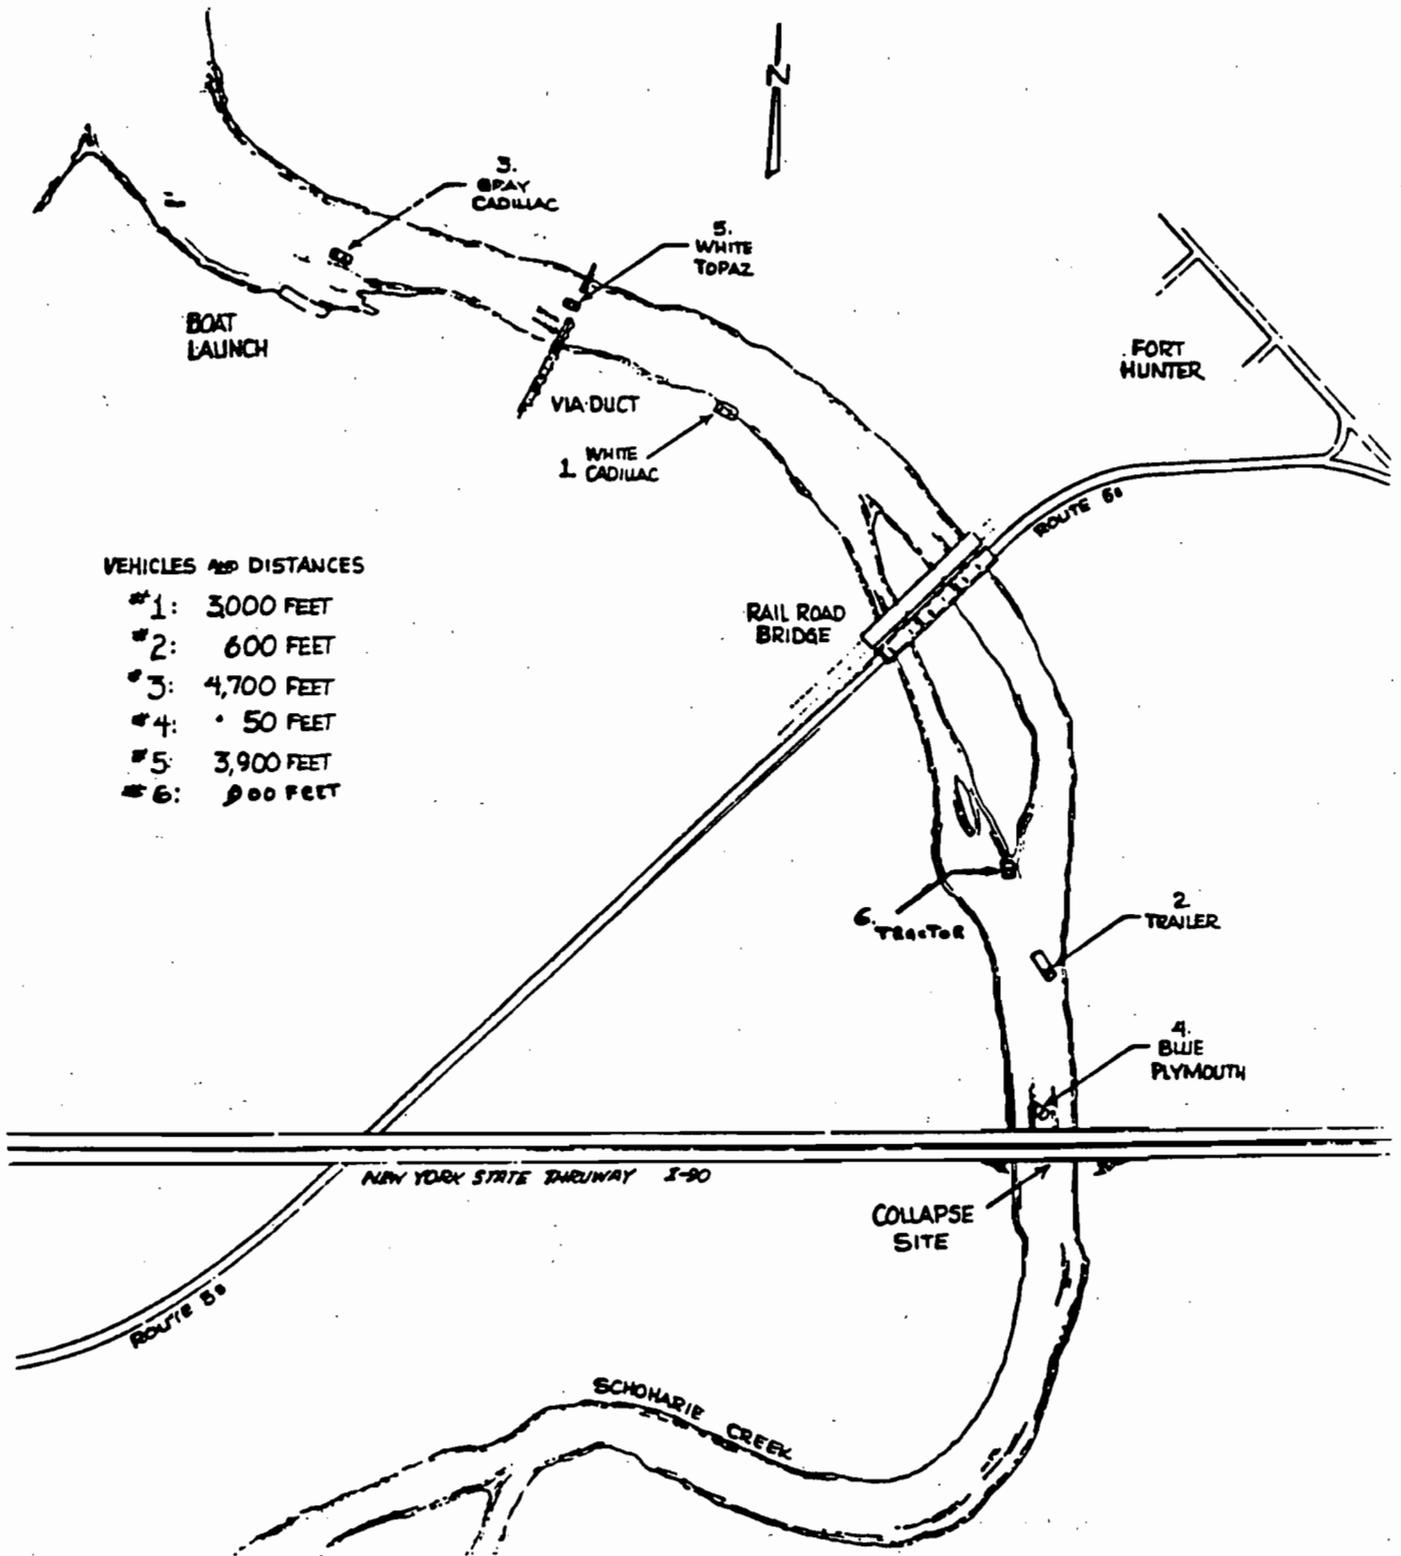
# LOCATION OF VEHICLES AFTER ACCIDENT

- #1: 3000 FEET
- #2: 600 FEET
- #3: 4,700 FEET
- #4: 50 FEET
- #5: 3,900 FEET
- #6: 900 FEET

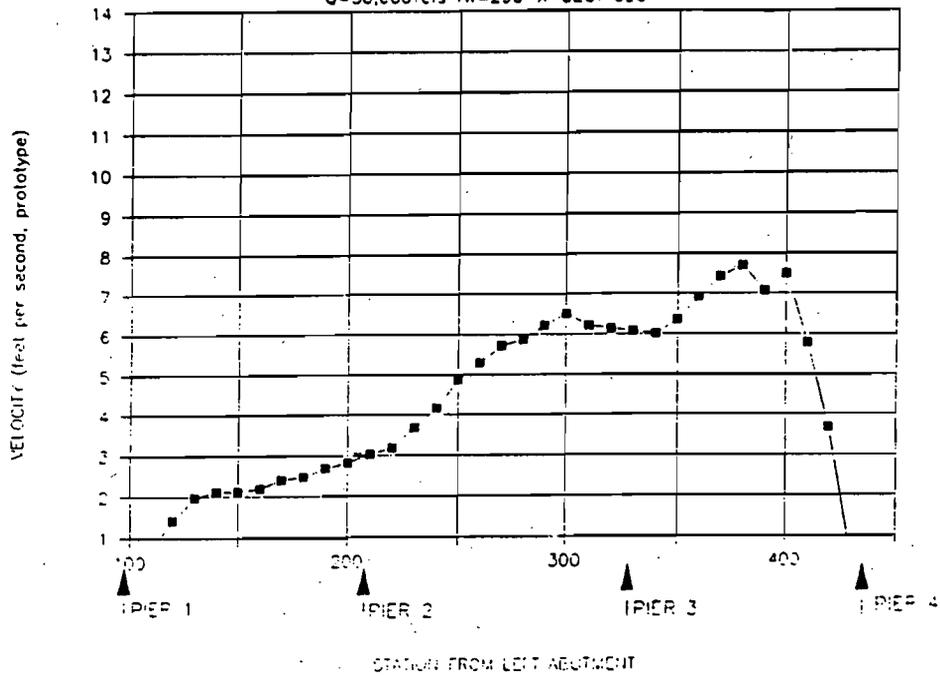
SCHOHARIE CREEK VELOCITY CROSS SECTION

Q=30,000 cfs TW=290' X-SECT U20

FIGURE D.10. Velocity profile for 30,000 cfs and a 290 feet elevation tailwater, the bank full condition.
