Motorcoach Run-Off-the-Road and Rollover
U.S. Route 163
Mexican Hat, Utah
January 6, 2008

NTSB/HAR-09/01
PB2009-916201

Highway Accident Report

National Transportation Safety Board. 2009. *Motorcoach Run-Off-the-Road and Rollover, U.S. Route 163, Mexican Hat, Utah, January 6, 2008.* Highway Accident Report NTSB/HAR-09/01. Washington, DC.

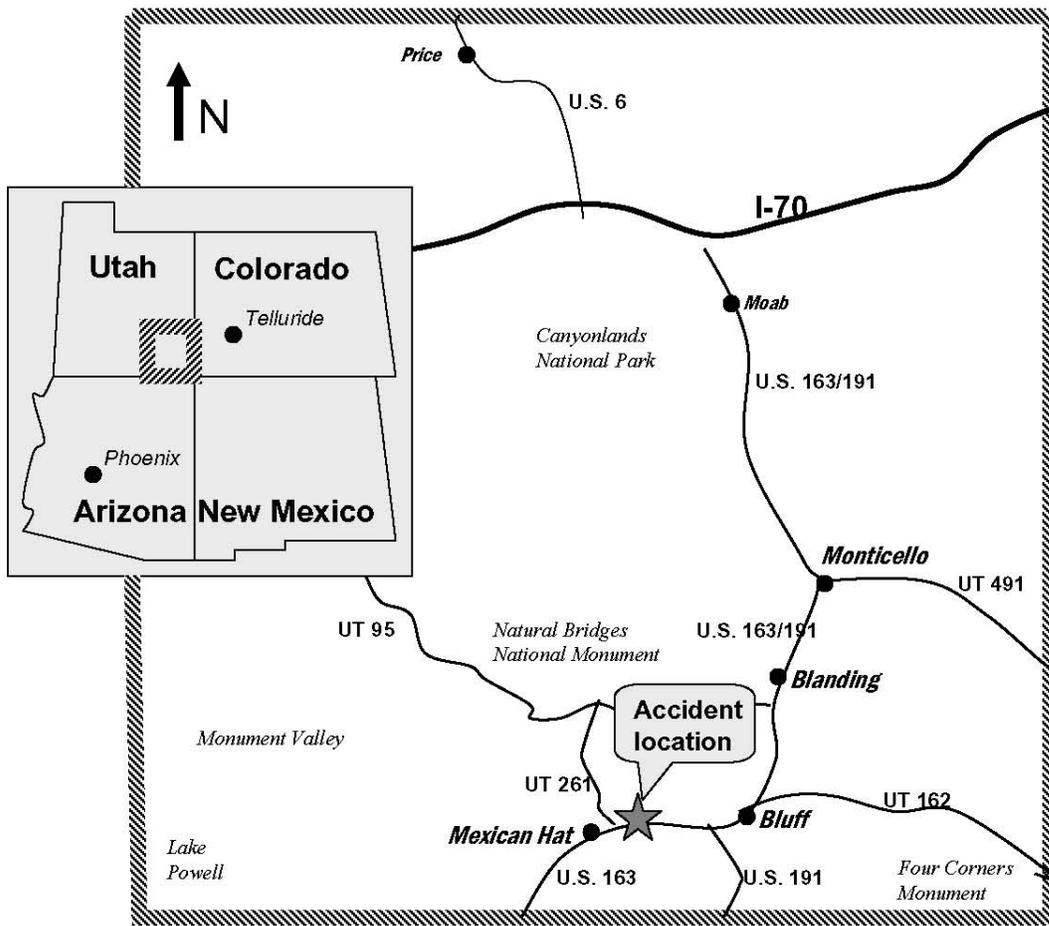
Figure 1. Accident motorcoach's route.

The motorcoach's travel route was affected by snow and ice during the Colorado segment of the trip. After crossing into Utah, the accident motorcoach turned south on U.S. 163/191 for approximately 80 miles, at which point U.S. 191 separates with a left turn to the south before crossing into Arizona. The accident driver missed the turn to remain on U.S. 191; instead he stayed on U.S. 163 going further west. Both U.S. 163 and U.S. 191 eventually join U.S. 160 heading southwest through Arizona. Most of the caravan of motorcoaches took the U.S. 191 route; the accident driver and one other driver remained on U.S. 163. Figure 1 shows the route of the motorcoach in the vicinity of the accident. In a postaccident interview, the driver stated that he was unsure of which route he was traveling but knew that the route he was on would take him toward Phoenix.

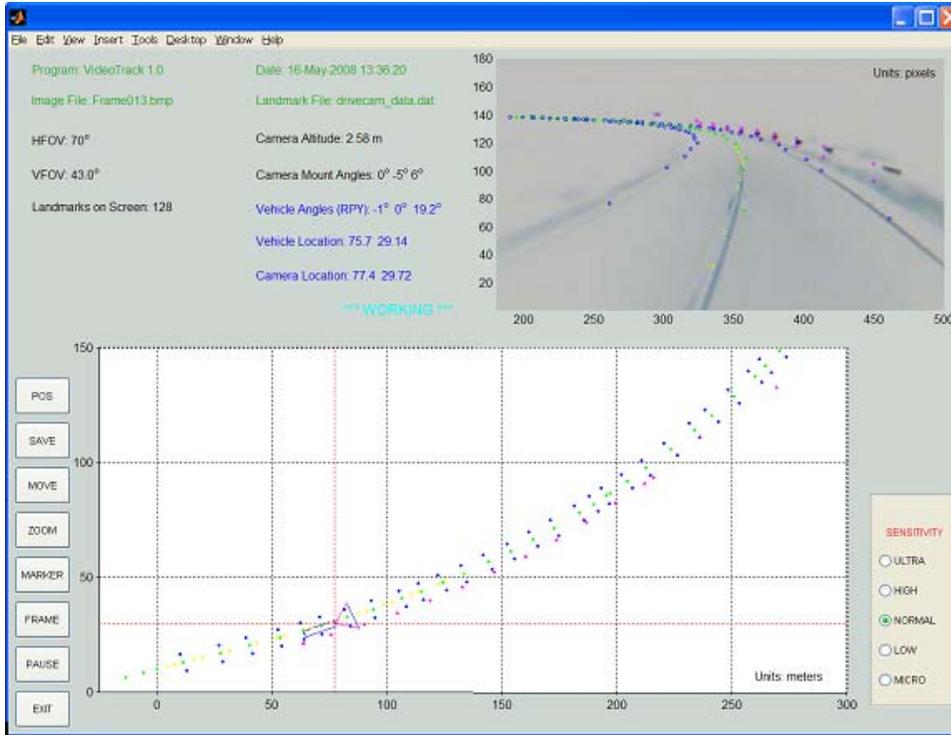
Figure C-1. Vehicle at time -7 seconds.

Speed estimation is performed interactively. The user moves the vehicle that is displayed in the program’s graphical user interface (GUI) until the landmarks coincide. Vehicle speed can be estimated by dividing the distance between two vehicle locations by the time difference between the corresponding camera image frames. Figures C-1, C-2, and C-3 show the program GUI at times –7 seconds, –6 seconds, and –5 seconds, respectively. The vehicle is positioned at its estimated locations at those times. The lower plot in figures C-1 through C-3 shows the surveyed landmarks and the vehicle, with plot points corresponding to survey points representing the white solid lines on the pavement, the solid yellow lane-dividing line, the ends of broken yellow line segments, and the locations of reflectors. The upper plot is the camera image (shown as negative of the original), which shows the locations of the survey points as computed by the camera model that is built into the analysis program. Each reflector is marked at the elevation of the reflective surface and at ground level beneath it.

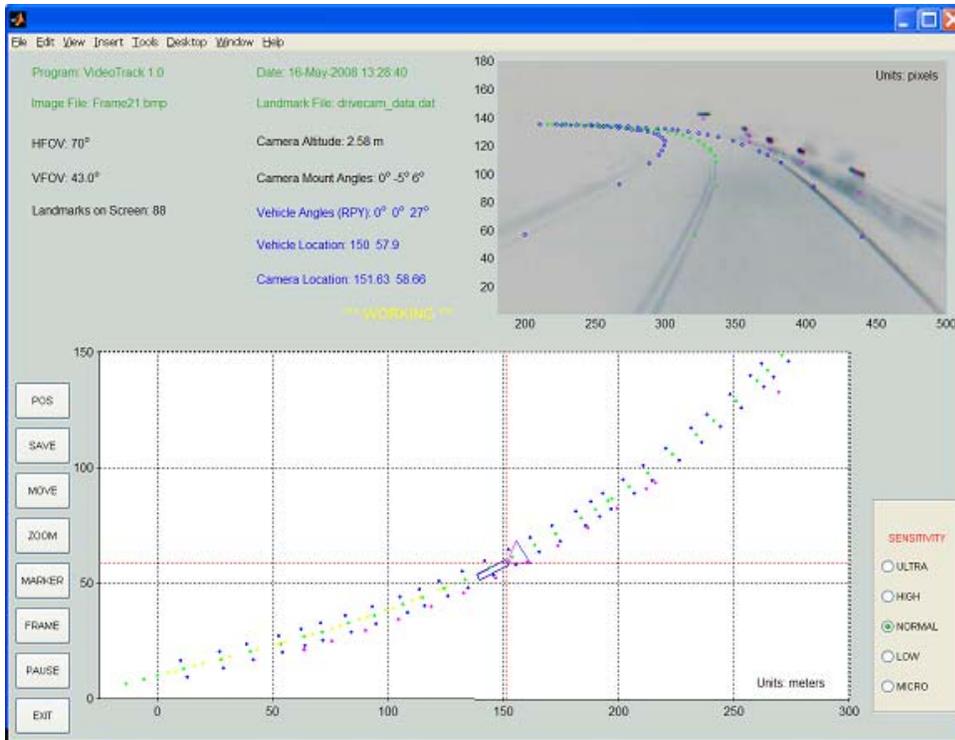
Figure C-3. Vehicle at time –5 seconds.

The motorcoach's location was estimated at 19 positions, corresponding to 19 camera frames spanning the time period from –8.75 to –4.25 seconds. The vehicle's speed was estimated using the formula $V_n = \Delta x / \Delta t$, where Δx is the total travel of the vehicle during n contiguous time intervals, and Δt is $0.25 \times n$. The middle line in the graph shown in figure C-4 represents this nominal speed estimate. The estimate becomes more accurate as more contiguous intervals are considered.
