Highway–Railroad Grade Crossing Collision  
Midland, Texas  
November 15, 2012

NTSB/HAR-13/02  
PB2014-100830

# Highway Accident Report

**Abstract:** About 4:35 p.m. on November 15, 2012, in Midland, Texas, a freight train collided with a parade float at a highway–railroad grade crossing, resulting in 4 fatalities and 12 injuries. The float consisted of a 2006 Peterbilt truck-tractor in combination with a 2005 Transcraft D-Eagle drop-deck flatbed semitrailer and was traveling south on South Garfield Street as part of a parade procession honoring US military men and women. The float, occupied by 12 veterans and their spouses, continued along South Garfield Street until it reached the intersection of West Front Avenue, where the traffic signal displayed red. Law enforcement personnel stationed to block cross traffic permitted the float and its escorts to continue across the intersection unhindered. About 80 feet south of the West Front Avenue intersection was an active highway–railroad grade crossing, and the crossing’s warning system activated as the float approached. The float continued across the railroad tracks at an estimated speed of 5 mph. A Union Pacific Railroad freight t

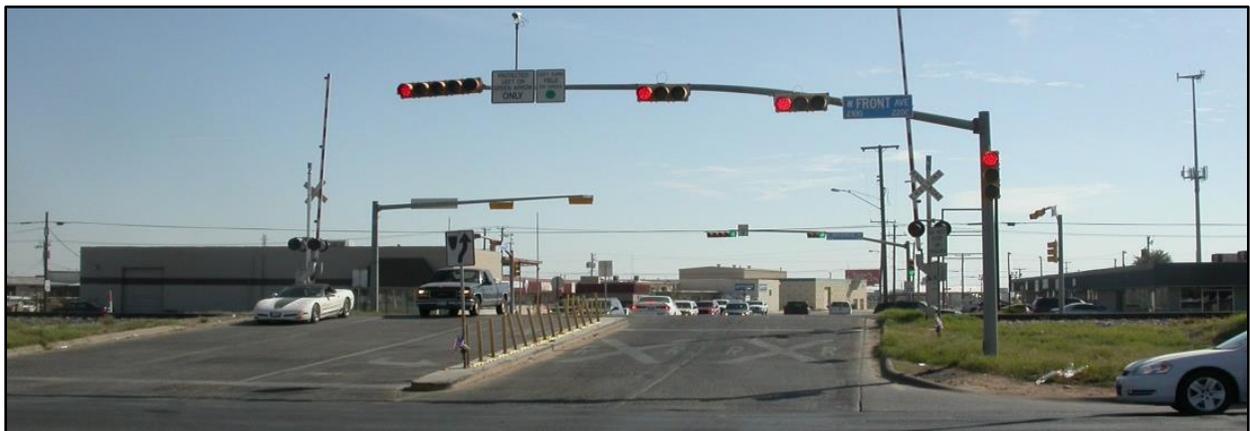
The float continued along South Garfield Street and reached the intersection of West Front Avenue, where it slowed to about 5 mph (see figure 4). The highway traffic signal at the intersection was red; however, law enforcement personnel blocking traffic on West Front Avenue allowed the float to proceed unhindered (see figure 5). About 80 feet from the south curb of the West Front Avenue intersection was an active hump highway–railroad grade crossing (grade crossing).<sup>1</sup> As the float negotiated the incline on approach to the grade crossing, the warning system activated. The float continued to move forward onto the railroad tracks. As it did so, the grade crossing gate, situated 12 feet north of the tracks, descended on the float. The escort vehicles slowed and came to a stop several feet north of the descending gate.

**Figure 4.** Traffic lights on southbound South Garfield Street at the intersection with West Front Avenue and the incline leading to grade crossing.

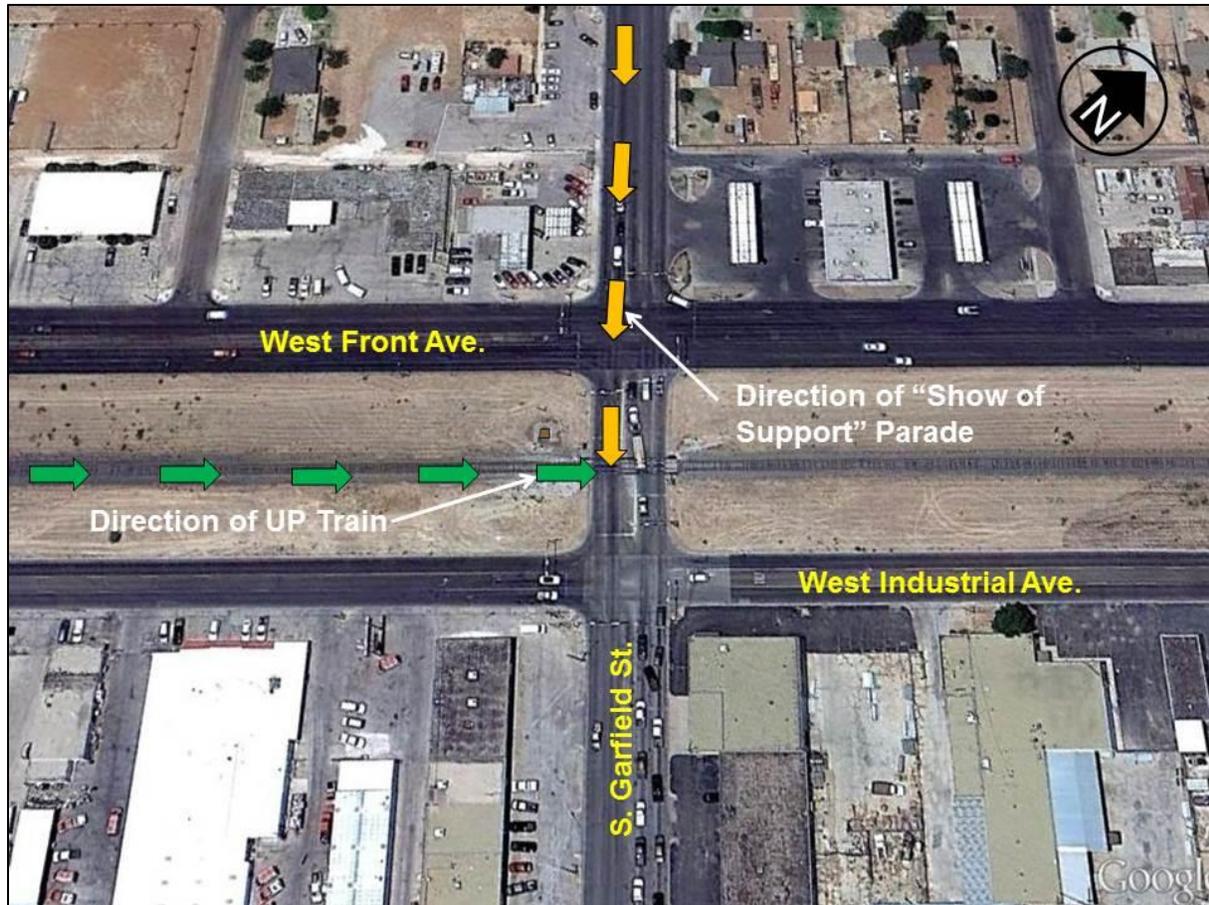
**Figure 5.** Aerial view of the crash site with arrows marking route of parade and train. (Photo courtesy of Google Maps)

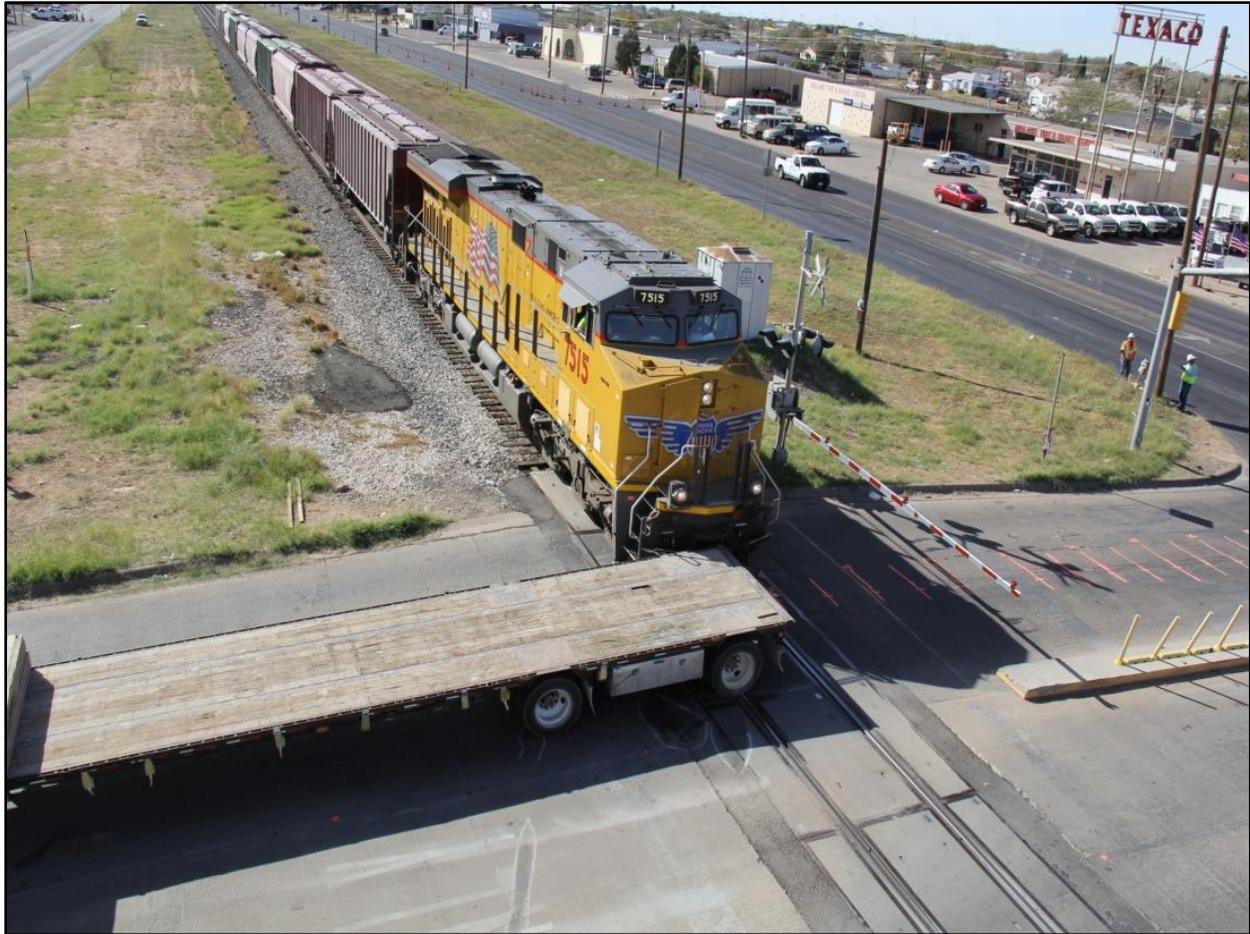
Union Pacific Railroad (Union Pacific) freight train ZLCAI-14 (train) was traveling east from Los Angeles, California, to Atlanta, Georgia, at a speed of 62 mph. The train crew consisted of a 35-year-old engineer and a 27-year-old conductor. The engineer stated that when he realized the float was not going to stop at the grade crossing, he sounded the train horn and placed the train into emergency braking. At about 4:35 p.m., the right front corner of the locomotive unit struck the right rear portion of the float (see figure 6). The train did not derail and continued braking to a stop.

**Figure 6.** Reconstruction of the vehicle positions at the time of the collision with train.

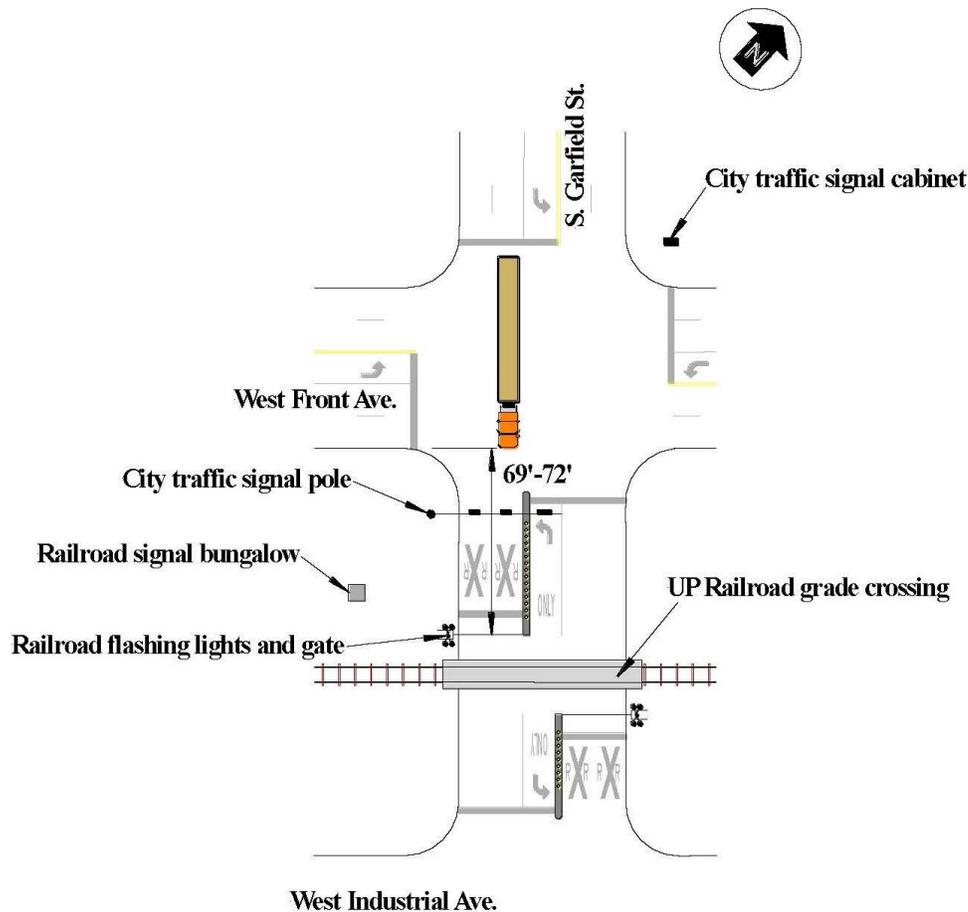
Approximately 21 seconds before impact, as the front of the float approached the south curb of the West Front Avenue intersection, the grade crossing warning system lights and bells activated. The float was approximately 61–64 feet from the grade crossing stop line and 69–72 feet from the crossing gate (see figure 8), which had not yet begun to descend. The float and escort vehicles continued to move forward. Soon after activation of the grade crossing warning system, the driver of the escort vehicle to the left of the float noticed the flashing lights and bells, and repeatedly yelled “train” over the Midland County Sheriff’s radio channel.<sup>4</sup> Approximately 13.5 seconds before impact, the crossing gate began to descend on top of the float.

**Figure 8.** Approximate position of the float when the grade crossing warning system activated.

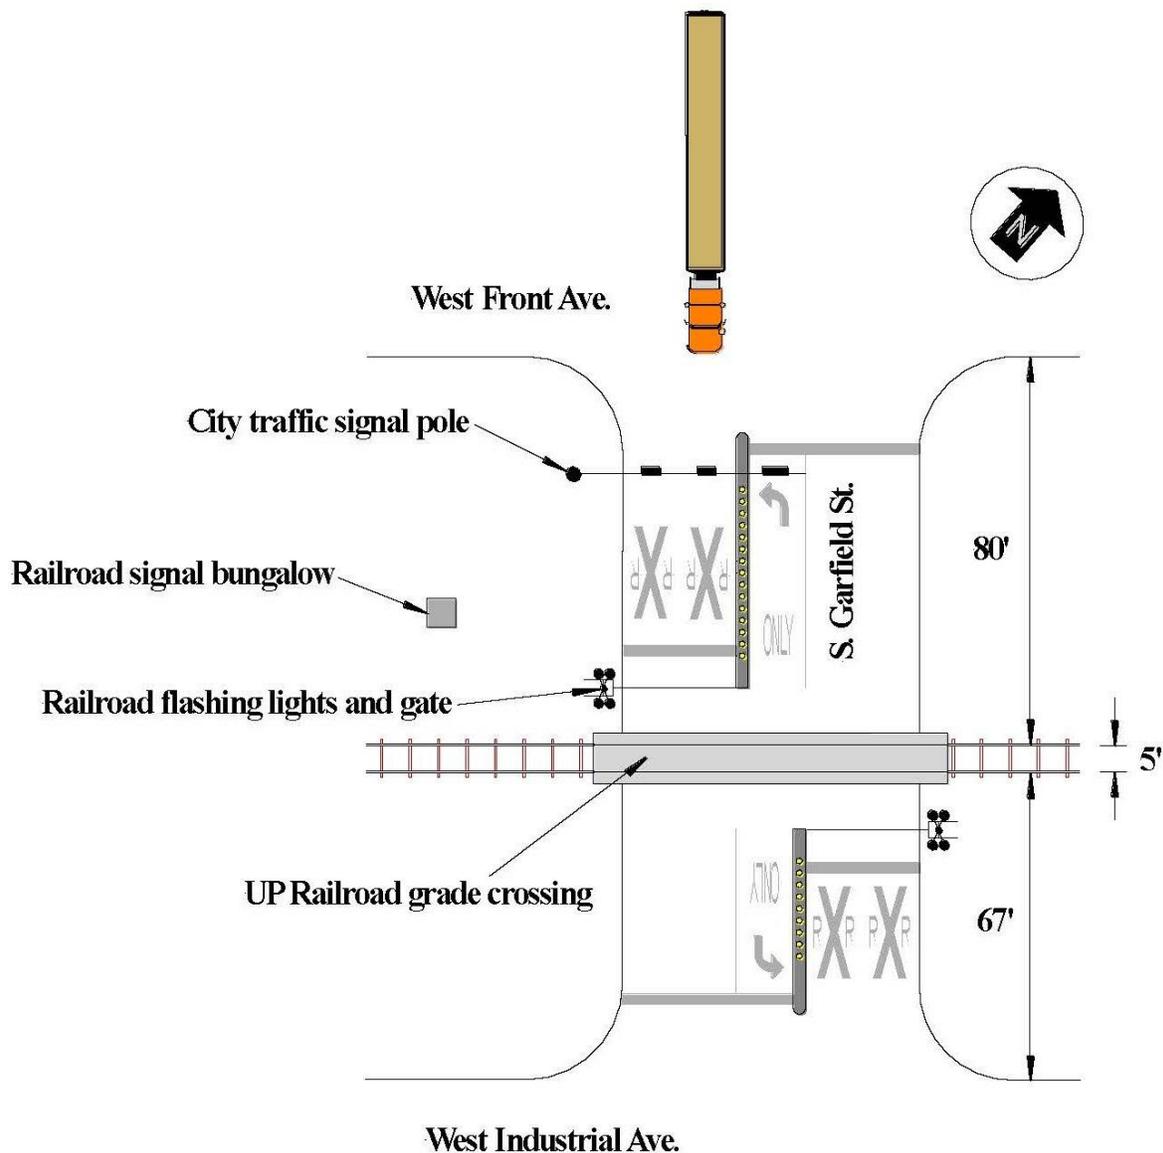
South of the West Front Avenue intersection, South Garfield Street slopes upward 5.6 percent on approach to the grade crossing. This slope plateaus at the grade crossing for a distance of 2 feet outside the rails. South Garfield Street then slopes downward 5.4 percent toward West Industrial Avenue. The slopes on either side of this grade crossing are not severe enough to obstruct low-clearance vehicles on the tracks. The distance from the south curb line of West Front Avenue to the nearest rail is approximately 80 feet. The distance from the north curb line of West Industrial Avenue to the nearest rail is approximately 67 feet (see figure 18).

**Figure 18.** Diagram showing the road markings around the grade crossing, including the railroad crossing markings for each of the two lanes, as well as a stop line.

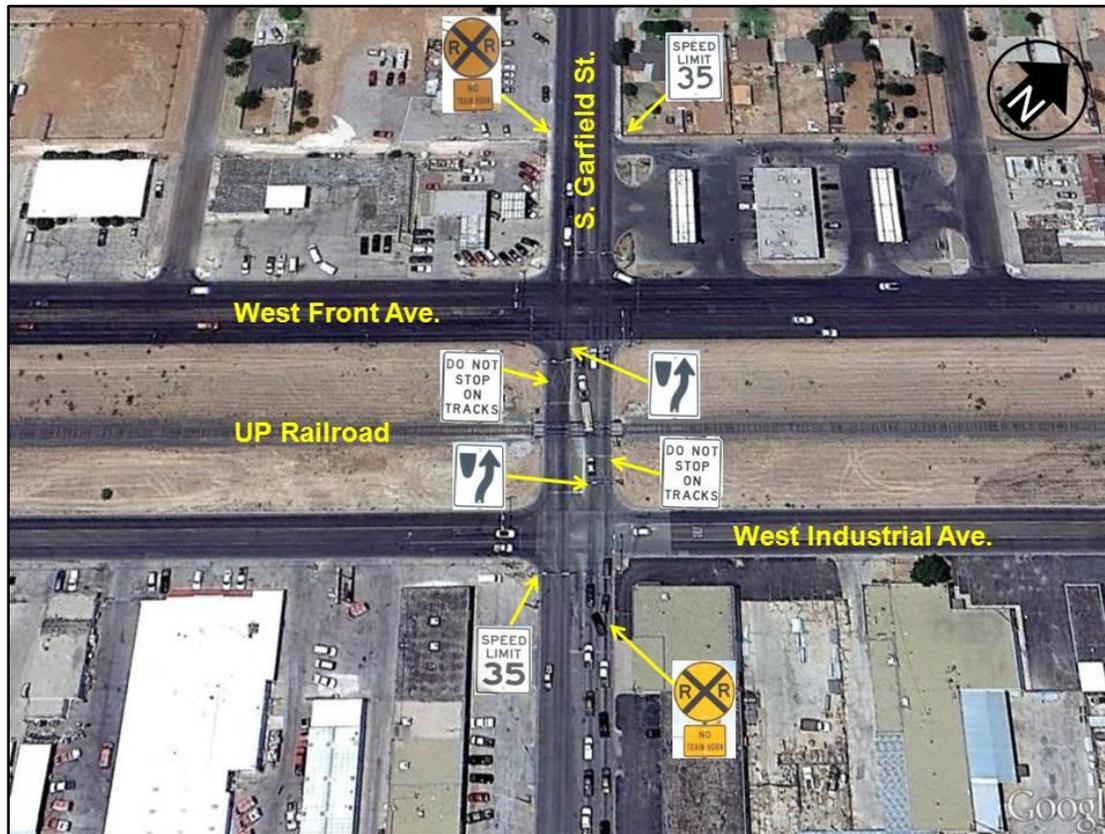
Figure 19 illustrates the signage in the vicinity of the grade crossing at the time of the collision. The signage on South Garfield Street consisted of an advance railroad crossing sign with a “No Train Horn” sign on both approaches to the grade crossing. A “Do Not Stop on Tracks” sign was located just prior to the tracks in the northbound and southbound directions. The pavement markings in the vicinity of the grade crossing consisted of grade crossing

pavement marking symbols located in the two northbound and two southbound through lanes. White stop lines<sup>17</sup> were located approximately 8 feet from the automatic gate on both approaches to the grade crossing. The left-turn lane was marked with left-turn-only markings.

**Figure 19.** Aerial photo of South Garfield Street around the grade crossing, with street signs highlighted.

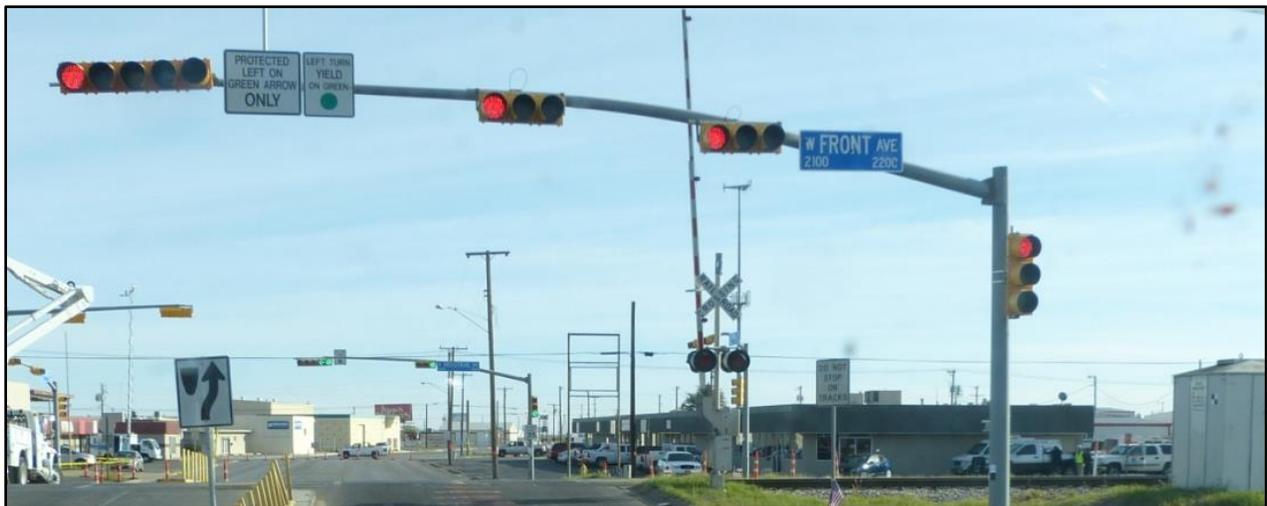
The grade crossing was equipped with an active grade crossing warning system (see figures 20, 21, and 22). The grade crossing warning system on southbound South Garfield Street consisted of two pairs of alternately flashing 12-inch warning lights, a warning bell, and a fiberglass gate arm—all mounted on a mast positioned to the west side of the roadway and 12 feet north of the nearest rail. The pairs of warning lights were mounted on opposite sides of the mast to warn southbound and northbound traffic. The grade crossing warning system on northbound South Garfield Street consisted of identical equipment mounted on a mast on the east side of the roadway.

**Figure 20.** Driver's view of the traffic signals on West Front Avenue from southbound South Garfield Street, showing the crossing arm, flashing light signal, and crossbuck of the southbound South Garfield Street grade crossing in the background.

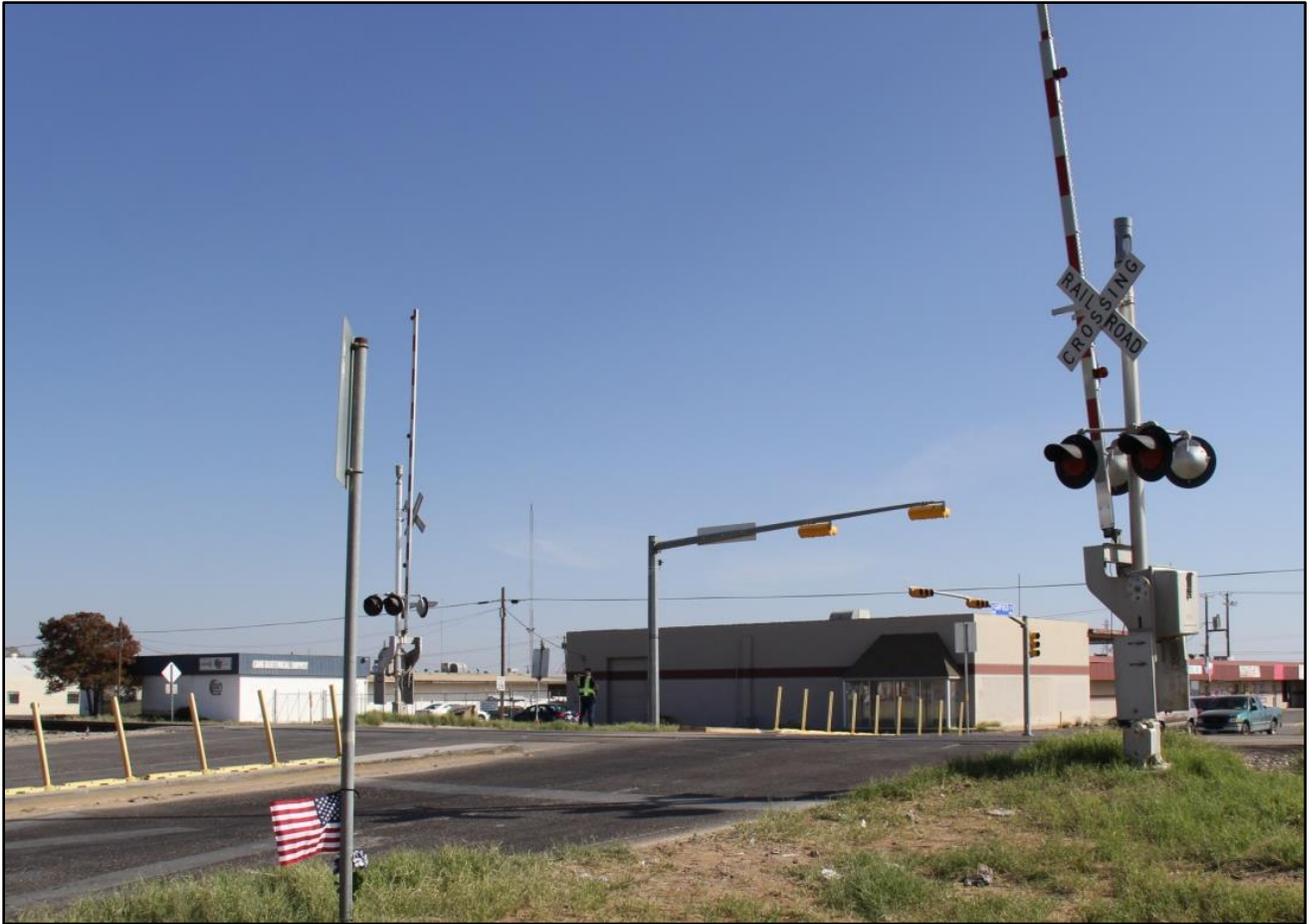
The collision between the train and the float damaged the automatic gate arm located in the northbound lanes of South Garfield Street. The gate arm was torn from its drive mechanism and was found on the grass in the southeast quadrant of the grade crossing. Postaccident testing on the gate arm in the southbound lanes found that it began descending about 6.8 seconds after the flashing light units activated. The gate arms assumed a horizontal position less than 15 seconds after the flashing light units were activated.

**Figure 21.** Grade crossing warning system mounted on the masts located on both northbound and southbound South Garfield Street.

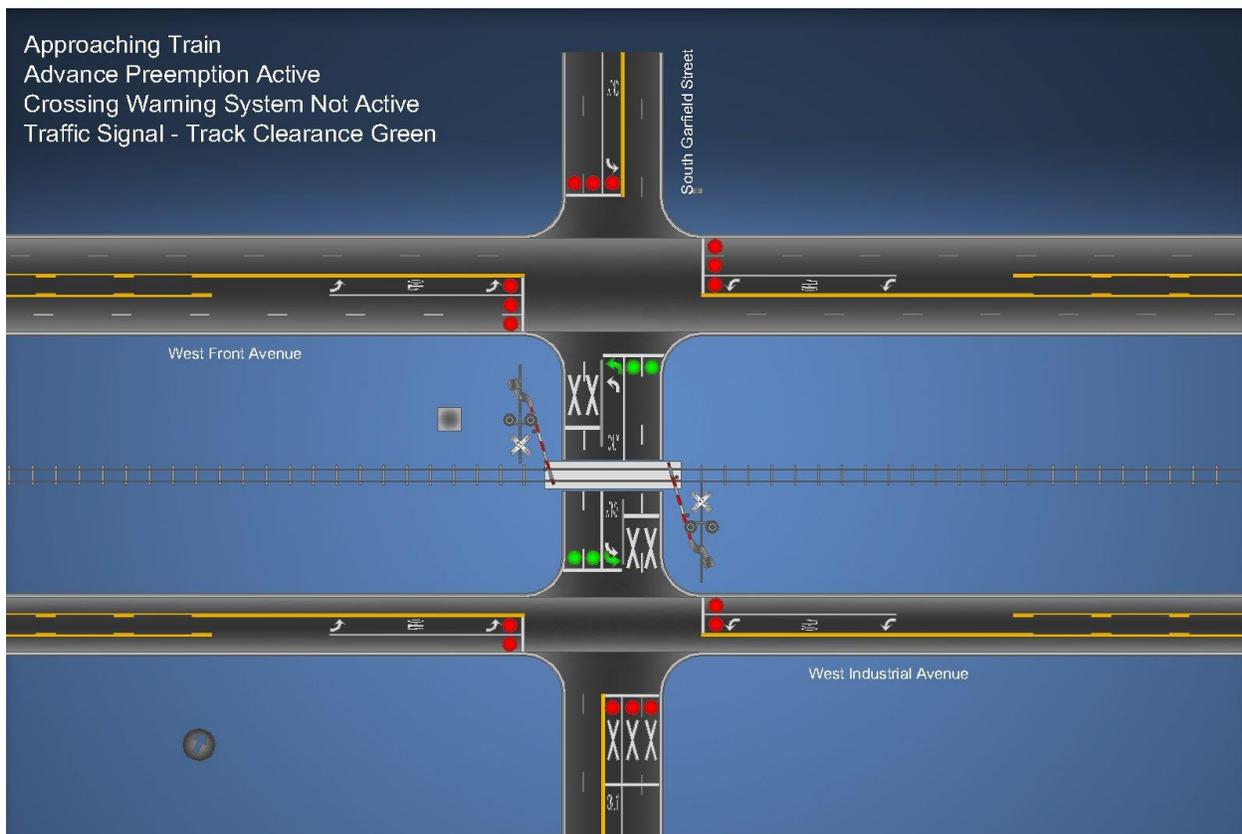
Figure 23 illustrates the typical traffic signal pattern under the track clearance green interval at the West Front Avenue intersection.<sup>25</sup> Advance preemption of the traffic signals is programmed to begin approximately 10 seconds before activation of the grade crossing warning system. Depending on when a train is detected during a normal traffic signal pattern, it could take as long as 5.8 seconds for the traffic signals to cycle to the track clearance green interval. The highway traffic signals would typically continue to operate in this interval for 25 seconds, then transition to a sequence that allows for traffic flow that does not conflict with passage of the train (referred to as the “dwell operation”; see figure 24). Once the train clears the grade crossing and the warning system deactivates, the highway traffic signals return to normal operation.

**Figure 23.** Depiction of the typical track clearance green interval. Only the signal next to the grade crossing is green. All others on South Garfield Street, West Front Avenue, and West Industrial Avenue are red. Note location of signals is for illustration purposes only.

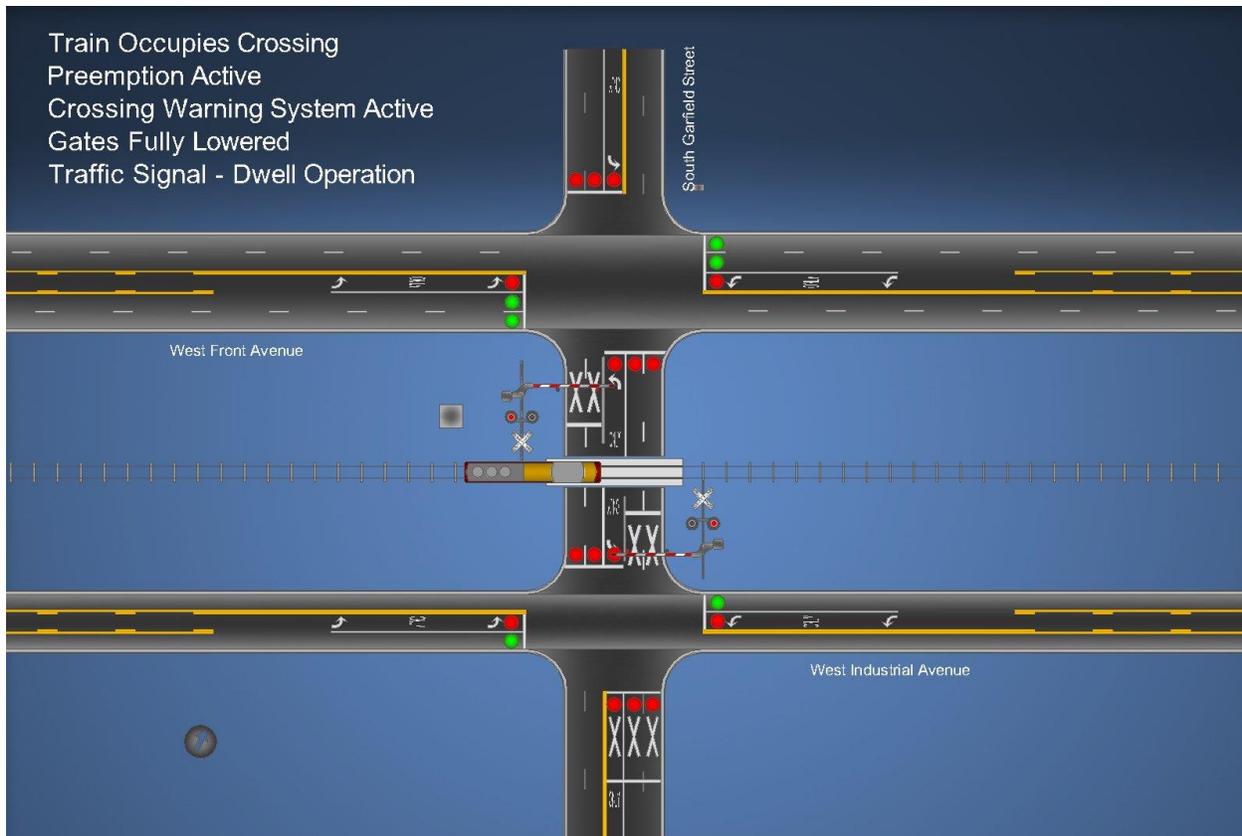
**Figure 24.** Depiction of the typical traffic signal pattern once the track clearance green interval has expired. This traffic signal pattern would occur while grade crossing gates are down, warning signals are active, and a train occupies the grade crossing—allowing for limited traffic flow that does not conflict with train operations.

Information obtained from the highway traffic signal controller and video footage from a Midland County Sheriff's vehicle dash camera indicated that the highway traffic signal facing southbound South Garfield Street at the West Front Avenue intersection was already displaying red when the float was 67 feet from the stop line (see figure 25). A reconstruction of the collision sequence—based on video evidence, data gathered from the downloaded logs of the grade crossing warning system, and the highway traffic signal controller—established that the highway traffic signals transitioned to advance preemption when the float was approximately 10–17 feet from the north curb line of the West Front Avenue intersection. Because the southbound facing highway traffic signal was programmed to display red during advance preemption, it simply continued to display red, with no overt sign given to drivers on South Garfield Street that the highway traffic signal had transitioned in response to an approaching train.

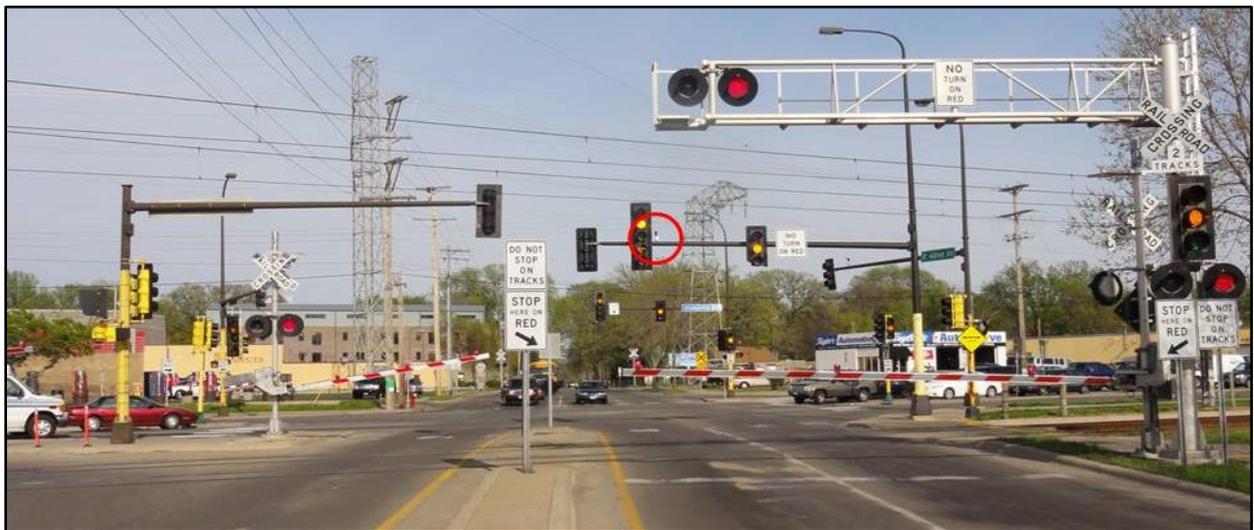
**Figure 26.** View of the confirmation light activating at a railroad grade crossing in Minneapolis, Minnesota. This light serves to warn traffic that the normal light sequence has been preempted. (Photo courtesy of the city of Minneapolis, MN)

The NTSB found that some communities have equipped signalized intersections near grade crossings with additional lights or signs to inform emergency responders and motorists when an approaching train has preempted traffic signals. For example, in localities where an emergency vehicle preemption (EVP) system has been installed, approaching emergency vehicles can preempt normal traffic signal operations. When an emergency vehicle successfully preempts a highway traffic signal, the traffic signal ahead of the emergency vehicle transitions to green, and a steady white confirmation light displays on the traffic signal post (see figures 26 and 27). Emergency vehicles arriving at the intersection from a different direction see a red signal light, accompanied by a flashing white confirmation light indicating that traffic signals have been preempted. If an intersection equipped with EVP is located near a rail line, an approaching train has precedence over all types of vehicles. Red signal lights are displayed, accompanied by flashing white confirmation lights, in all directions of traffic to inform approaching emergency vehicles that they do not have the right of way.

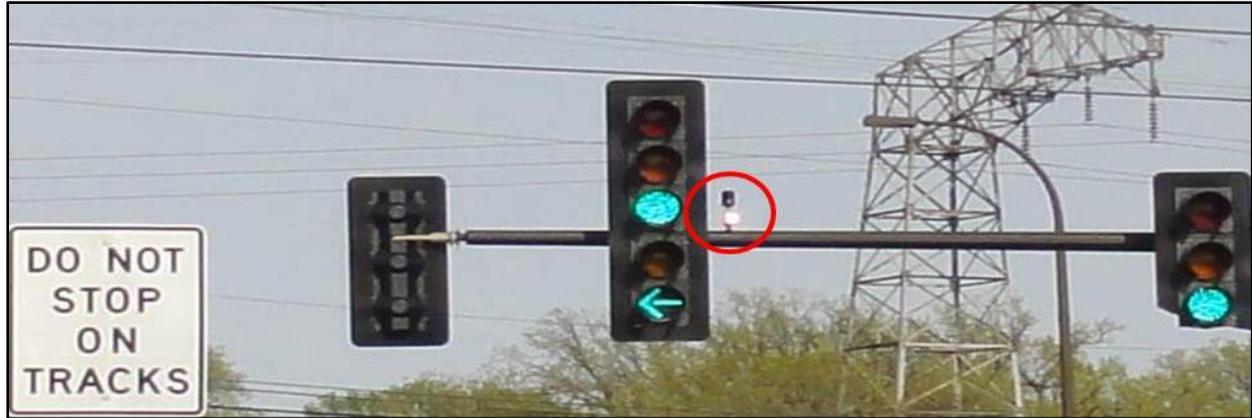
**Figure 27.** Close-up view of the same confirmation light activating at the same railroad grade crossing in Minneapolis, Minnesota. (Photo courtesy of the city of Minneapolis, MN)

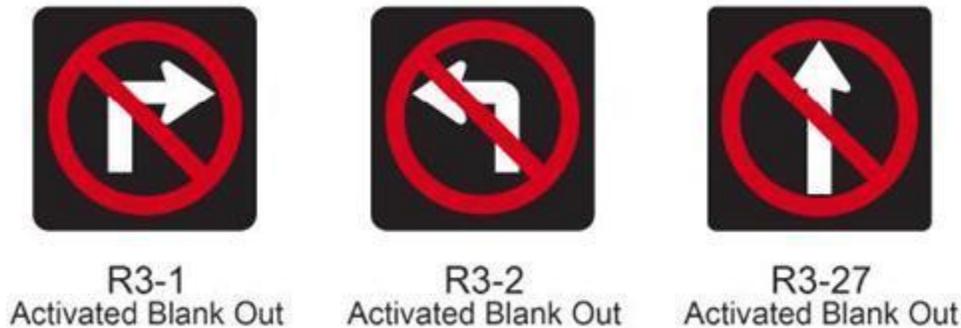
**Figure 28.** No-right-turn, no-left-turn, and no-through movement-activated blank-out signs. (Images courtesy of the FHWA's MUTCD, 2009)

Movement-activated blank-out signs have also been used to inform motorists of the approach of a train. These signs display a fixed message when activated and are blank when inactive (see figures 28, 29, and 30).

In summary, a number of traffic control options, such as confirmation lights and movement-activated blank-out signs, can be used to warn emergency responders and motorists that an approaching train has preempted traffic signals. The MUTCD references only movement-activated blank-out signs and does not describe where confirmation lights should be used. Specifically, it is difficult to discern from the manual the circumstances in which movement-activated blank-out signs would be appropriate near highway–rail grade crossings.

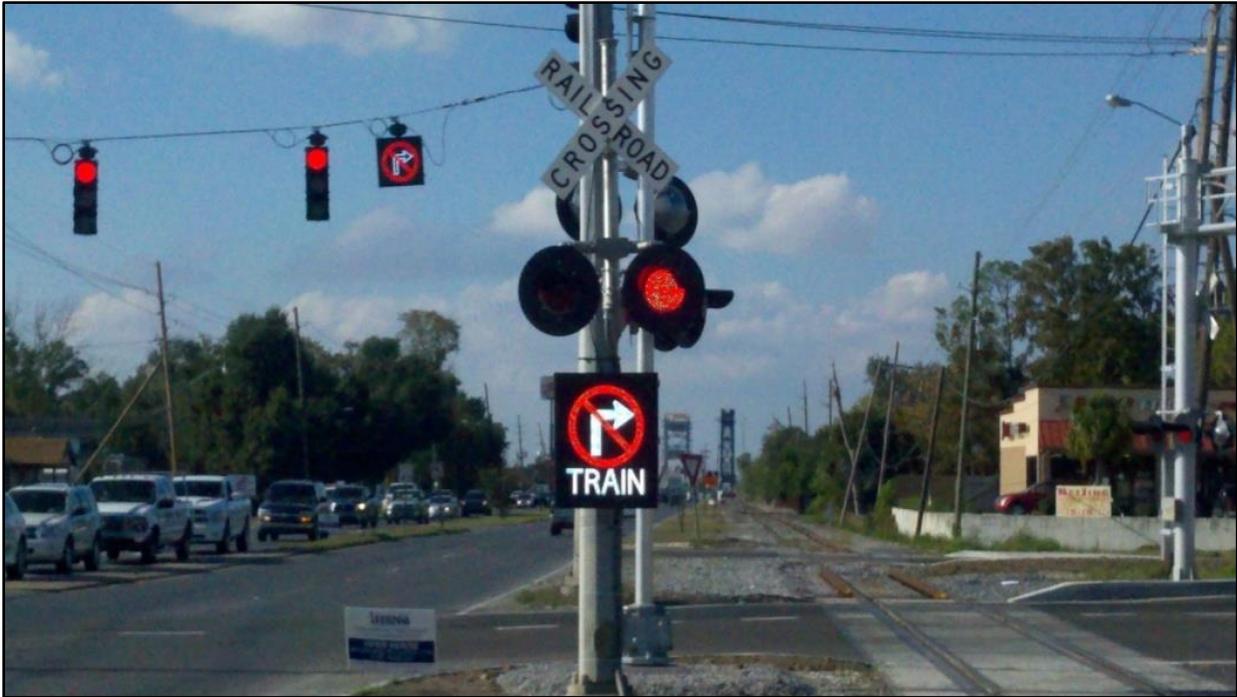
**Figure 30.** Movement-activated blank-out sign near grade crossing in Belle Chasse, Louisiana, with a no-right-turn icon and “train” at bottom warning that a train is approaching the crossing. (Photo courtesy of the Louisiana Department of Transportation)

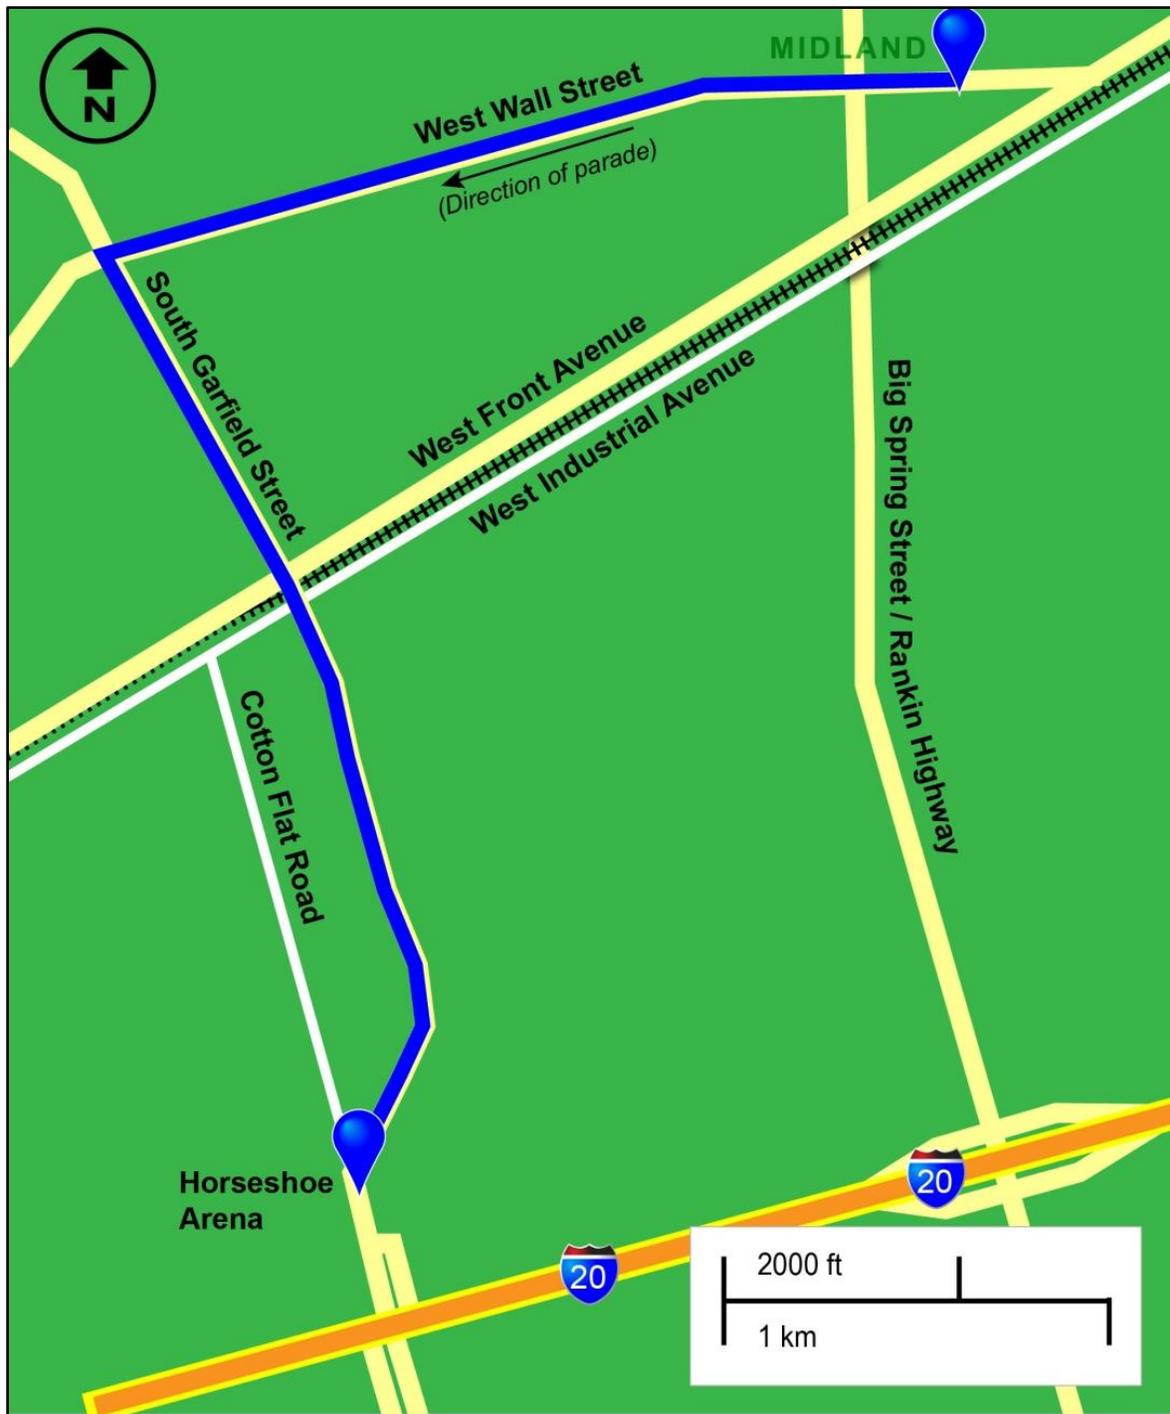
Figure 33. Parade route 2011–2012.

The parade route has changed twice since 2004. For the first 2 years, the parade was routed through an underpass to avoid the railroad tracks (see figure 31). The parade organizers changed the route in 2006 to accommodate the growing number of participants and to increase Show of Support's exposure in the community (see figure 32). This revised parade route proceeded west from the DoubleTree Hotel on West Wall Street to South Garfield Street, turned south on South Garfield Street to the grade crossing, turned right on West Industrial Avenue for two blocks, and then turned left onto Cotton Flat Road to the Midland County Horseshoe Arena. Parade organizers adopted the current parade route in 2011 after South Garfield Street was extended to the Horseshoe Arena (see figure 33).

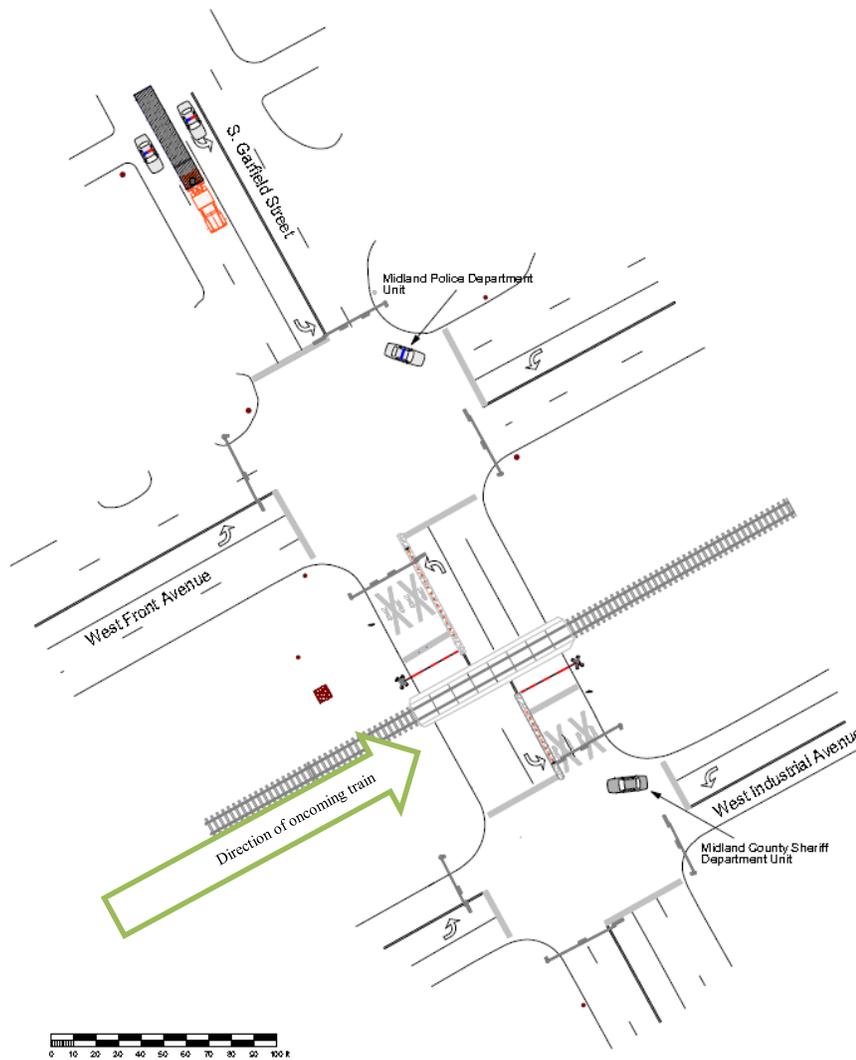
**Figure B.2: Time to Impact: 30.4 seconds**

Float at north stop line of West Front Avenue / Float distance to impact 243 feet / Train distance to impact 2,767 feet

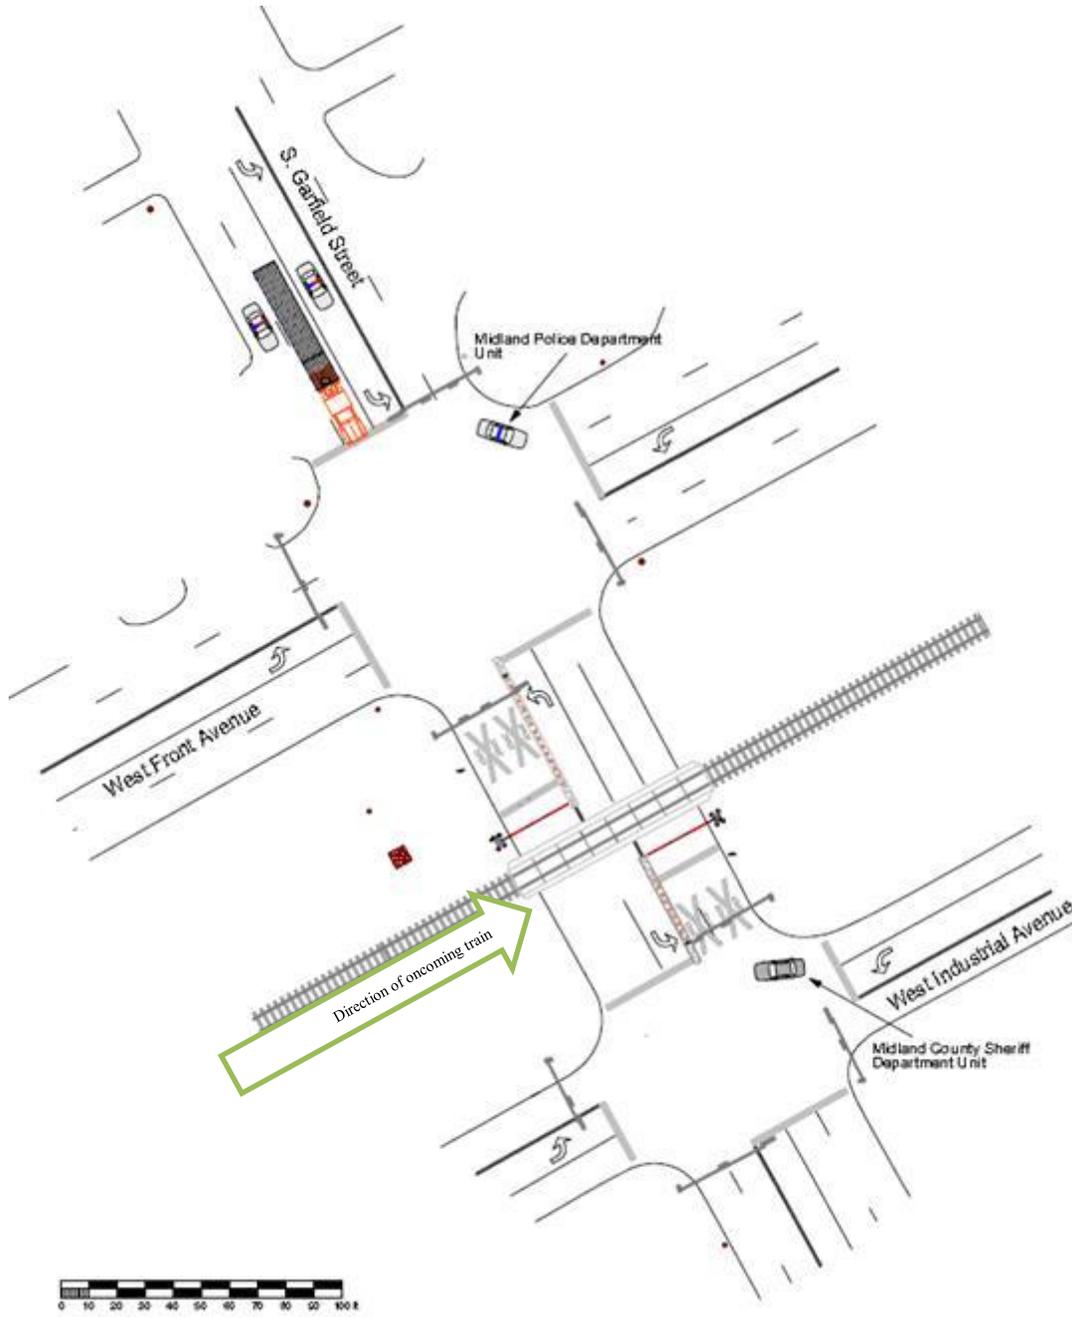
**Figure B.3: Time to Impact: 30 seconds**

Float at highway traffic signal preemption / Float distance to impact 231 feet / Train distance to impact 2,729 feet

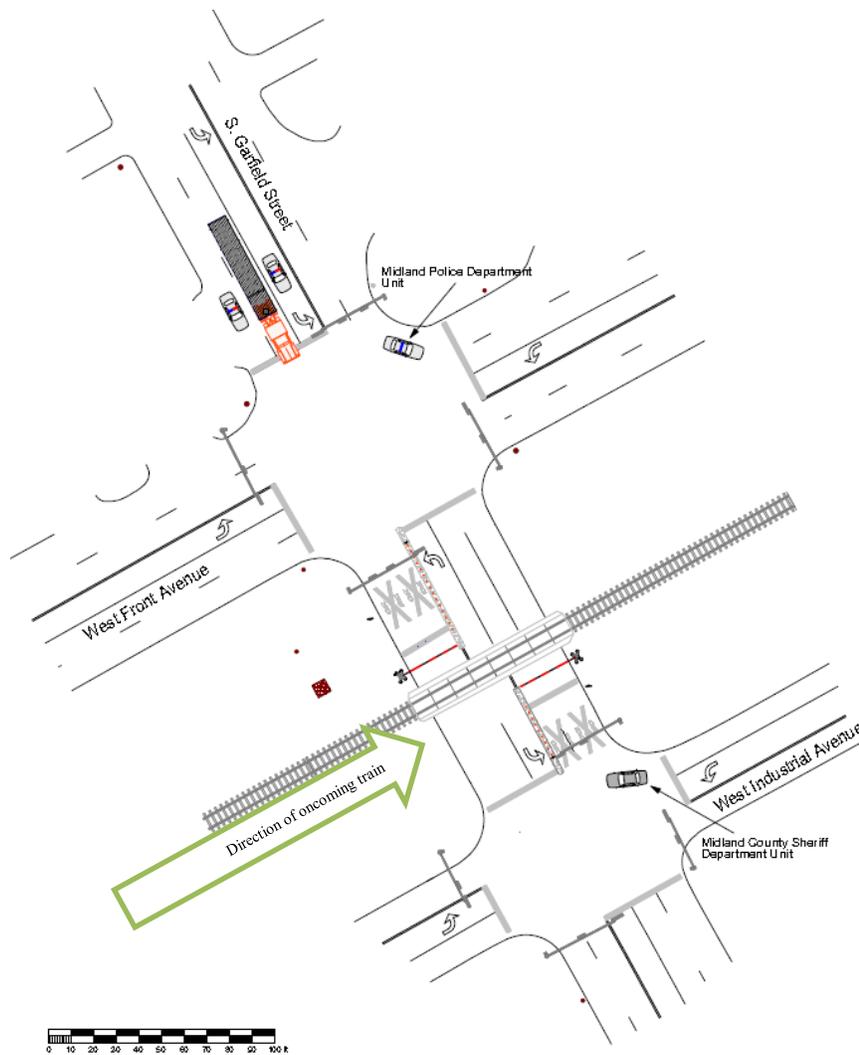
**Figure B.4: Time to Impact: 21 seconds**

Grade crossing warning system activation / Float distance to impact 155 feet / Train distance to impact 1,910 feet

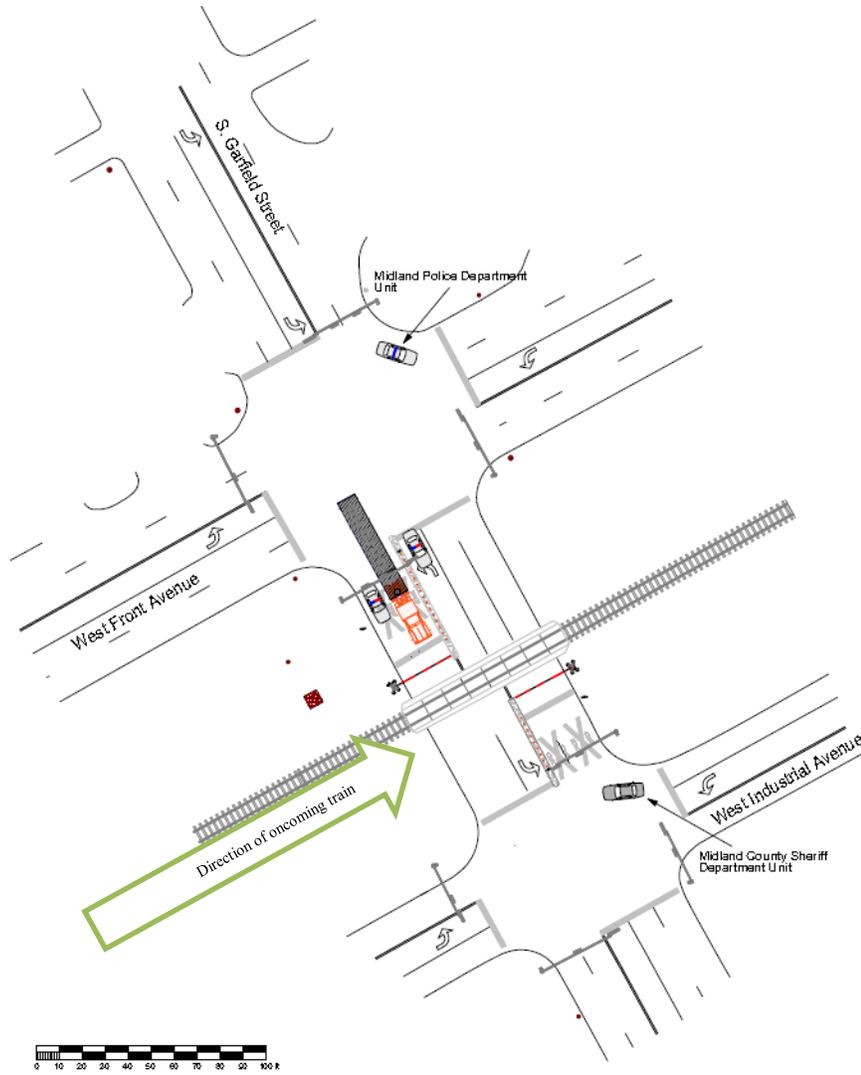
**Figure B.5: Time to Impact: 13.5 seconds**

Float at beginning gate descent / Float distance to impact 98 feet / Train distance to impact 1,228 feet

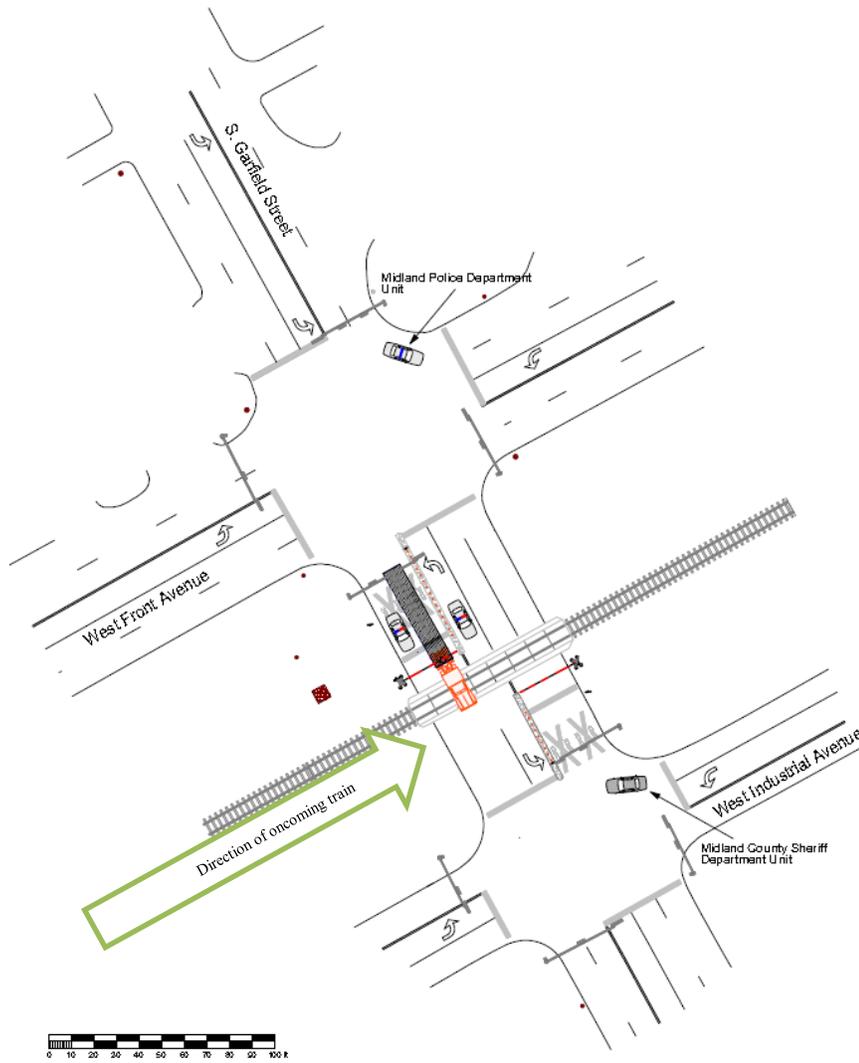
**Figure B.6: Time to Impact: 8.9 seconds**

Float crossing rails / Float distance to impact 65 feet / Train distance to impact 808 feet
