Highway–Railroad Grade Crossing Collision  
Midland, Texas  
November 15, 2012

NTSB/HAR-13/02  
PB2014-100830

# Highway Accident Report

**Abstract:** About 4:35 p.m. on November 15, 2012, in Midland, Texas, a freight train collided with a parade float at a highway–railroad grade crossing, resulting in 4 fatalities and 12 injuries. The float consisted of a 2006 Peterbilt truck-tractor in combination with a 2005 Transcraft D-Eagle drop-deck flatbed semitrailer and was traveling south on South Garfield Street as part of a parade procession honoring US military men and women. The float, occupied by 12 veterans and their spouses, continued along South Garfield Street until it reached the intersection of West Front Avenue, where the traffic signal displayed red. Law enforcement personnel stationed to block cross traffic permitted the float and its escorts to continue across the intersection unhindered. About 80 feet south of the West Front Avenue intersection was an active highway–railroad grade crossing, and the crossing’s warning system activated as the float approached. The float continued across the railroad tracks at an estimated speed of 5 mph. A Union Pacific Railroad freight t

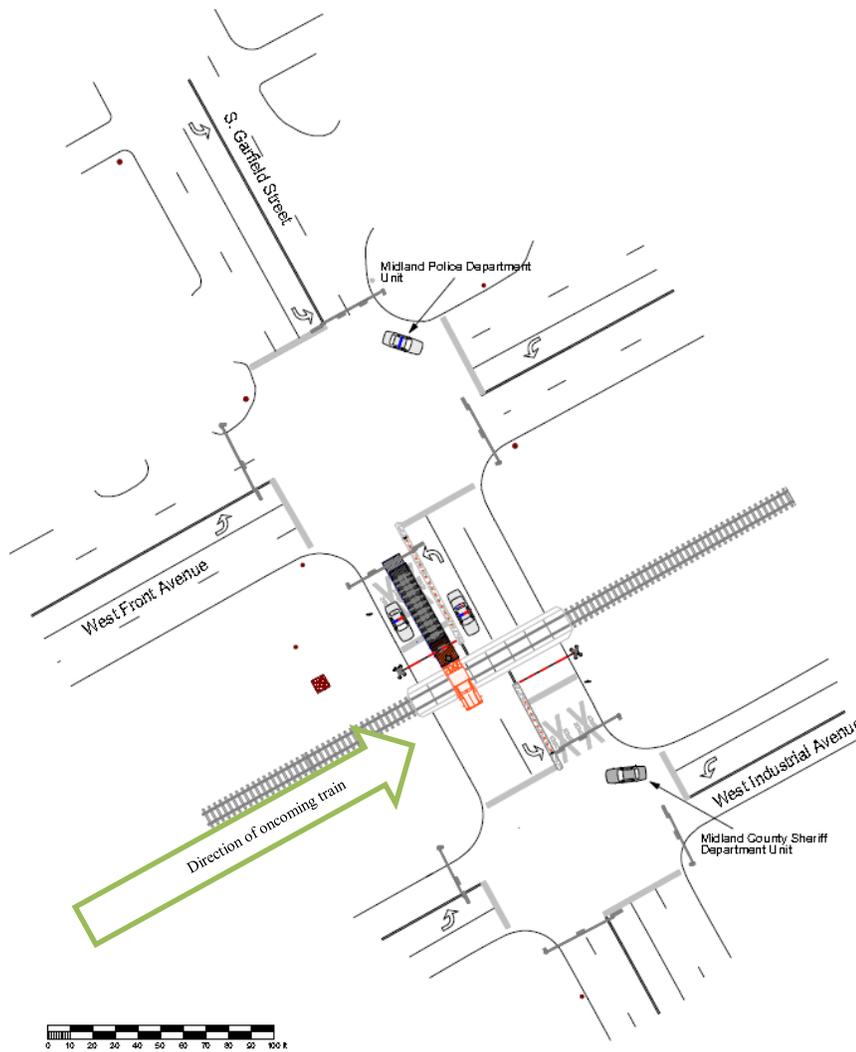
**Figure B.7: Time to Impact: 7.8 seconds**

Train horn sounds / Float distance to impact 57 feet / Train distance to impact 709 feet

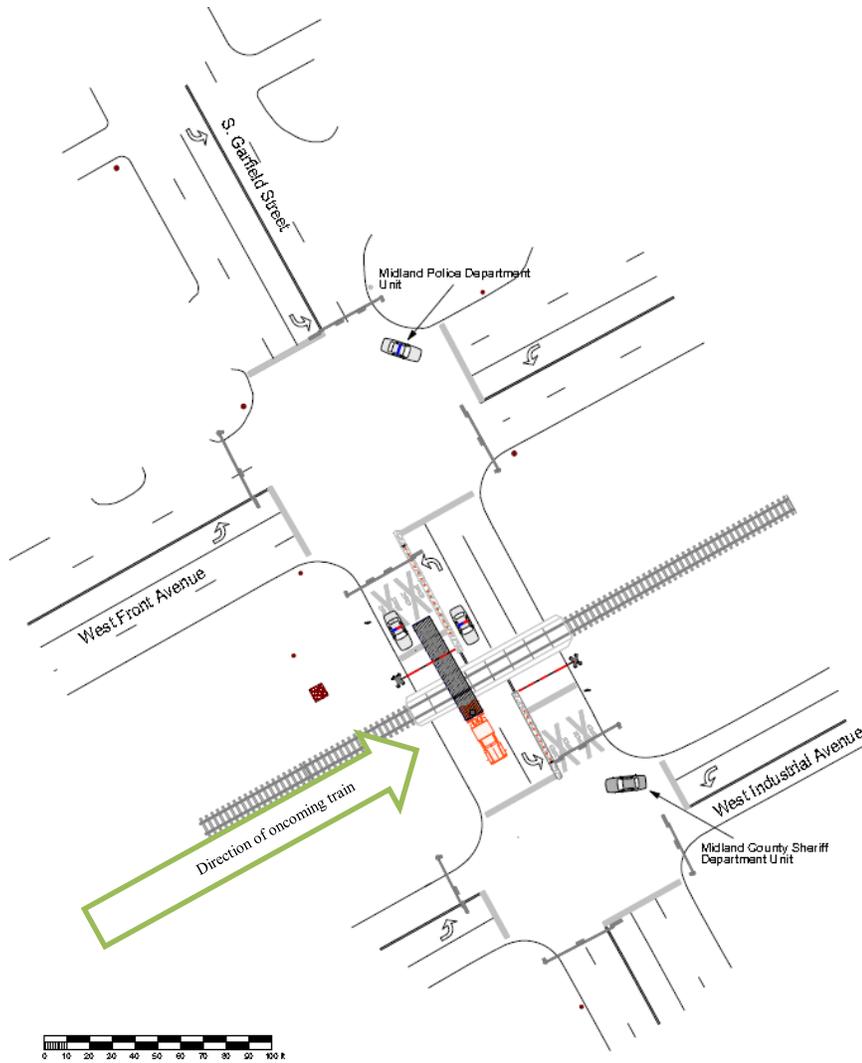
**Figure B.8: Time to Impact: 4.8 seconds**

Train begins braking / Float distance to impact 36 feet / Train distance to impact 437 feet

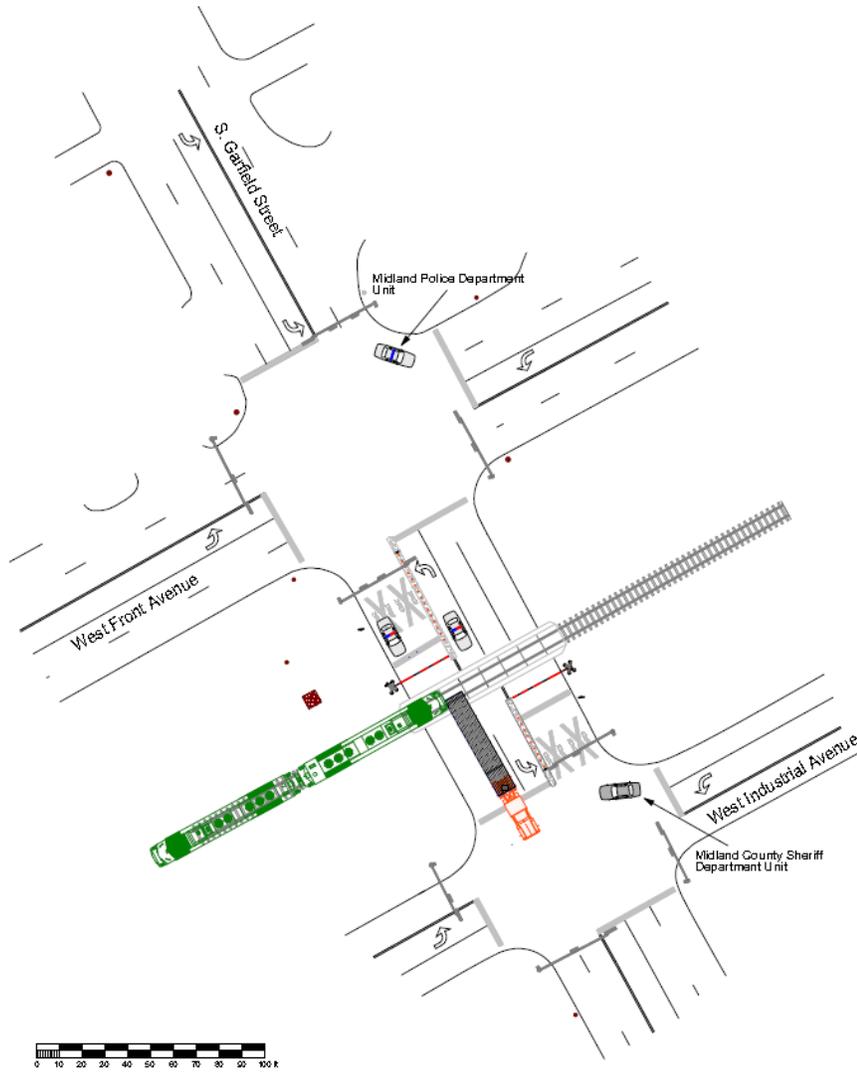
**Figure B.9: Impact**  
Float distance past north rail 73 feet
