Agricultural Labor Bus and Truck-Tractor Collision at US-98–SR-363 Intersection Near St. Marks, Florida July 2, 2016

NTSB/HAR-17/05 PB2018-100307

Highway Accident Report

The National Transportation Safety Board determines that the probable cause of the St. Marks, Florida, crash was the bus driver's failure to stop at the intersection due to inattention, likely caused by the effects of fatigue; and his unfamiliarity with the rural roadway, which was dark with limited lighting. Contributing to the crash were the failure of Billy R. Evans Harvesting, Inc., to exercise adequate safety oversight of the bus driver and the lack of effective oversight of the motor carrier by the Federal Motor Carrier Safety Administration and the US Department of Labor. Contributing to the severity of the injuries were the rupture of the truck's right-side-mounted diesel fuel tank, leading to a fast-spreading postcrash fire; and the failure of the truck driver to wear his lap/shoulder belt.

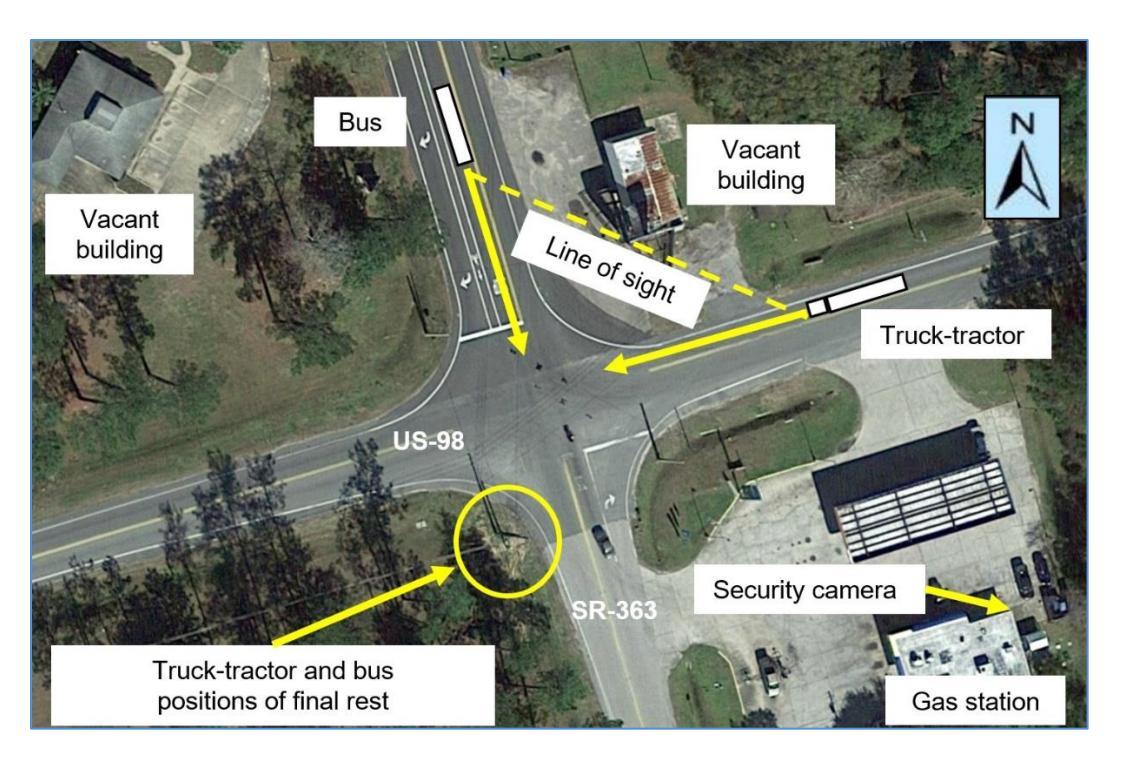
Figure 2. Aerial view of US-98–SR-363 intersection, showing approach path of each vehicle, security camera location, and vehicle positions of final rest. (Source: Google Earth image dated December 2015)

The security video showed the bus travel through the intersection without stopping and proceed directly into the path of the truck-tractor. During the crash sequence, the front of the truck-tractor struck the left side of the bus, slightly behind its front axle, which resulted in the rapid counterclockwise rotation of the truck-tractor and the breach of its right-side-mounted diesel fuel tank. Figure 3 is a still image from the security camera video depicting an explosion of fire from the truck-tractor less than 1 second after impact.

A vacant building at the northeast corner of the intersection partially obscures the views on southbound and westbound approaches (see also figure 2). Until the line of sight for each driver extended beyond the corner of this building, neither driver would see approaching traffic on the cross highway.

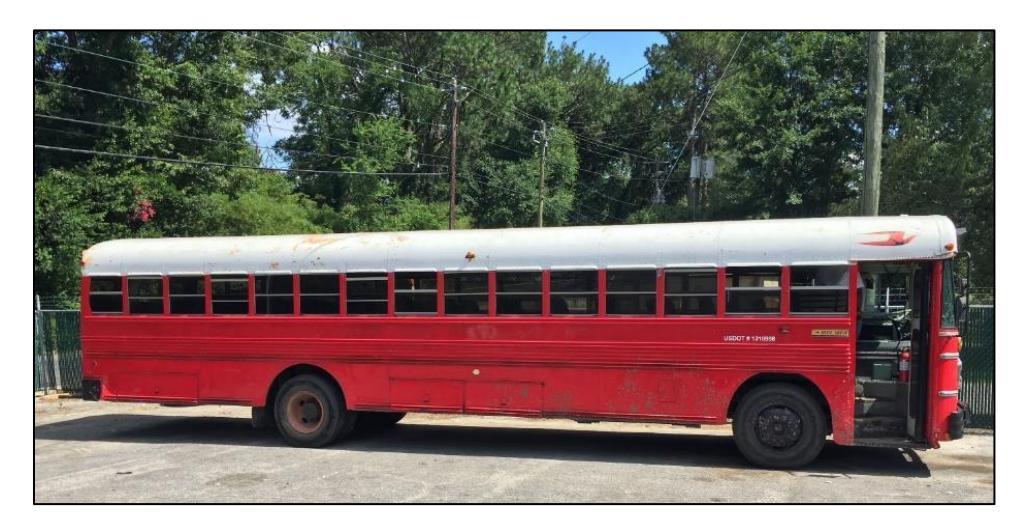
investigator completed a walk-around of the 1979 Blue Bird bus but did not conduct a database check to see if it was appropriately inspected and authorized for the transportation of workers. Figure 11 shows the right side of the bus in a precrash photograph taken by the WHD investigator.

Figure 11. Precrash photograph of accident bus taken during DOL–WHD spot check of Billy R. Evans on June 22, 2016. (Source: DOL)

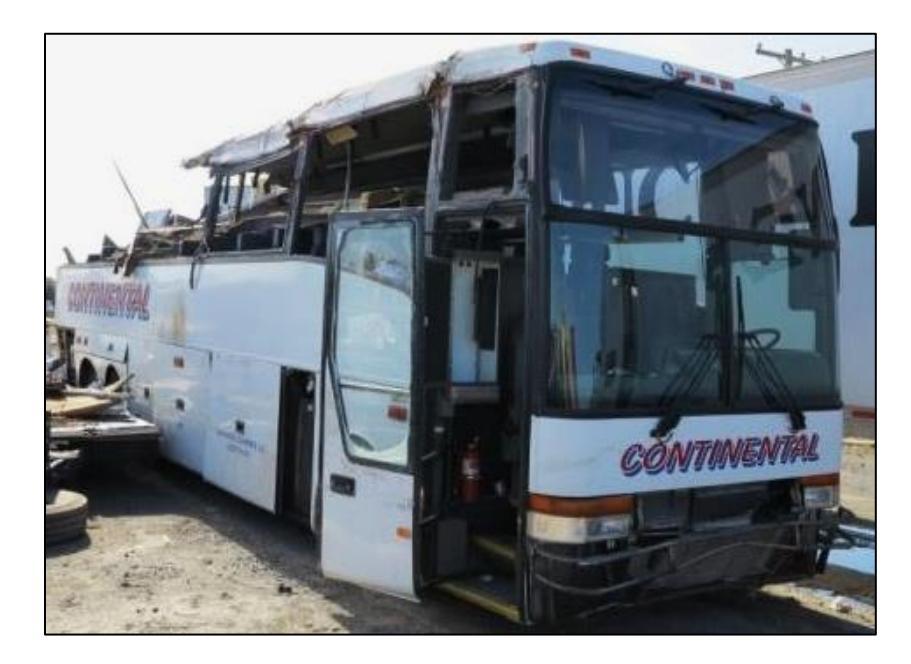
with a concrete barrier. Subsequently, the right front and rear portion of the vehicle roof struck a bridge column and the North Hills Boulevard overpass. Figure 12 shows the motorcoach postcrash. Six of the motorcoach occupants were fatally injured, and three of them had been ejected. The driver, codriver, and remaining passengers received injuries of varying degrees. Immediately following the crash, the driver submitted to a blood test performed by the Arkansas State Police. The test results for alcohol and other drugs were negative.

Figure 12. View of Little Rock, Arkansas, motorcoach, postcrash.

A postcrash inspection of the motorcoach and driver by Arkansas State Police commercial vehicle inspectors identified numerous violations, including:

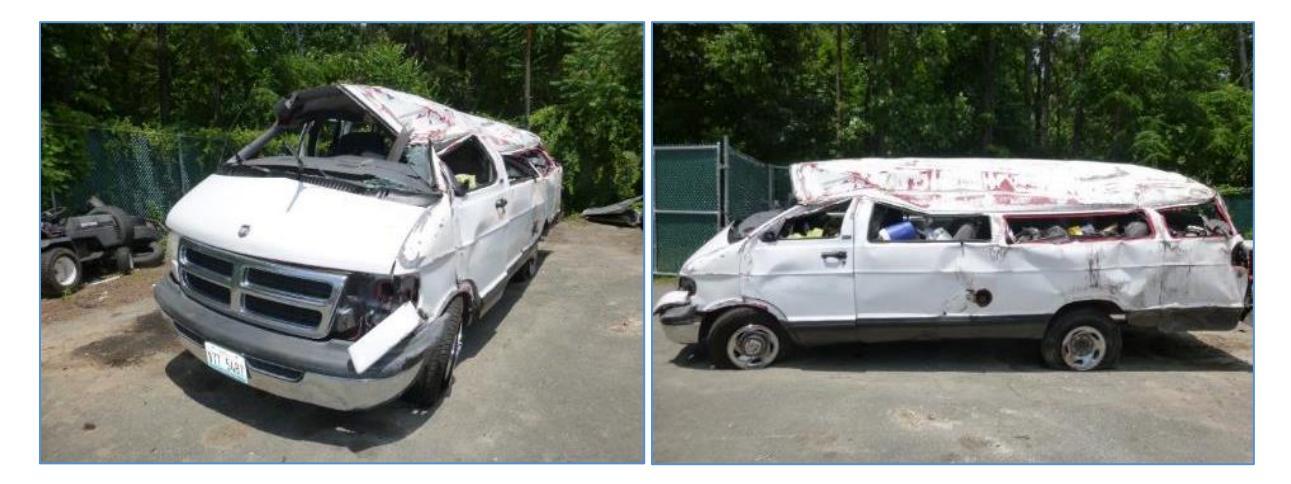
passenger rows of seats; nine seat belts had been cut out (precrash), and four were found to be tied and twisted in knots. A postcrash vehicle inspection found no mechanical deficiencies. Additionally, a postcrash toxicology test of the van driver was negative for the presence of alcohol or other drugs. Figure 13 shows two postcrash views of the 15-passenger van.

Figure 13. Damage to Ruther Glen, Virginia, 15-passenger van.

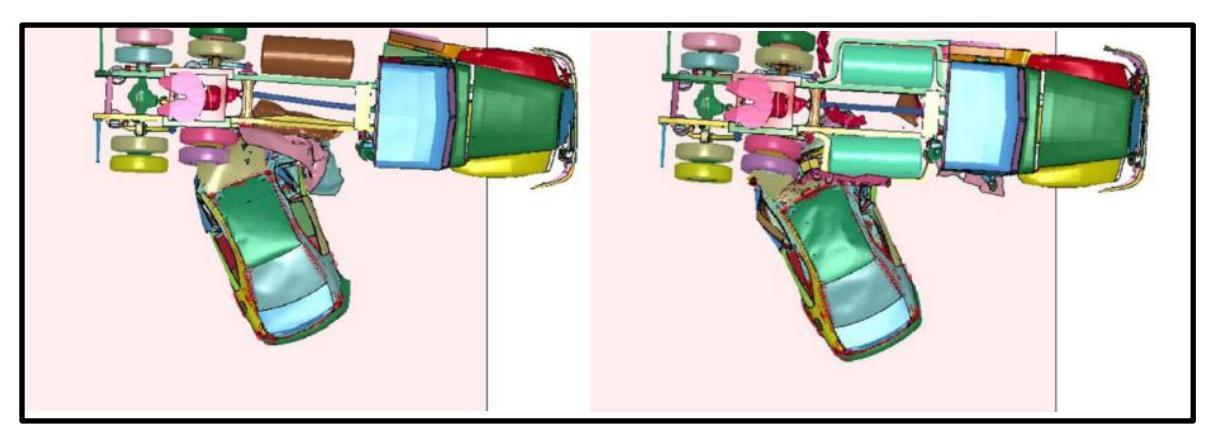
Advances in frame rail design for heavy trucks have provided increased opportunities to protect fuel storage systems. Alternative truck designs incorporating the fuel storage system within tapered frame rails have been tested using virtual models. Testing of a tapered frame integrated (TFI) fuel tank system and other alternative designs shows substantial reductions to the amount of crush energy sustained by the tanks (Friedman and others 2016; 2015). Figures 18 and 19 show two comparisons of a truck-tractor baseline model to an alternative design. In both examples, the vehicles are moving 50 mph at impact. The results of finite element simulation highlight the vulnerability of current fuel tank systems under the impact conditions studied.

Figure 18. Virtual model test comparing baseline truck-tractor (left) to alternative design with frame rails outside of tank (right). (Source: Friedman and others 2015)

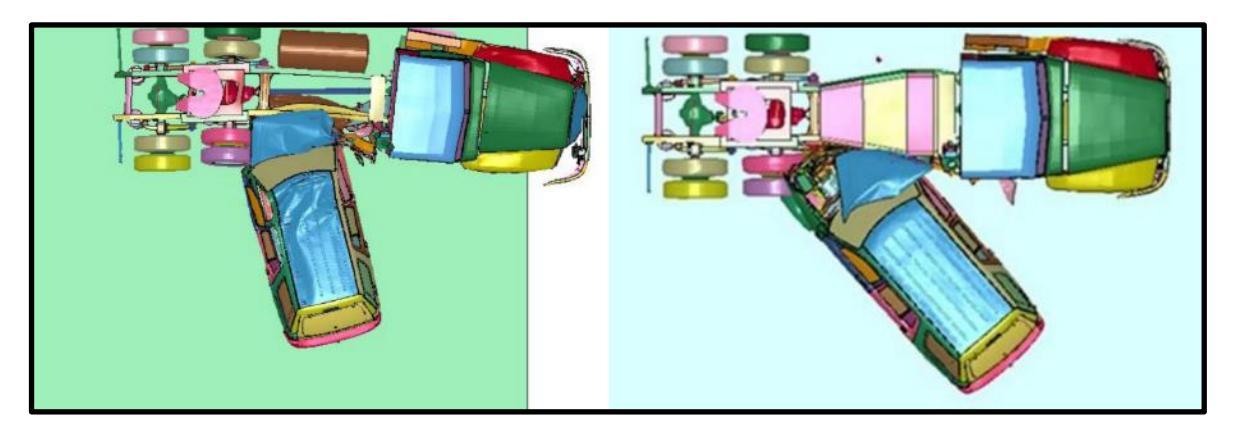
Figure 19. Virtual model test comparing baseline truck-tractor (left) to TFI design (right). (Source: Friedman and others 2016)
