Motorcoach Run-Off-the-Road and Overturn  
US Highway 83  
Laredo, Texas  
May 14, 2016

NTSB/HAR-18/03  
PB2019-100083

# Highway Accident Report

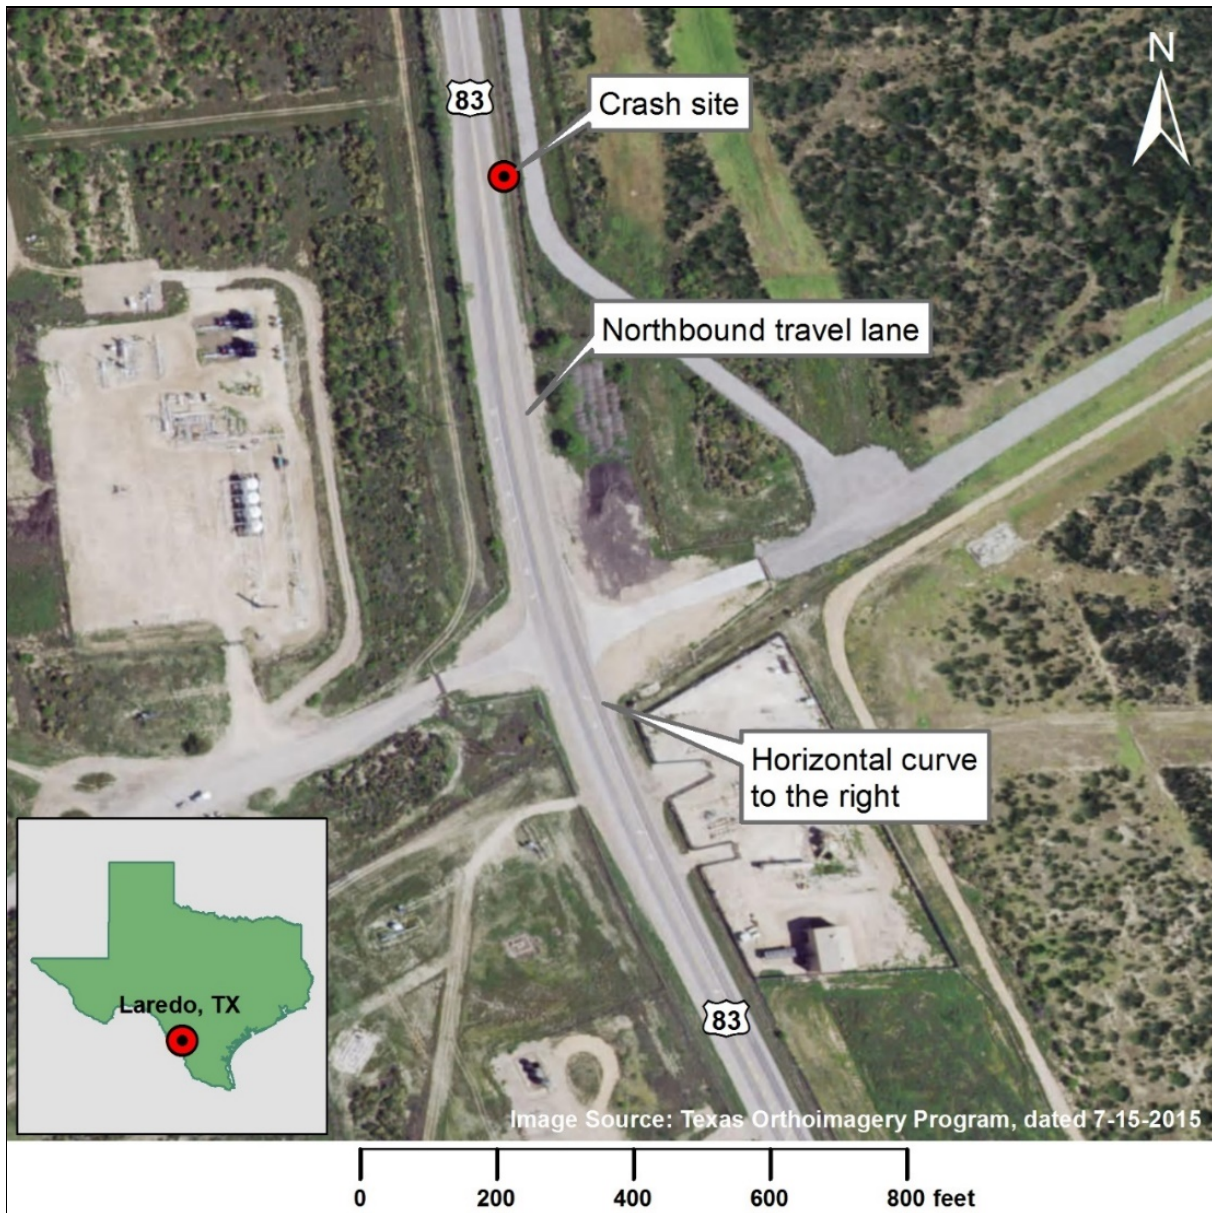
In the vicinity of mile marker (MM) 670.7, the northbound motorcoach entered a horizontal curve to the right. Roadway evidence and postcrash simulations (discussed in section 1.9) suggest that, while in the curve, the motorcoach drifted out of its lane to the left, and the driver made sudden steering and braking input to correct the drift. During a postcrash interview, the motorcoach driver said that he recalled applying the brakes and feeling the bus slide before going off the road. Near the end of the curve, the motorcoach departed the right, or east, side of the highway. The vehicle overturned 90 degrees onto its left side. The motorcoach continued to yaw clockwise and came to rest with its front end partially on the eastern edge of the northbound roadway. (See figures 2, 3, and 4.)

**Figure 2.** Approach to crash site on US-83, Laredo, Texas.

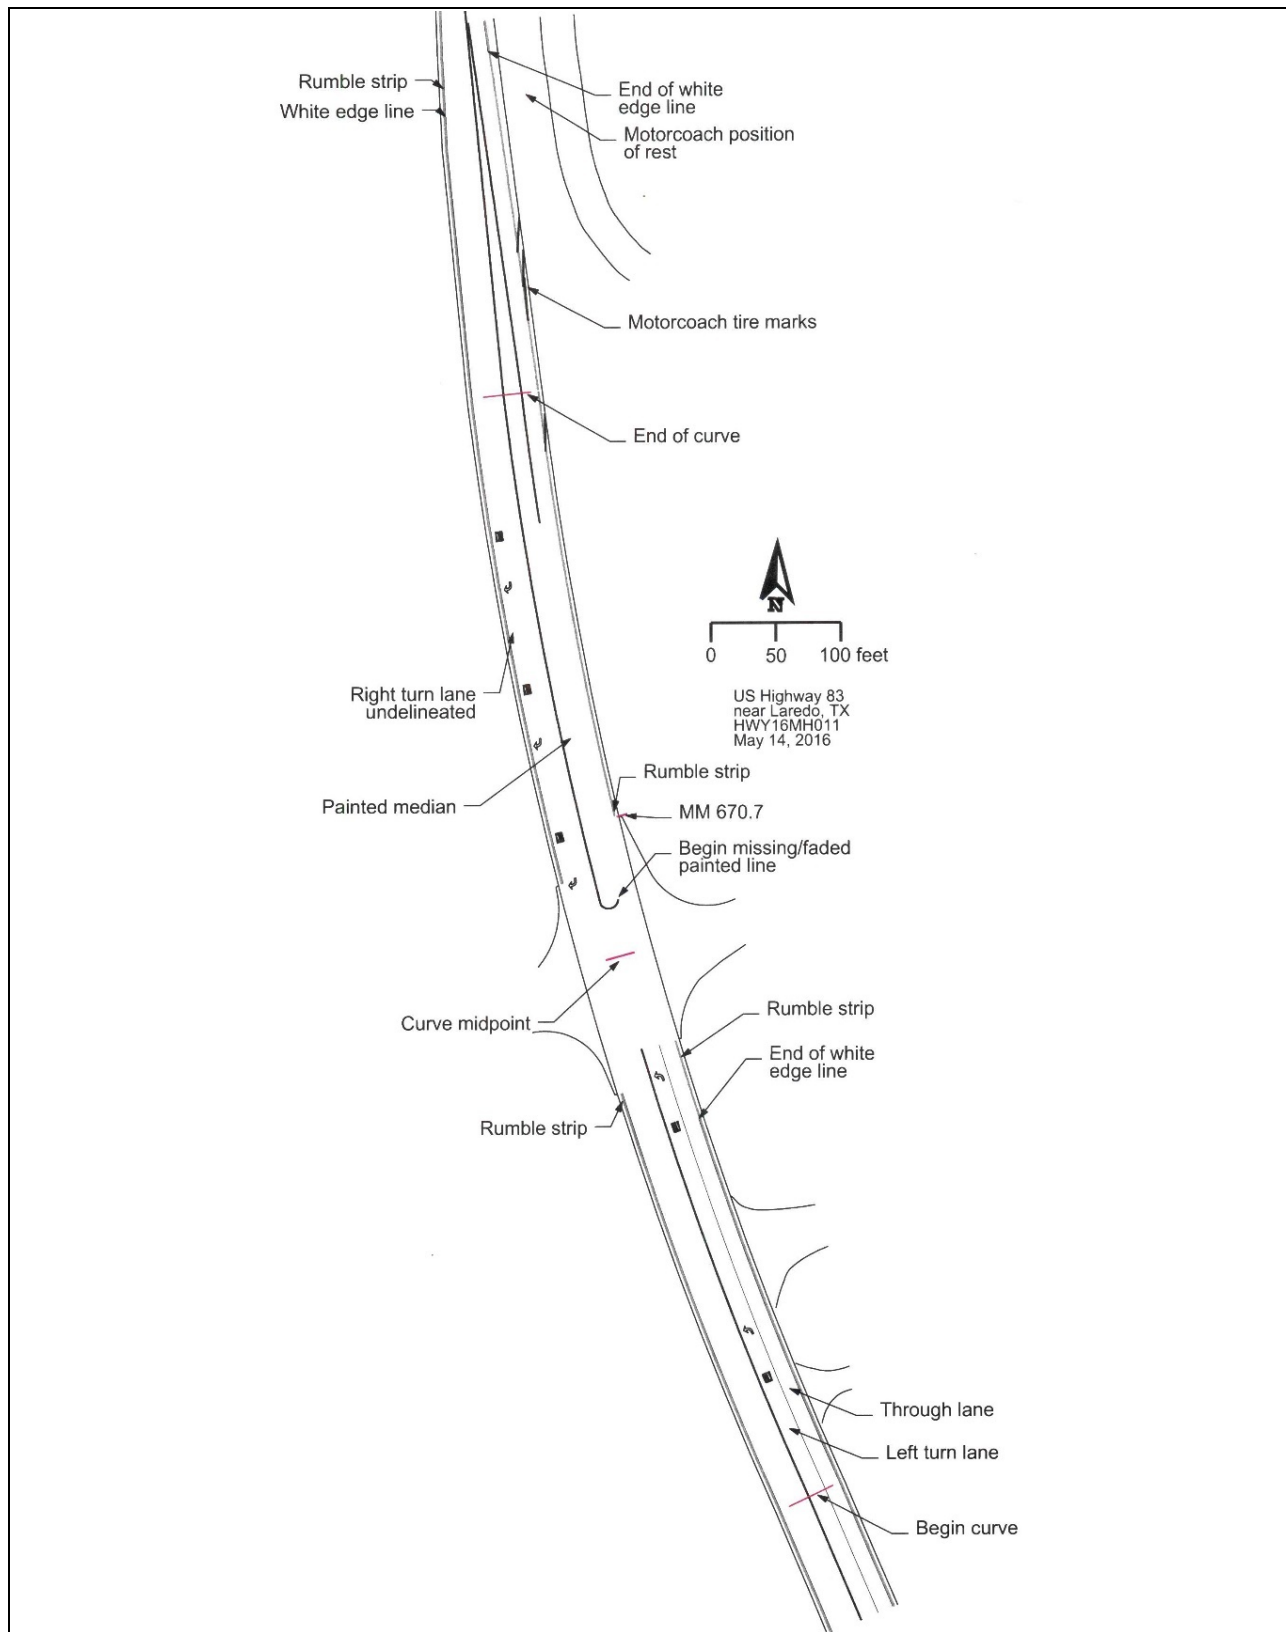
The crash occurred about 45 miles north of Laredo, in the northbound travel lane of US-83 near MM 670.7. At this location, US-83, as oriented from the motorcoach's direction of travel, has a compound curve to the right, and the road configuration changes from two travel lanes in each direction to a multilane, channelized road with a painted center median that is delineated from the travel lanes by yellow-painted lines.<sup>26</sup> The loss-of-control event that preceded the motorcoach crash originated in the curve. The 2-degree horizontal curve is about 881 feet long and has a super-elevation of about 4 percent.<sup>27</sup> The crest of the vertical curve is near the midpoint of the horizontal curve. Three private driveways are located within the curve along the east side of the roadway, and a single driveway to a gas and oil facility is located near the midpoint of the curve on the west side. (See figure 8 for a diagram of the crash scene curve.)

**Figure 8.** Crash scene diagram.

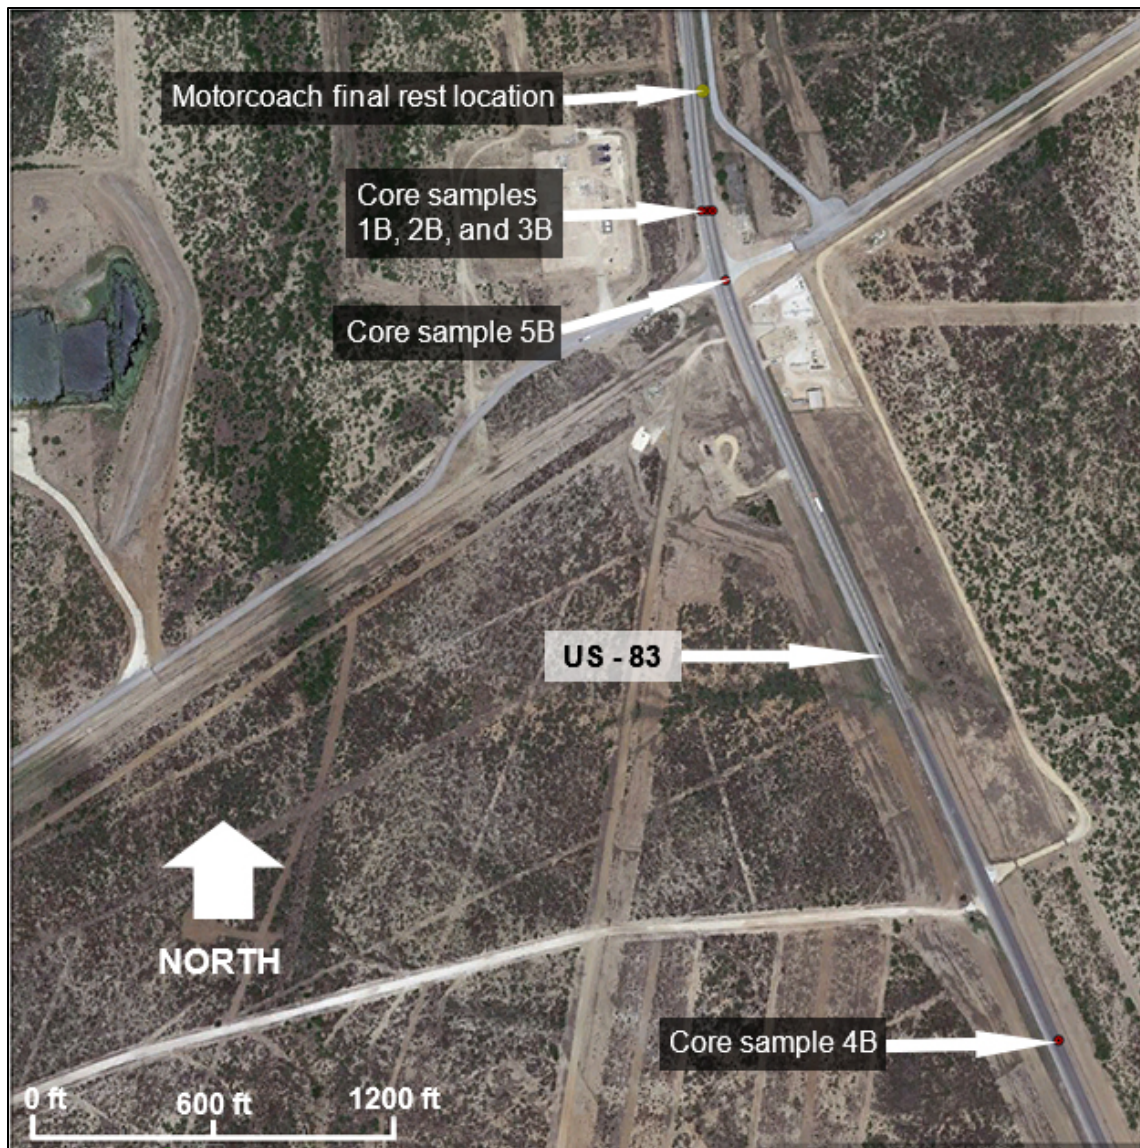
**1.6.6.1 Core Sample Information.** At the request of the NTSB, on May 17, 2016, TxDOT drilled and obtained ten pavement cores from the travel lanes and paved median of US-83 near the crash location. The NTSB took possession of all ten core samples and provided five to the Federal Highway Administration (FHWA) Turner-Fairbank Highway Research Center (TFHRC) for testing and analysis. The TFHRC tested the following pavement core samples, the locations of which can be seen in figure 10:

**Figure 10.** Locations on US-83 where the pavement core samples were obtained. (Source: Google Earth modified)

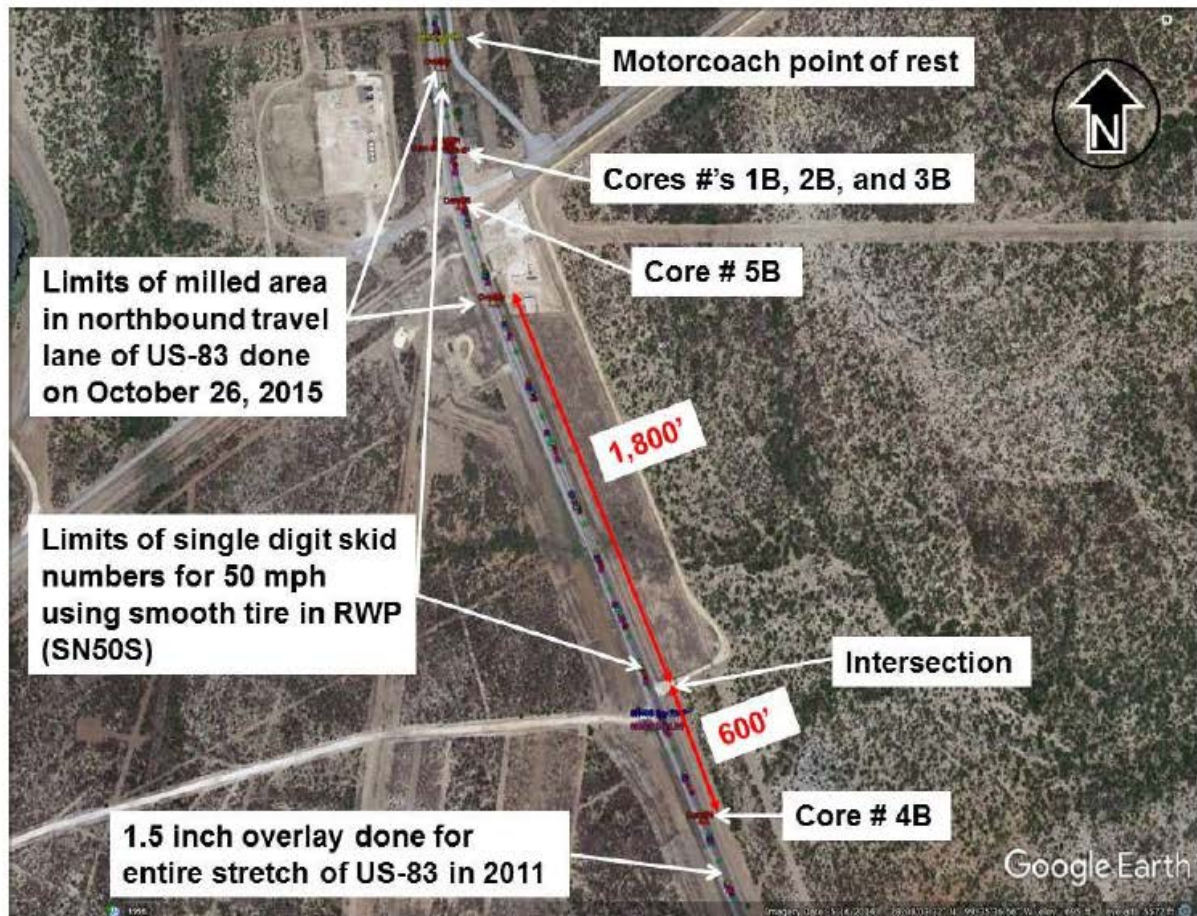
Core #1B and #5B are of particular interest as they were obtained from the area of low pavement friction and the area where the crash likely originated.

**Figure 2:** Site map with locations of low friction test values and NTSB-retrieved pavement cores. The point of rest of the motor coach is indicated. The locations of the driveways added in February 2014 are approximately the crest of the compound curve. The 1800 foot section of low friction from the "intersection" to the limit of the milled section is generally a slight positive grade. (Figure 3)

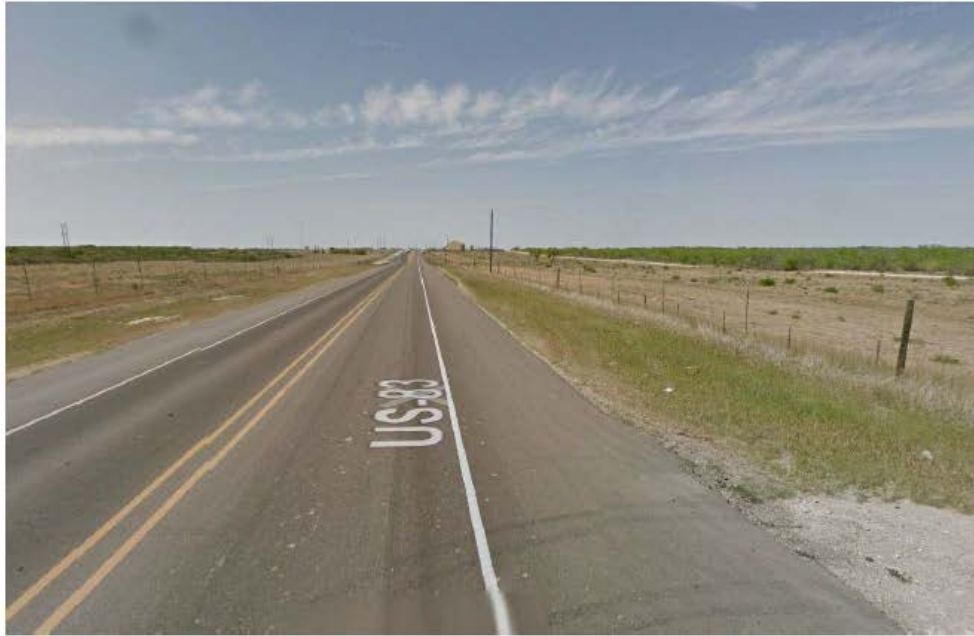
**Figure 3:** View of US83 looking north from intersection to crest of compound curve

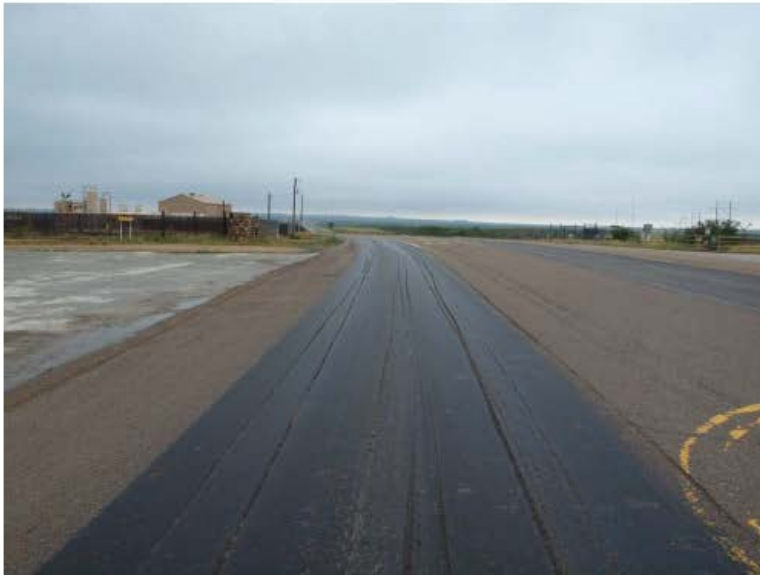
**Figure 5:** US83 northbound lane, looking south, from crest of vertical curve at vicinity of driveways. Image obtained by NTSB on 05/15/2016.

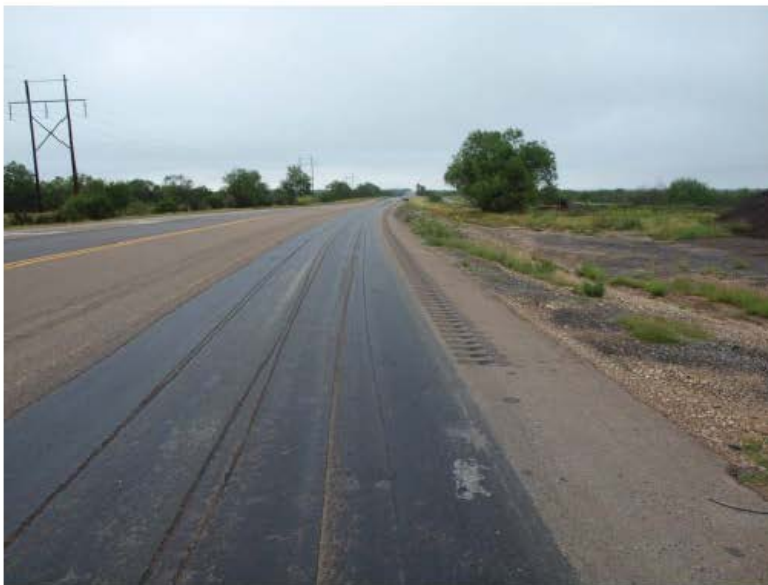
**Figure 6:** US83 northbound lane, looking north, from crest of vertical curve at vicinity of driveways. Image obtained by NTSB on 05/15/2016.

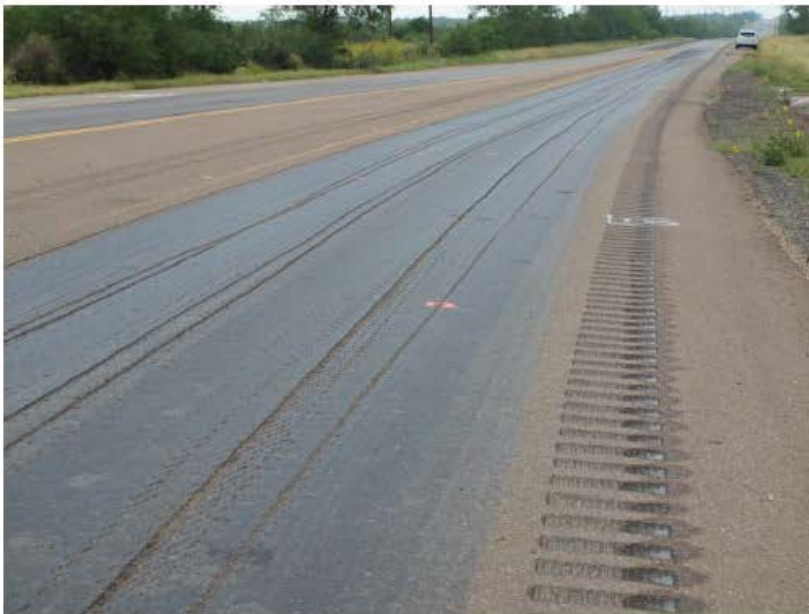
**Figure 8:** US83 northbound lane, looking north, in vicinity of driveways. the car on shoulder is approximately in location of final rest of motor coach. Image obtained by NTSB on 05/15/2016.

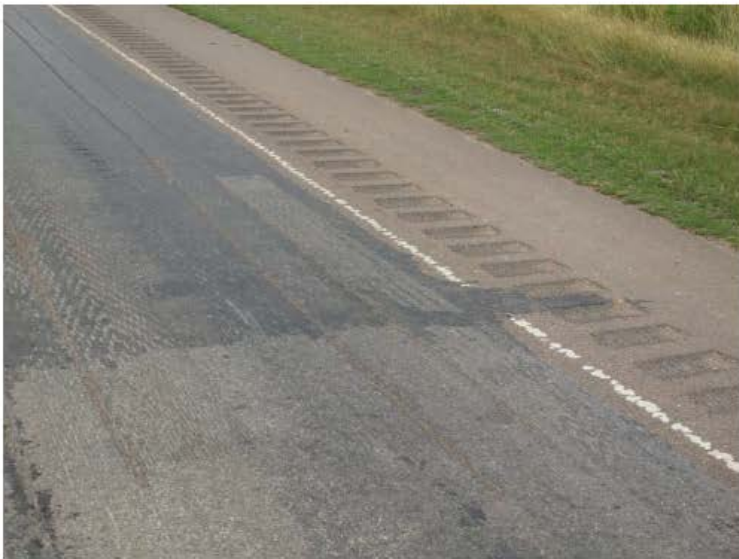
**Figure 10:** US83 northbound lane, looking north, close up of south end of milled section. Image obtained by NTSB on 05/18/2016.
