Collision Between a Sport Utility Vehicle Operating With  
Partial Driving Automation and a Crash Attenuator  
Mountain View, California  
March 23, 2018

NTSB/HAR-20/01  
PB2020-100112

# Highway Accident Report

**National Transportation Safety Board. 2020. *Collision Between a Sport Utility Vehicle Operating With Partial Driving Automation and a Crash Attenuator, Mountain View, California, March 23, 2018. Highway Accident Report NTSB/HAR-20/01. Washington, DC.***

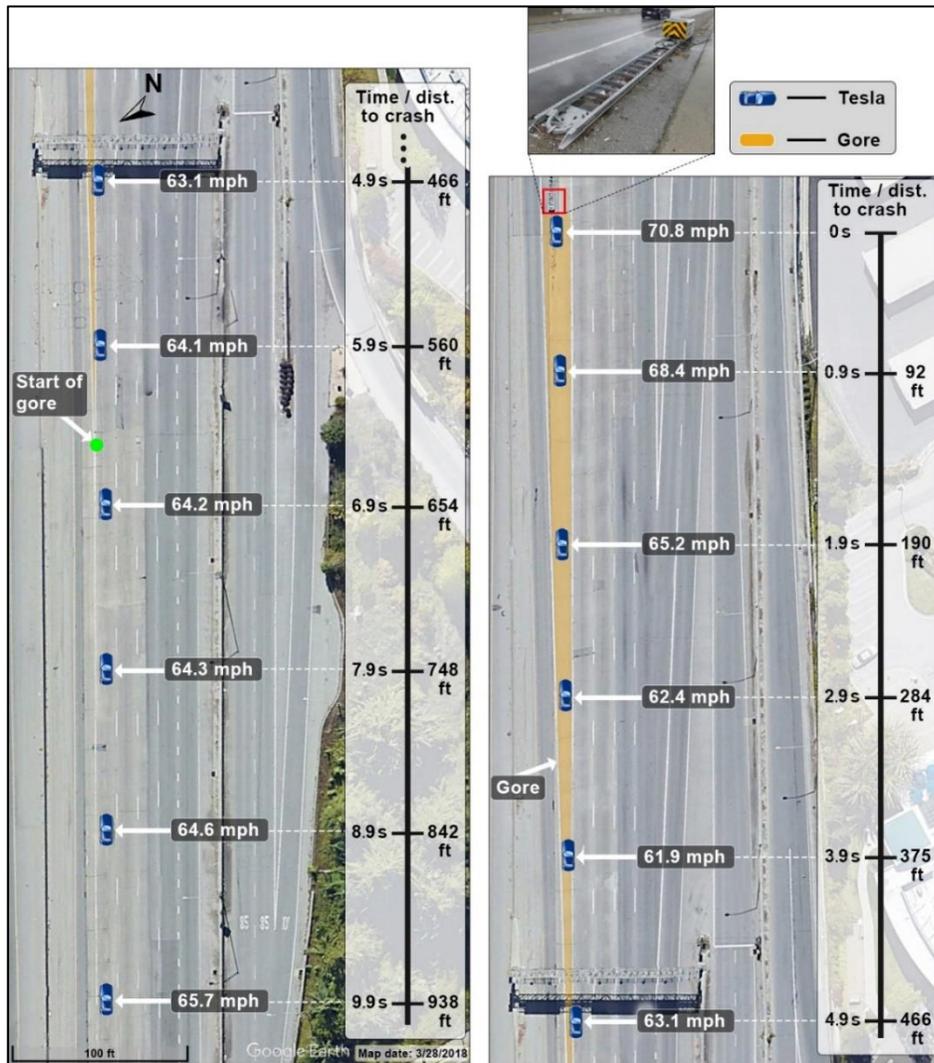
motion of the SUV during the 10 seconds leading up to the crash.<sup>6</sup> The time-position diagram is divided into two images. The left image shows the position of the SUV 9.9 to 4.9 seconds precrash and the right image depicts the final 4.9 seconds leading to the crash with the attenuator.

**Figure 5.** Movement of the Tesla SUV (blue vehicle) during the 10 seconds leading up to the crash with the attenuator. (The gore is highlighted yellow in this graphic for better clarity.)

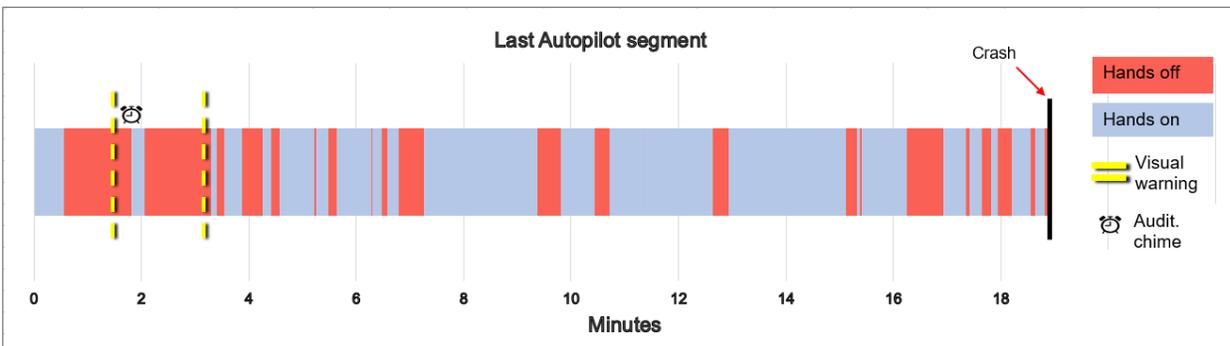
Tesla Carlog data showed that the crash trip lasted 28 minutes 33 seconds. Autopilot was active more than 75 percent of the time and during the final 18 minutes 55 seconds. According to the data, driver-applied torque to the steering wheel was not detected 34.4 percent of the time that Autopilot was active. Figure 12 depicts the last Autopilot segment, during which the system issued two visual alerts for hands-off driving. Because the system continued not to detect driver-applied torque to the steering wheel, one of these visual alerts progressed to the second alerting stage, with an audible warning.

About 6 seconds before the crash, no driver-applied steering wheel torque was detected by Autosteer.<sup>29</sup> This lack of driver input on the steering wheel continued until the impact with the crash attenuator.

**Figure 12.** Last Autopilot segment of the crash trip, including warnings for hands-off driving operation.

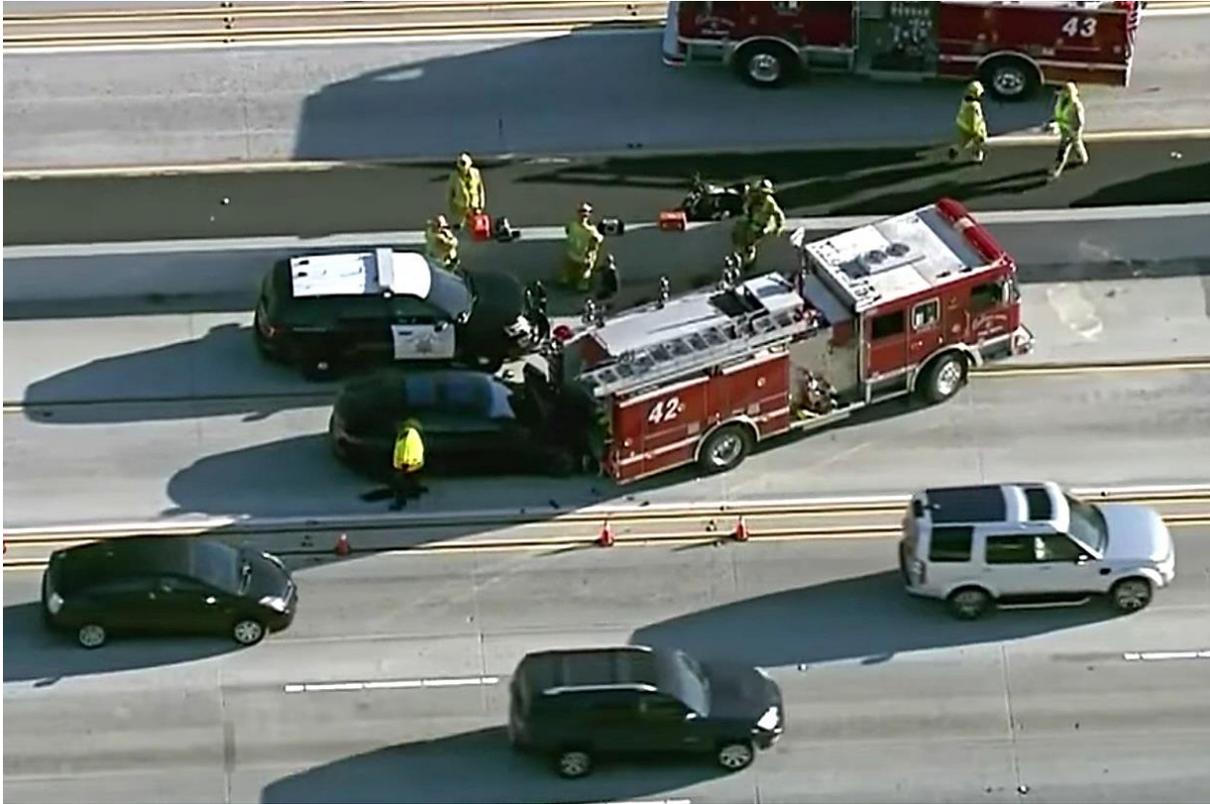
At 8:40 a.m. on Monday, January 22, 2018, a 2014 Tesla Model S P85 electric-powered car was traveling behind another vehicle in the HOV lane of southbound Interstate 405 (I-405) in Culver City, California (NTSB 2019a). Because of a collision in the northbound freeway lanes that happened 25 minutes earlier, a CHP vehicle was parked on the left shoulder of southbound I-405, and a Culver City Fire Department truck was parked diagonally across the southbound HOV lane. The emergency lights were active on both the CHP vehicle and the fire truck. The vehicle ahead of the Tesla changed lanes to the right to go around the fire truck, but the Tesla remained in the HOV lane, accelerated, and struck the rear of the unoccupied fire truck at a recorded speed of 31 mph (see figure 17).<sup>43</sup> The Tesla driver did not report any injuries. System performance data downloaded from the car indicated that the driver was operating it using the Autopilot system features TACC and Autosteer.

**Figure 17.** Overhead view of the 2014 Tesla and fire truck on I-405 in Culver City, California. (Source: CHP)

The NTSB determined that the probable cause of the Culver City crash was the Tesla driver's lack of response to the stationary fire truck in his travel lane, due to inattention and overreliance on the vehicle's ADAS; the Tesla's Autopilot design, which permitted the driver to disengage from the driving task; and the driver's use of the system in ways inconsistent with guidance and warnings from the manufacturer.

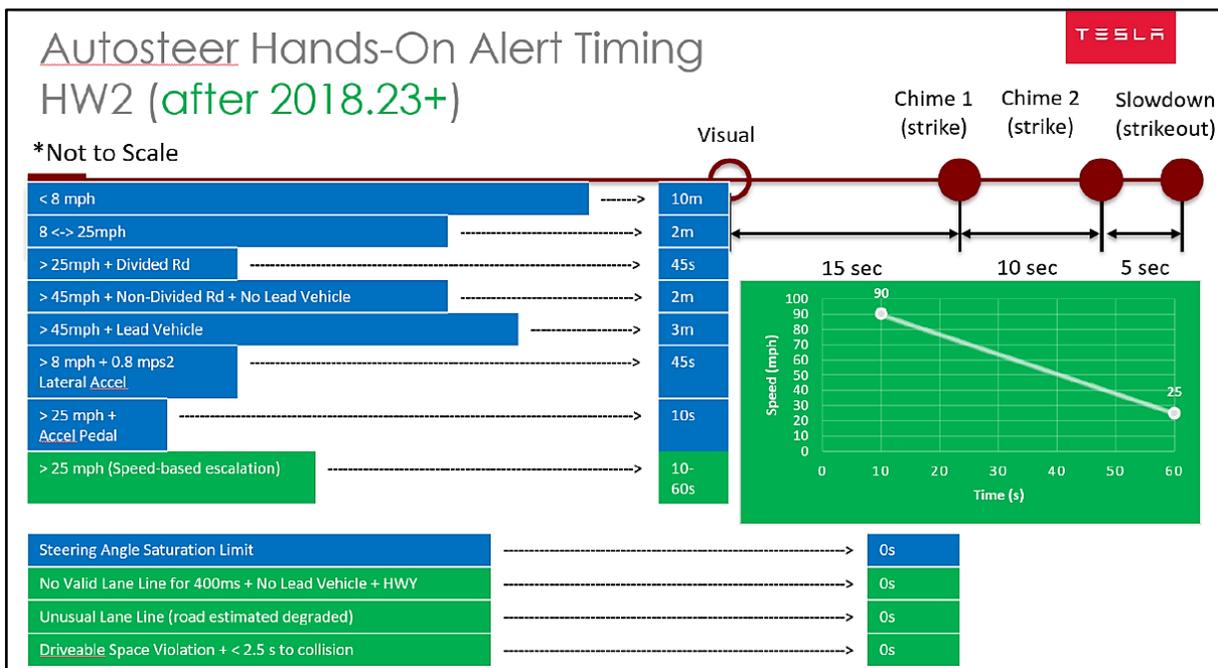
**Figure D-1.** Autosteer hands-on alert timing for the Tesla after firmware 2018.23 was implemented in June 2018. (Changes are highlighted in green)

- Autopilot Hands-Off-Wheel Alert Timing** (Firmware Update 2018.23, released June 2018): The firmware changed the alert timing to include more immediate alerts when hands are not detected on the steering wheel and there is no valid lane line (plus no lead vehicle) or if an unusual lane line is detected (see figure D-1). It also includes visual alerts based upon speed-based escalation for travel speeds over 25 mph. For example, at a speed of 25 mph if the vehicle does not detect hands on wheel for 60 seconds, a visual alert would be provided. At 90 mph, the alert would be provided after 10 seconds. Tesla advised that more immediate audible warnings are also provided if the system no longer recognizes a lane while hands are not detected on the steering wheel.
