**NATIONAL  
TRANSPORTATION  
SAFETY  
BOARD**

**HIGHWAY ACCIDENT REPORT**

**MULTIPLE -VEHICLE COLLISIONS**

**NEAR CORONA, CALIFORNIA**

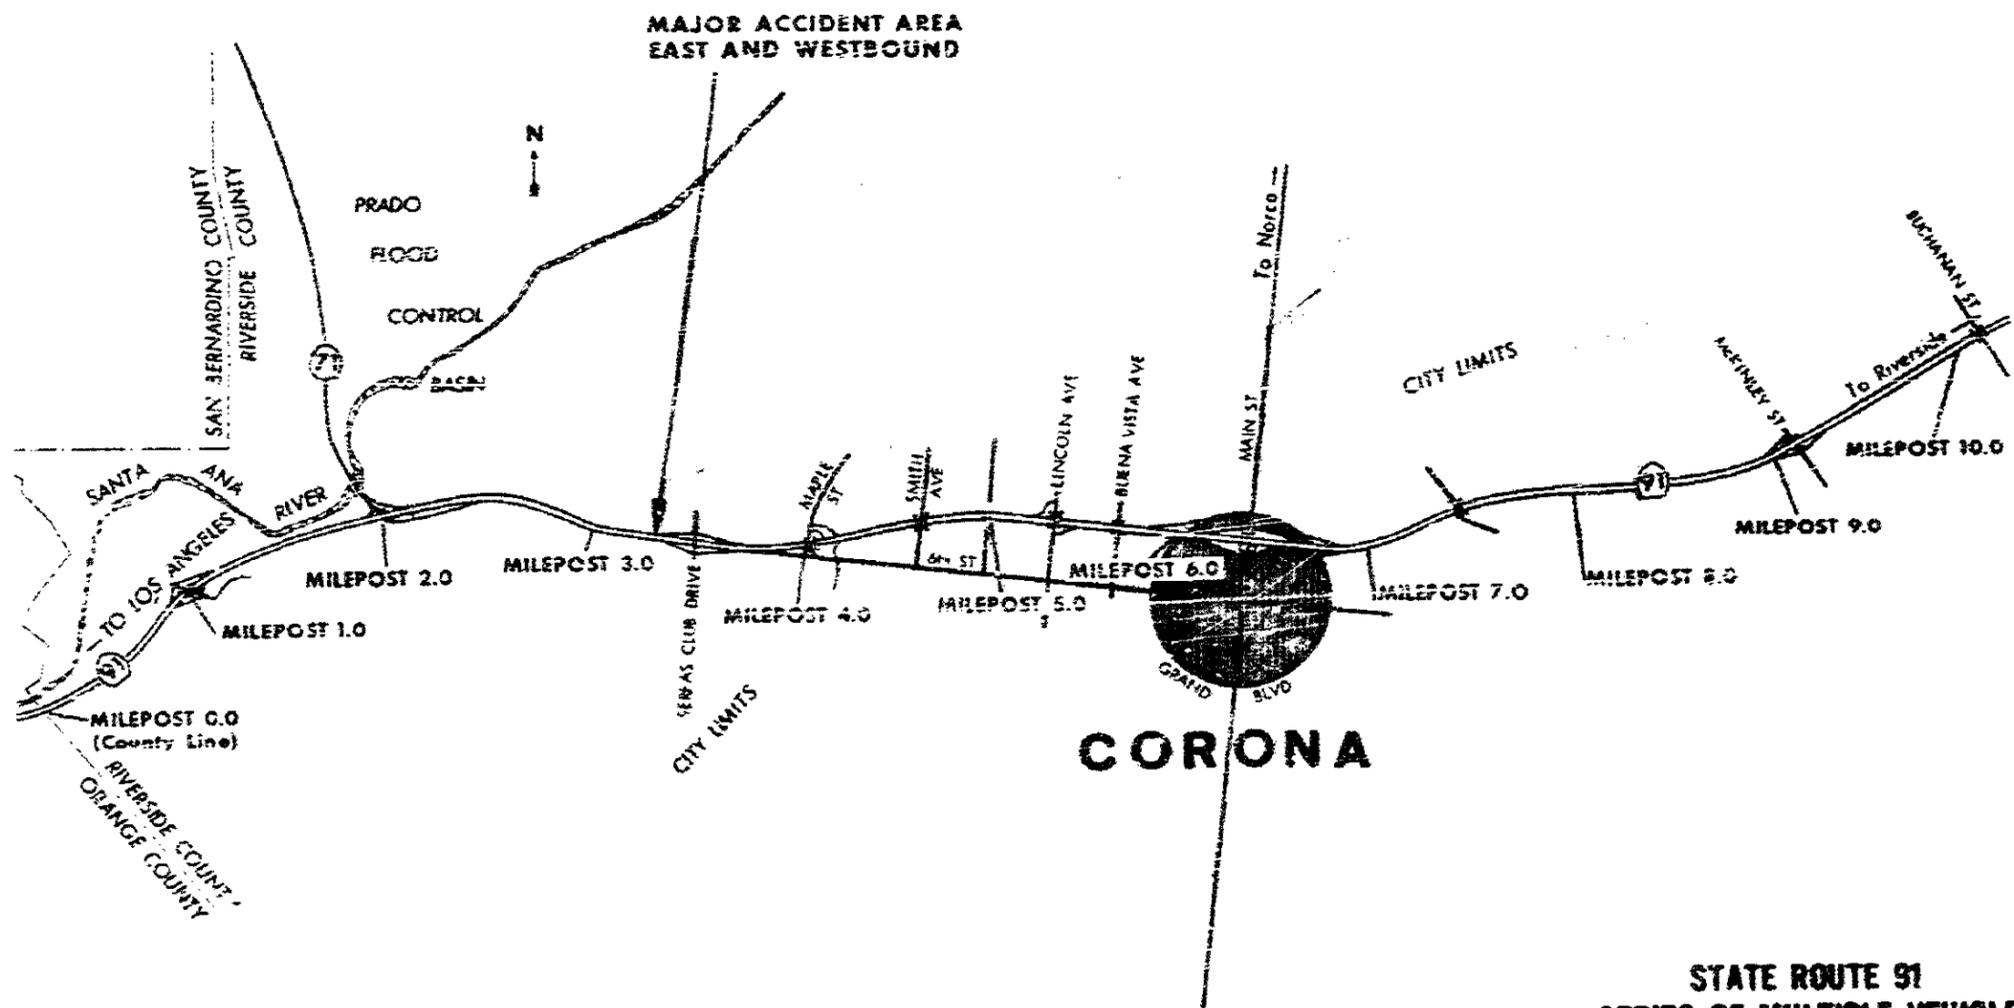
Figure 1. ACCIDENT SITES

At 7:40 a.m., a multiple-vehicle collision occurred on the westbound lanes of State Route 91 near Corona. About 10 minutes later, a second multiple-vehicle collision occurred on the eastbound lanes. These accidents occurred in the vicinity of milepost 3.5, Serfas Club Drive. (See Figure 1.) Another collision occurred on the eastbound lanes between mileposts 4 and 5 and another on the westbound lanes at milepost 1.7. One of the series of collisions occurred on the westbound lanes and involved 30 vehicles; most of the collisions involved 3 to 5 vehicles. (See Figures 2, 3, and 4.) These collisions involved vehicles which were not in convoys. Most of the drivers involved in the collisions were not aware of the convoys.
