**STUDENT TRANSPORTATION LINES, INC.,
CHARTER BUS CLIMBING OF
BRIDGE RAIL AND OVERTURN**

NEAR MARTINEZ, CALIFORNIA

MAY 21, 1976

REPORT NUMBER: NTSB-HAR-77-2

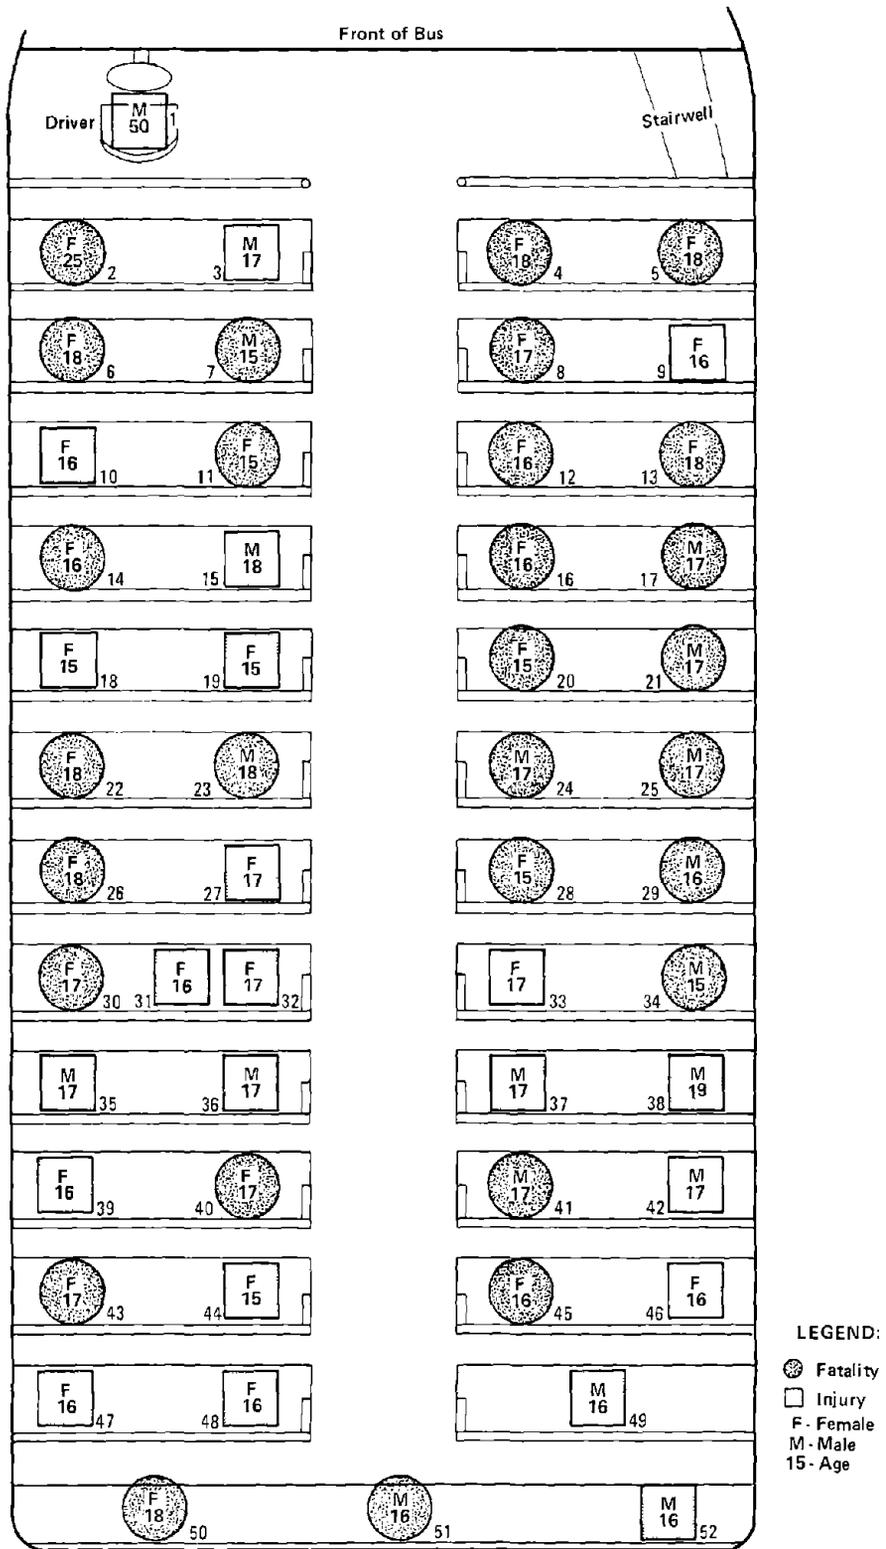
Figure 6. Seating chart of accident bus.

Twenty-nine of the occupants died, and the 23 others experienced minor to severe injuries. Passengers in the right front quadrant of the vehicle received the most severe injuries. (See figure 6.)
