NATIONAL TRANSPORTATION SAFETY BOARD

HIGHWAY ACCIDENT REPORT

**TRACTOR-SEMITRAILER/SCHOOLBUS
COLLISION AND OVERTURN**

REPORT NUMBER: NTSB-HAR-78-1

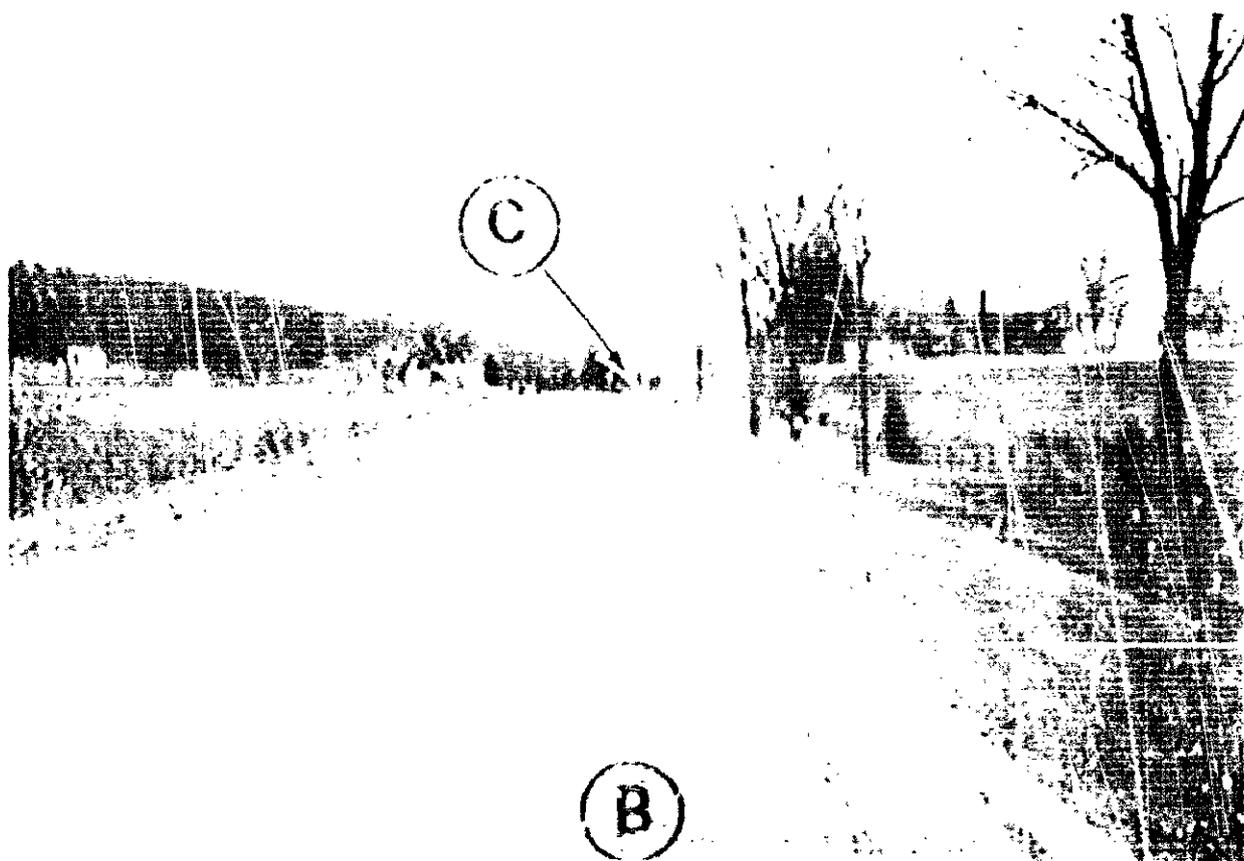
The back of the bus body was deformed 56 inches forward of its original position on the left side and about 12 inches on the right side. Maximum deformation occurred on the left side between the upper windowsill and the bottom of the body. The glass in both rear body panel windows and the emergency door window was missing. The bus body parts at the rear were stripped forward and clear of the vehicle's chassis frame siderails. (See figure 2 and 3.) Red paint transfers were found in the area of the rearmost roof panels. An imprint of the tractor radiator grill and red paint transfers were found on the emergency door panel. The emergency door was not attached to the door frame, having been removed during rescue operations. The rear bumper and siderails were bent approximately 10 inches toward the

displaced rearward 17 1/2 inches. The right-front tire was flattened and badly cut. The inside edge of the right-front wheel rim was gouged. The radiator was displaced rearward with maximum displacement at the left edge. The windshield was missing and its centerpost was deflected rearward. The forward edge of the cab roof was deformed toward the right and rearward. Yellow and black paint transfers were found on the front surfaces of the tractor cab, and on the bumper. (See figure 4.)

The upper part of the tractor frame-mounted sliding fifth wheel assembly separated from its lower components. Three teeth on the left side of the upper assembly showed evidence of extremely high loadings. The front tooth had sheared at its outboard end. The left side channel in which the upper slide plate moves fore and aft, had been deformed upward and inboard. (See figures 5 through 8.) Wear marks on the lower ratchet teeth indicate that the fifth wheel had been positioned 4 inches aft of the bogie axle centerline. The fifth wheel stop plate, mounted at the forward end of the assembly, failed at the attachment welds.
