HIGHWAY ACCIDENT REPORT

**OSTERKAMP TRUCKING, INC.,
TRUCK/FULL TRAILER AND
DODGE VAN COLLISION, U.S. 91
NEAR SCIPIO, UTAH**

AUGUST 26, 1977

1. Report No. NTSB-HAR-79-1	2. Government Accession No.	3. Report Number PB293501
4. Title and Subtitle Highway Accident Report - Caterkamp Trucking Inc., Truck/Full Trailer and Dodge Van Collision, U.S. 91, near Scipio, Utah, August 26, 1977	5. Report Date February 22, 1979

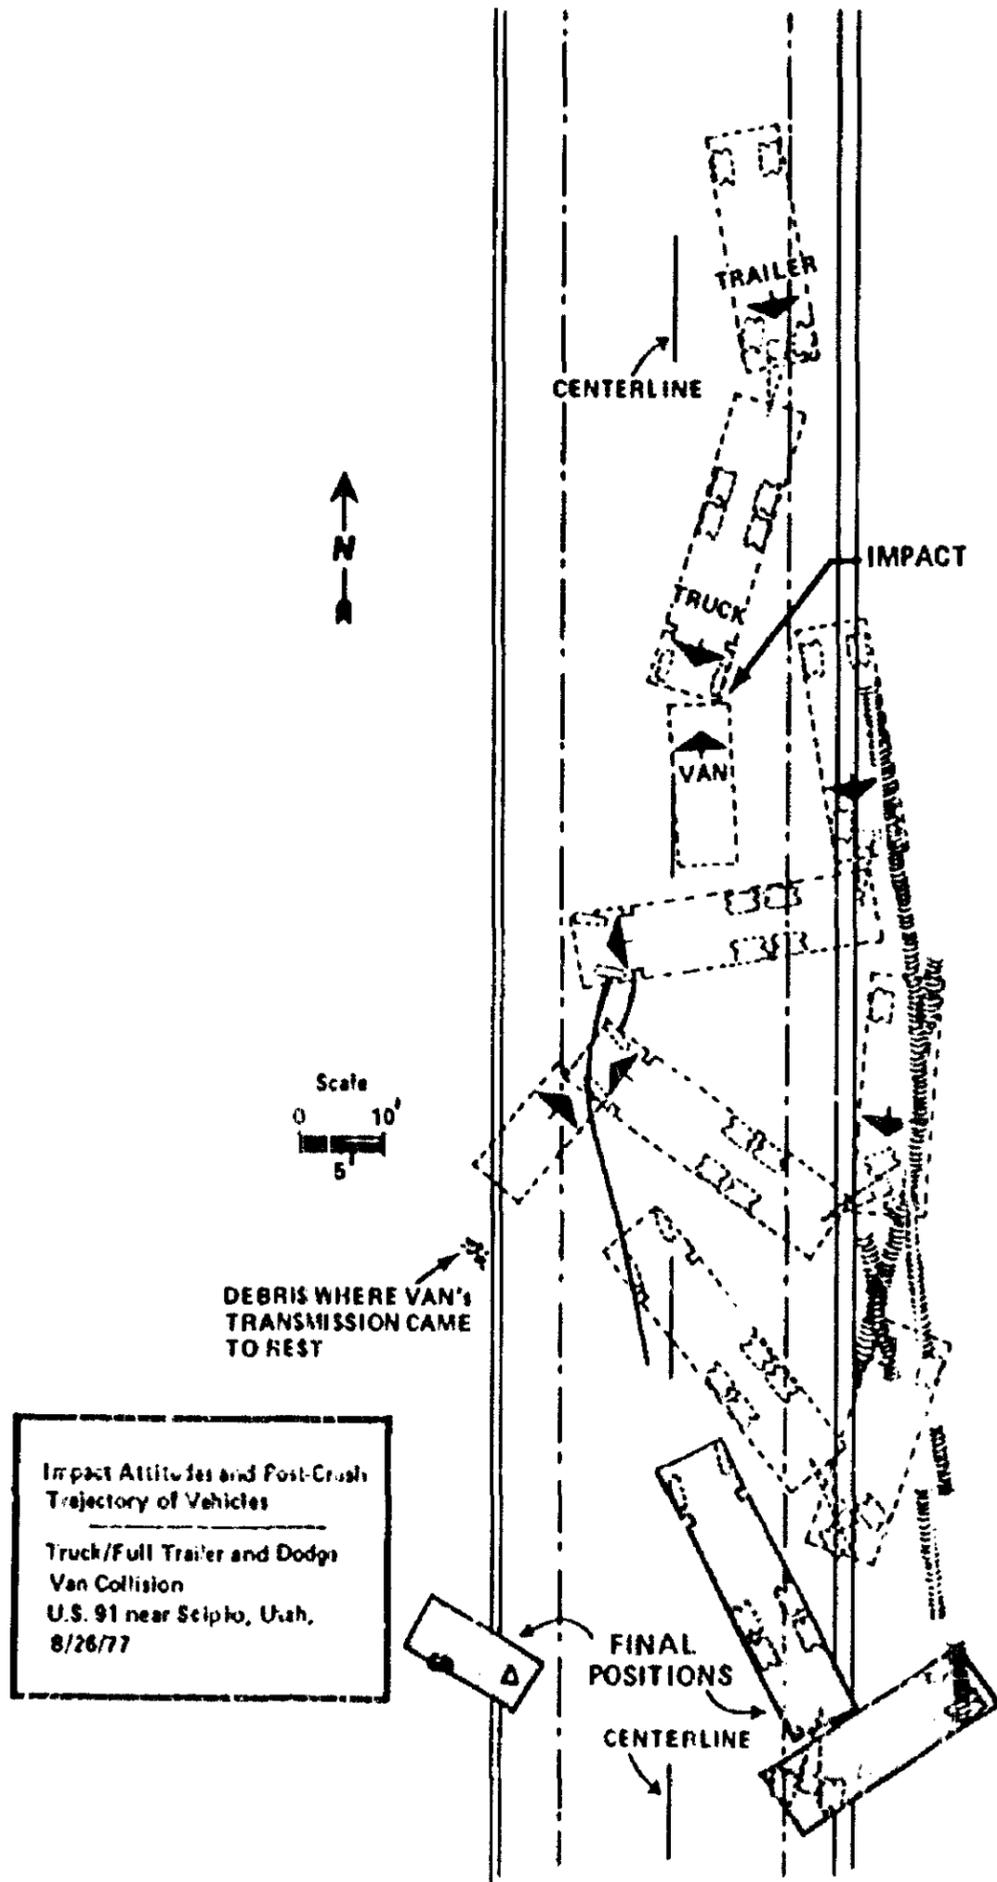
Figure 1. Impact attitude and post-impact trajectory of vehicles.

The physical evidence (gouge marks on the pavement matched to undercarriage damage to the two vehicles and a match-up of damaged components between the two vehicles) indicated that both vehicles were straddling the centerline at impact; the truck/full trailer was almost fully on the van's side of the road, while the van was just across the centerline. (See figure 1.) After impact, the truck/full trailer rotated clockwise while continuing forward. Upon impact, the van immediately rotated counterclockwise and then rotated clockwise with the truck while traveling rearward and to its left. The truck/full trailer stopped on the east side of the road. The van came to rest on the west side of the road.
