NATIONAL TRANSPORTATION SAFETY BOARD

HIGHWAY ACCIDENT REPORT

OVERTURN OF A
YPSILANTI, MICHIGAN, BOYS CLUB BUS,
ON I-75, NEAR TIFTON, GEORGIA
APRIL 11, 1978

1. Report No. NHSB-HAR-79-2	2. Government Accession No.	3. Report Number PB294004	
4. Title and Subtitle Highway Accident Report - Overturn of a Ypsilanti, Michigan, Boys Club Bus, I-75, Near Tifton, Georgia, April 11, 1978.		5. Report Date March 8, 1979	6. Performing Organization Code

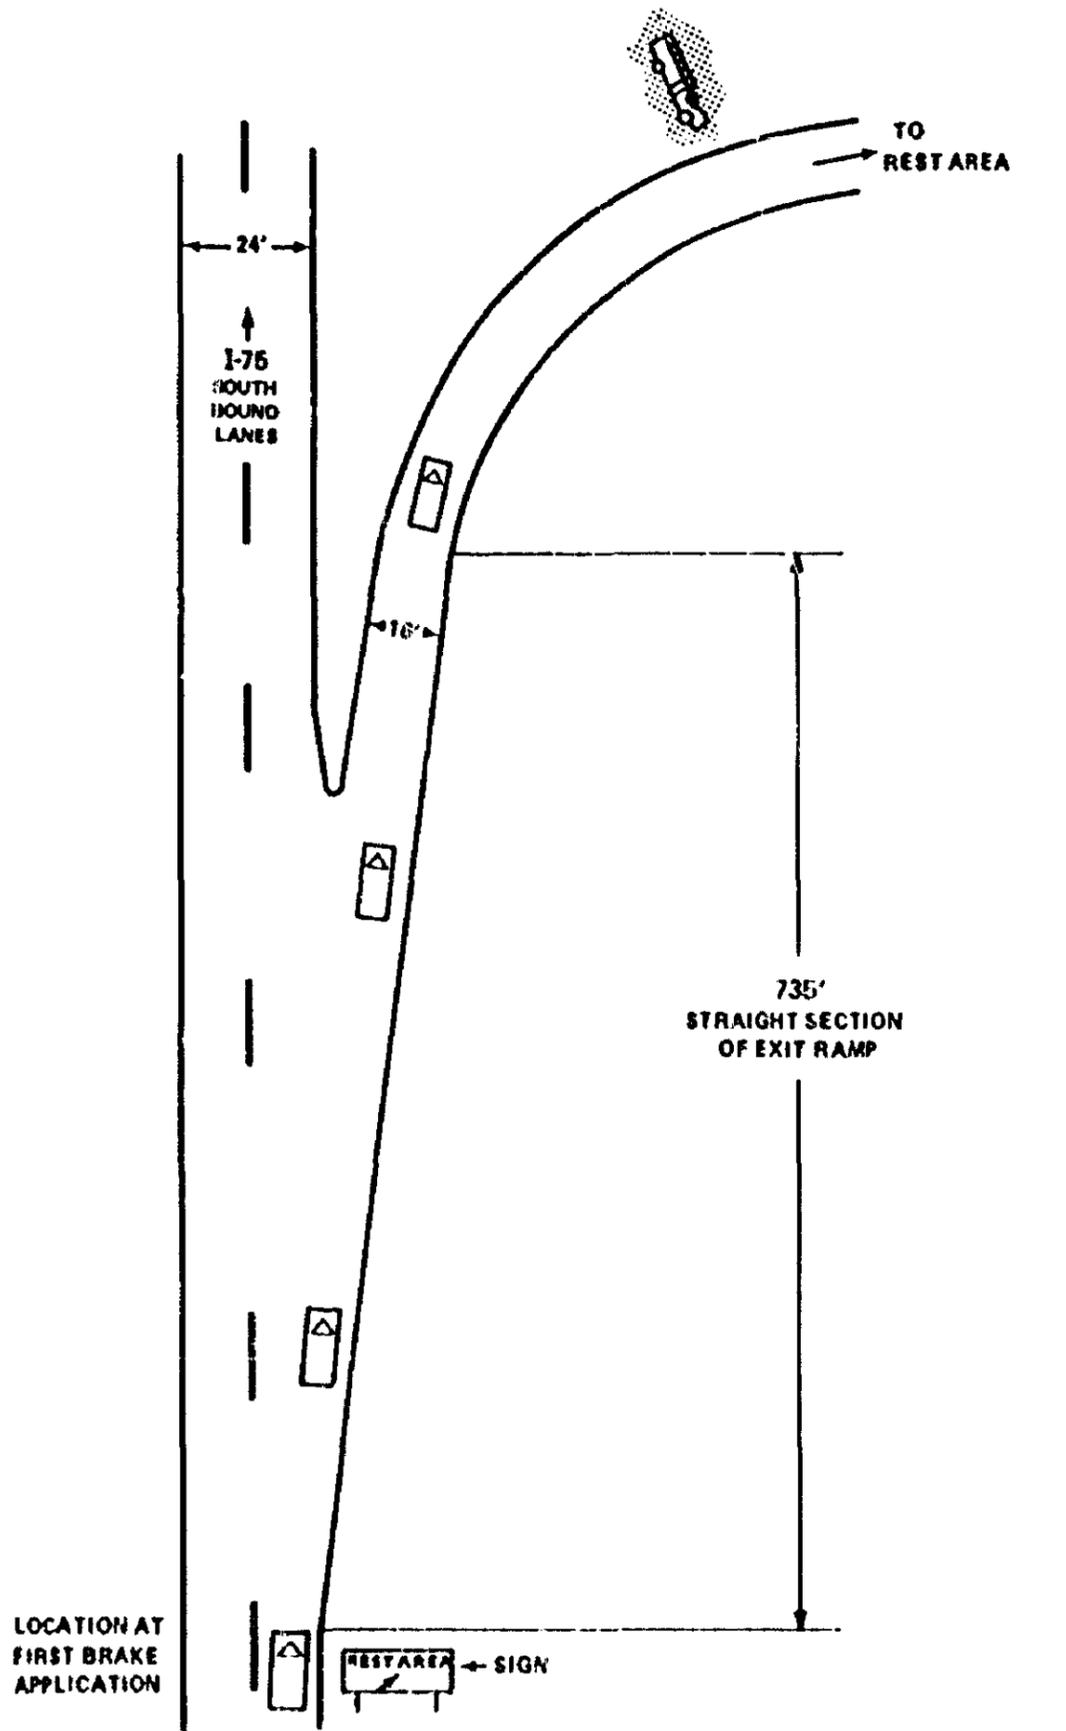
The busdriver stated that she steered onto the exit lane at its beginning; at that time, she took her foot off the accelerator and pumped the brakes, but the bus did not decelerate. She was adjacent to the rest area exit sign when she pumped her brakes for the first time at the exit ramp. (See figure 2.) She exclaimed to her relief driver, who was standing in the front of the bus at the glove compartment, "the brakes...", and then braked again as she started into the curve. She claimed that the brakes did not work. She stated that at the beginning of the curve the bus was going about 35 to 40 mph and was four to six car-lengths behind the van.

Figure 2. Path of bus on exit ramp.

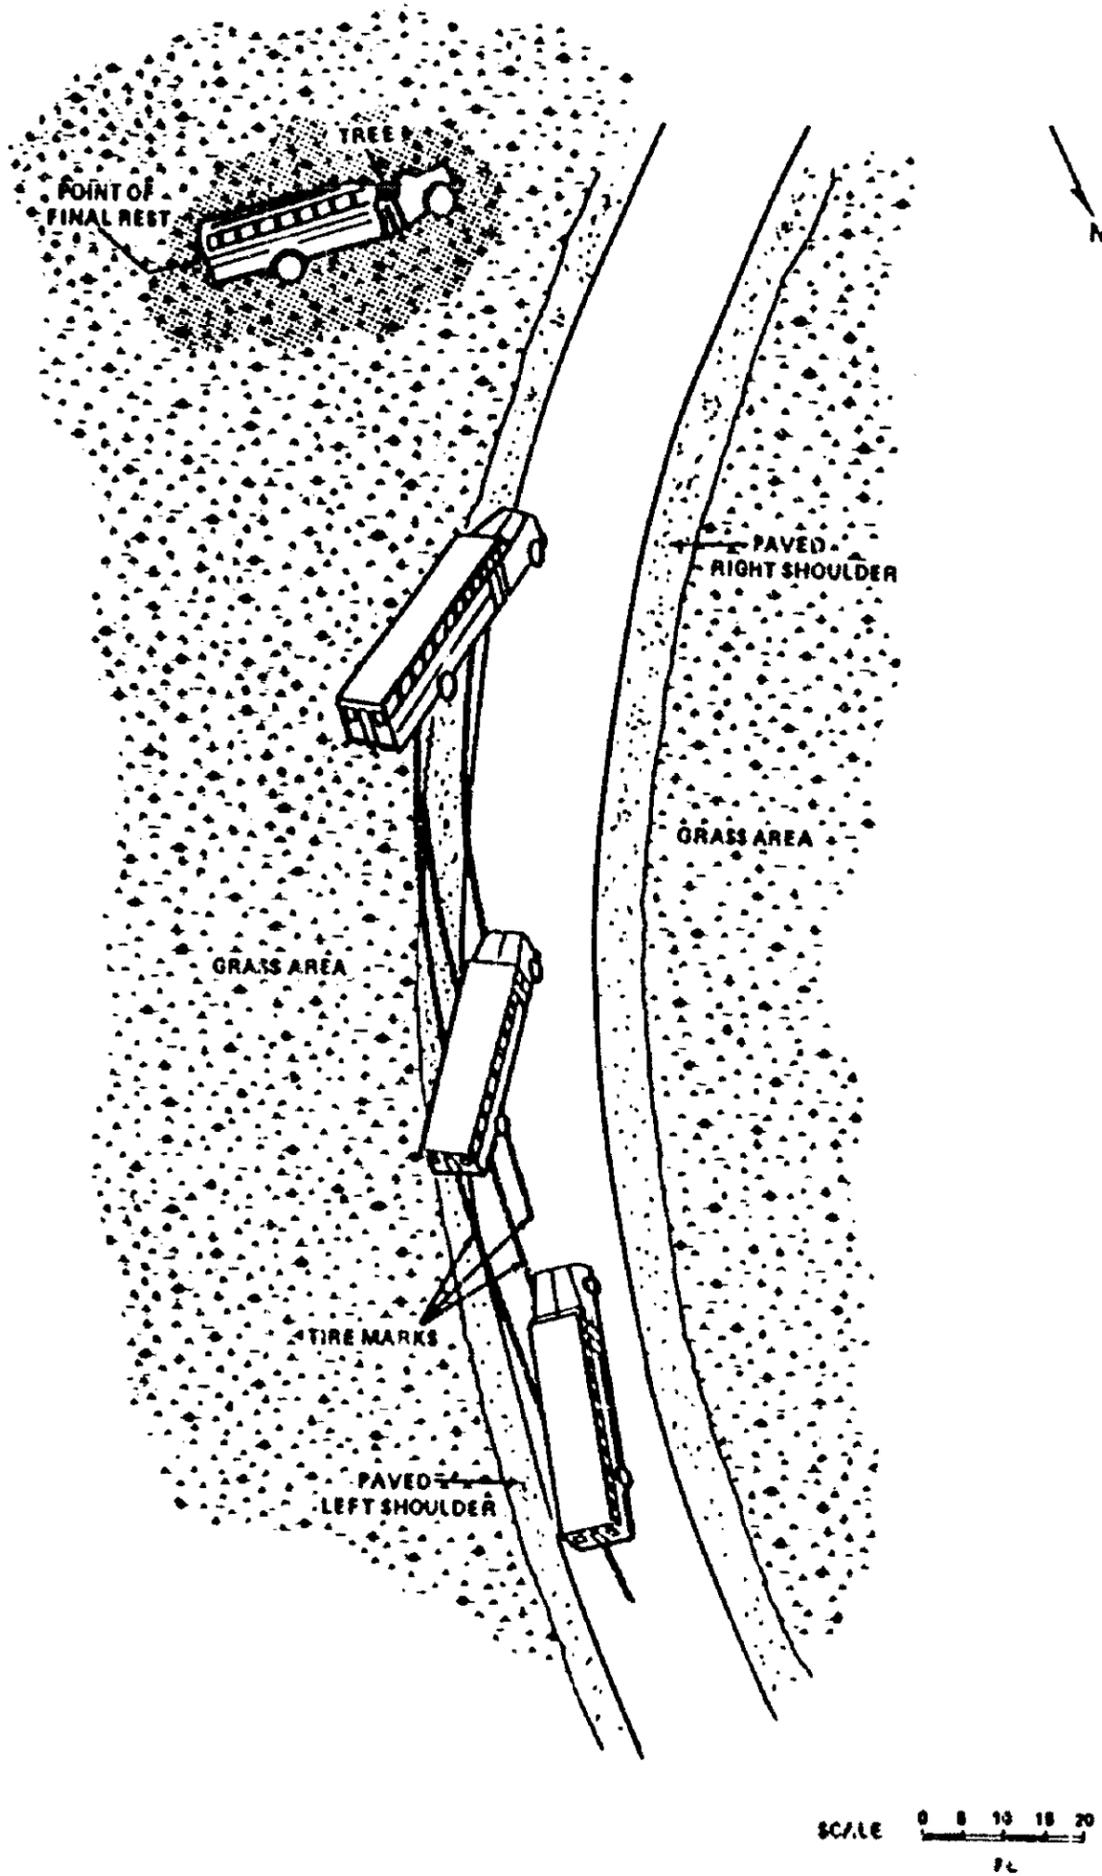
About 10:00 a.m., 100 miles south of the Macon rest stop on I-75, near Tifton, Georgia, the van driver became tired and wanted to switch with his relief driver. He saw a sign indicating a rest area 2 miles ahead and decided to make a driver change there. Since this was not a scheduled stop, the van passed the bus and with its right turn signal flashing exited at the rest area; the busdriver activated her right turn signal and followed. The vehicles were traveling about 50 to 55 mph. After a 735-foot straight tapered section, the exit ramp curved right at 27°30' (208-foot radius). As the bus attempted to negotiate the curve, it yawed clockwise, crossed the left shoulder onto a grass embankment, rolled over onto its left side, and slid roof-first into a tree. (See figures 2, 3, 4, and 5.)

Figure 3. Path of bus.

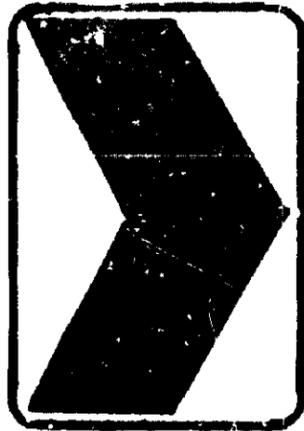
Although the Georgia Highway Department's Sign Plan specifies placement of a ramp speed sign on the right shoulder 244 feet before the point of curvature, such a sign was not in place at the time of the crash. Maximum recommended speed would have been 25 mph. On April 13, 1978, the Georgia Department of Transportation District Traffic Engineer recommended that "Chevron" signs be placed around the curve on the exit to Safety Rest Area No. 9 (see figure 9a) and that 25-mph advisory exit speed signs be installed on all five exit ramps in District No. 4. At the time of the crash, there were no traffic-control signs facing traffic on the exit ramp. A guide sign stating "rest area" with a 45° arrow indicating the appropriate turn was in place on the right shoulder 22 feet north of the beginning of the exit ramp.

Figure 9a. Chevron alignment sign intended to provide additional emphasis and guidance for vehicle operators as to changes in horizontal alignment of the roadway.

Since the crash, the recommended signs have been installed. Additionally, an audit was made of all similar locations in the State to insure that appropriate signs had also been installed at those sites.
