# NATIONAL TRANSPORTATION SAFETY BOARD

## HIGHWAY ACCIDENT REPORT

STATIONWAGON PENETRATION OF  
BRIDGERAIL, I-10  
NEAR ALHAMBRA, CALIFORNIA  
NOVEMBER 11, 1978

NTSB-HAR-79-5

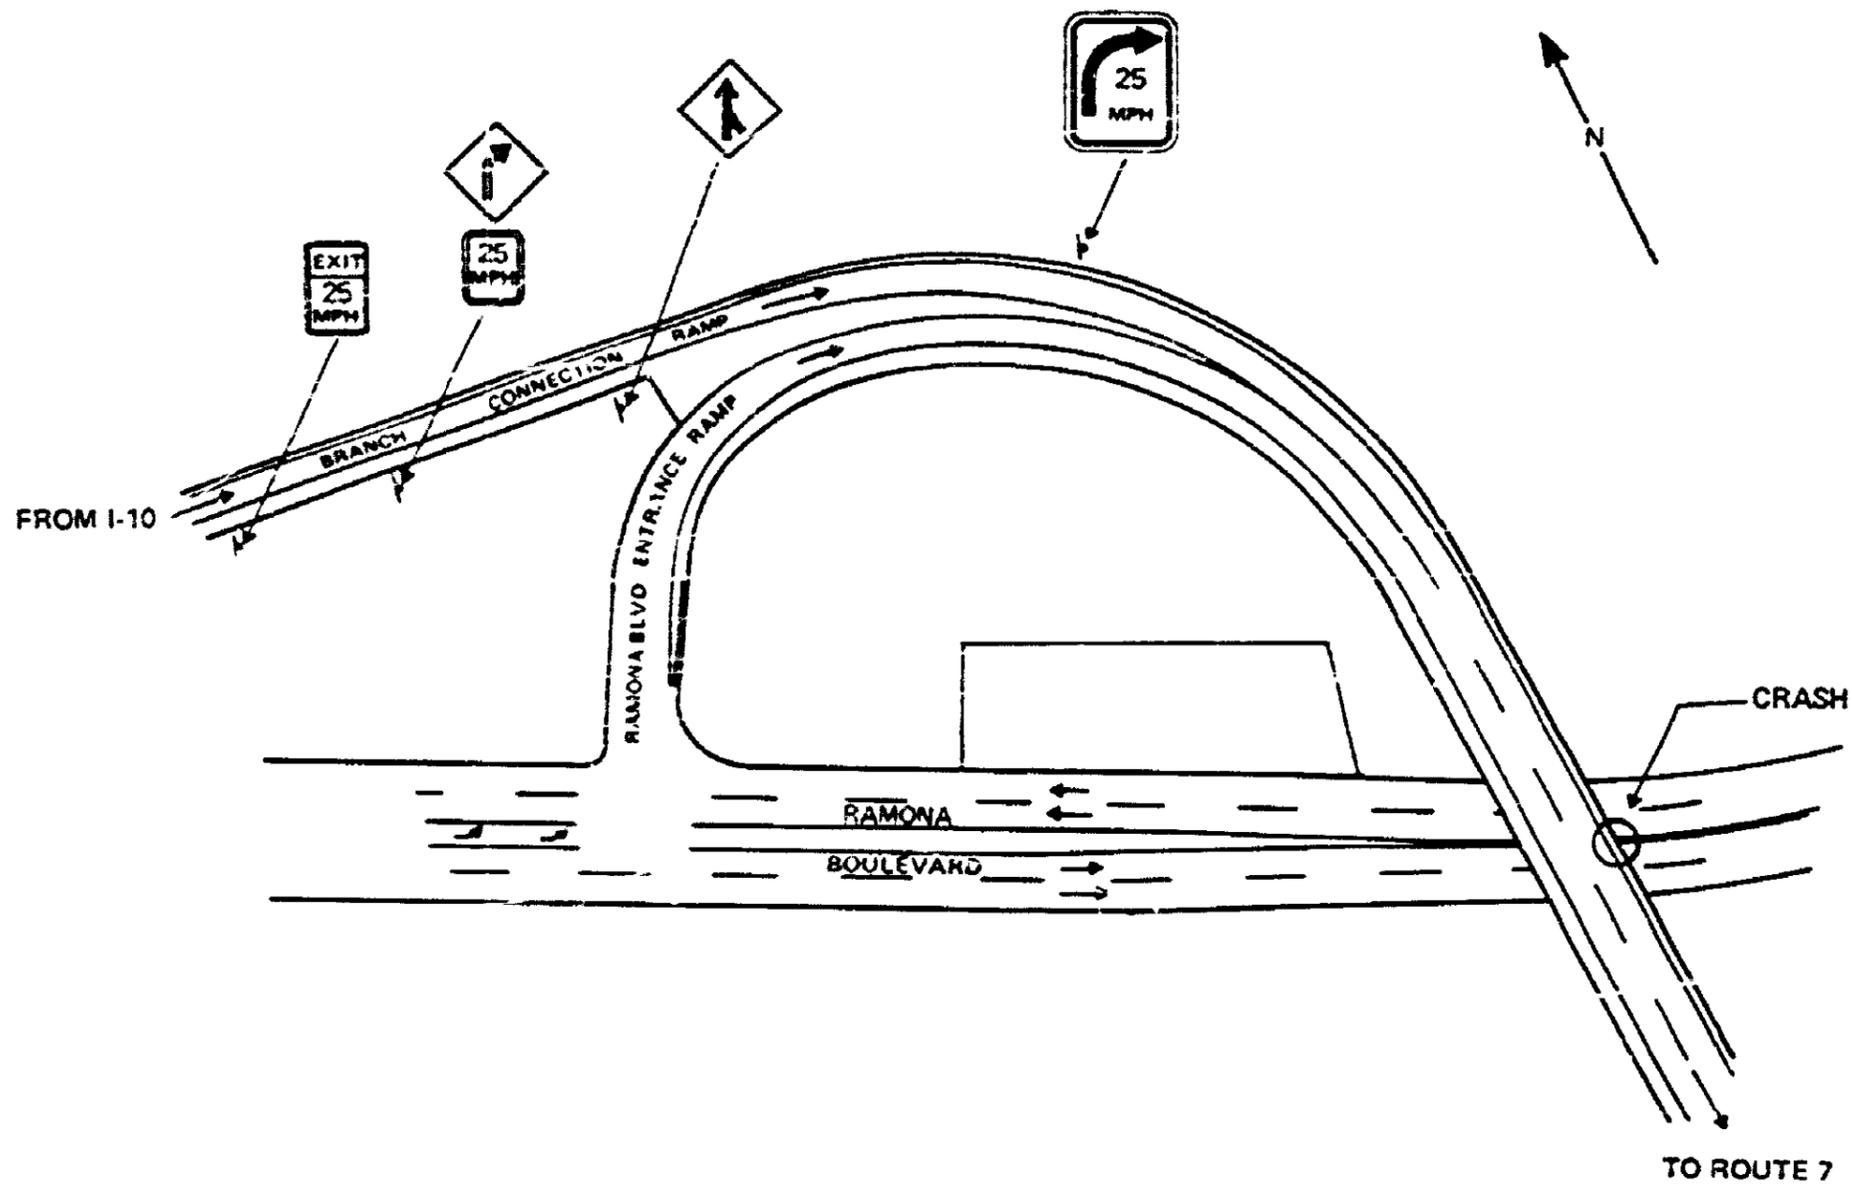
Figure 1. Plan of crash site.

At about 3:40 p.m., 6 miles from the factory, the stationwagon exited eastbound Interstate 10 (San Bernardino Freeway), according to the driver's wife, onto a branch connection ramp which led to California State Route 7 (Long Beach Freeway). The single-lane connection ramp curved right and joined another ramp which originated at Ramona Boulevard. The two lanes continued across a bridge overpass and eventually merged with Route 7. (See figure 1.)
