Highway Accident Report: Cross-Median,
Multiple-Vehicle Collision and Fire,
State Route 2, Near Cleveland, Ohio, May 6, 1979

1. Report No. NTSB-HAR-79-7		2. Government Accession No.		3. Publication No. PB300914	
4. Title and Subtitle Highway Accident Report — Multiple Vehicle Collision and Fire, State Route 2, Near Cleveland, Ohio, May 6, 1979				5. Report Date September 20, 1979

CROSS MEDIAN MULTIPLE VEHICLE COLLISION AND FIRE
STATE ROUTE 2, NEAR CLEVELAND, OHIO
MAY 6, 1979

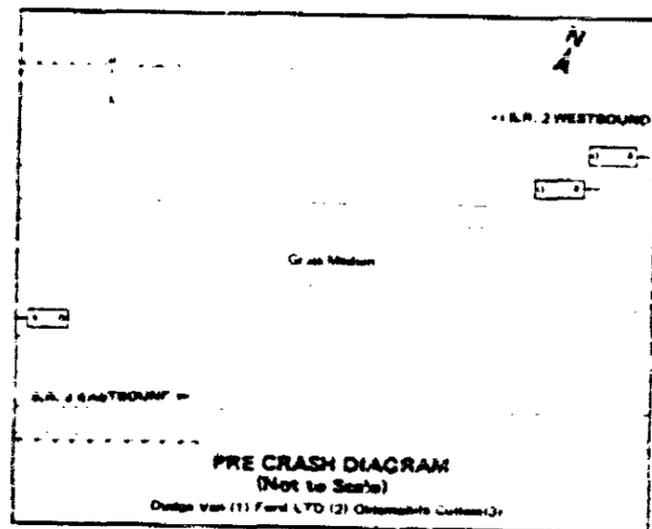
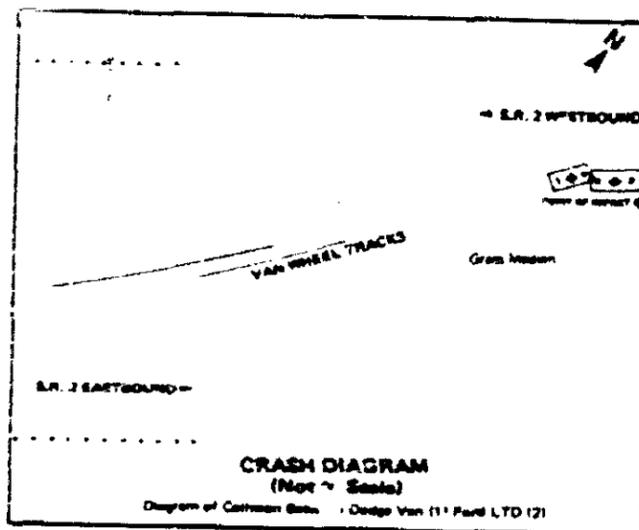
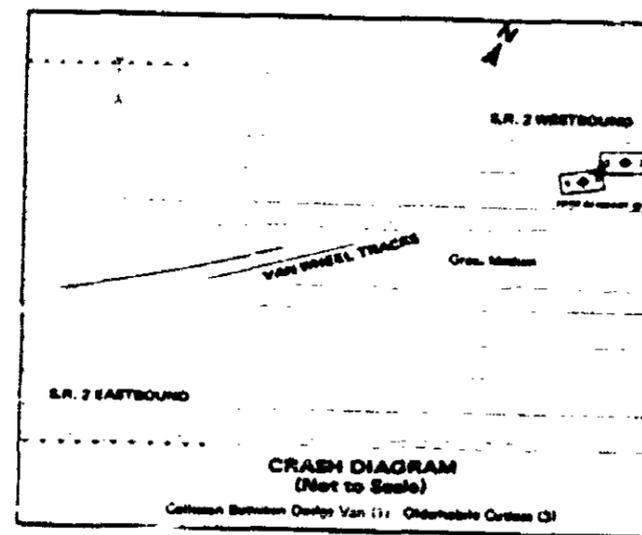
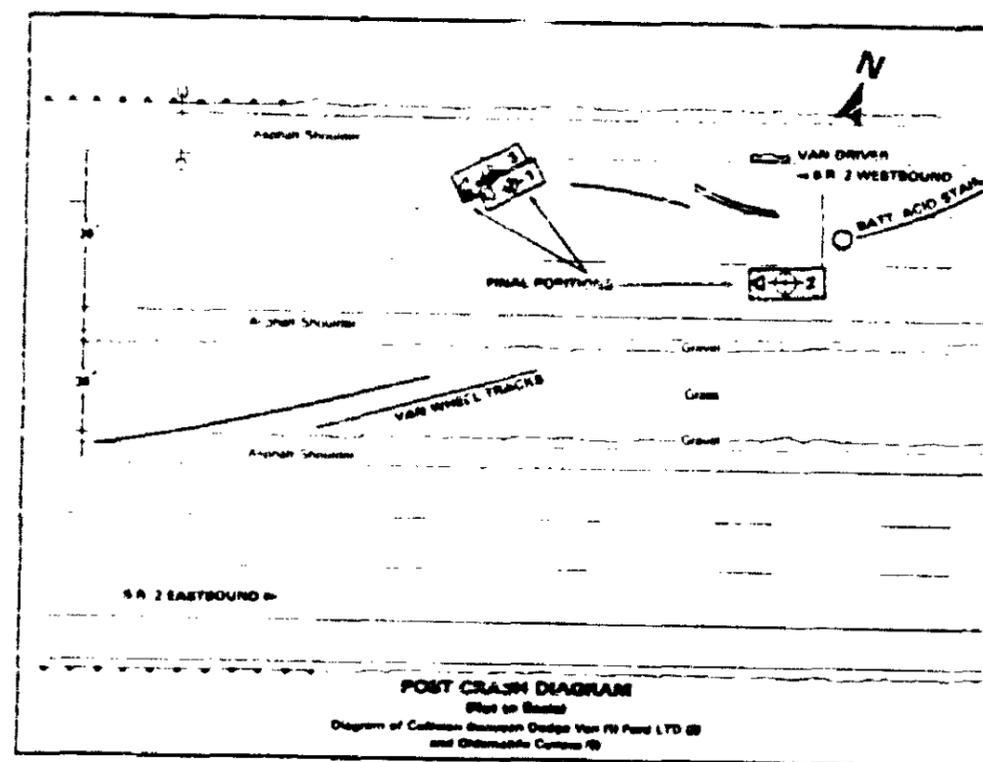
Figure 1.--Accident Diagrams.

About 3:05 a.m. on May 6, 1979, an eastbound 1976 Dodge van was traveling in the fast lane of State Route 2, a six-lane divided highway, when it drifted across the grassy median divider and collided, first, with a westbound 1971 Ford LTD sedan and, then, with a westbound 1976 Oldsmobile Cutlass. (See Figure 1.) The Ford was traveling in the fast lane and the Oldsmobile was traveling in the middle lane. In the collision between the van and the Ford, the front bumper separated from the Ford and became wedged between the rear axle of the van and the pavement. The van then collided with the Oldsmobile. Sometime during the accident dynamics the van driver was ejected onto the side of the road. As the van and Oldsmobile slid to a stop (see Figure 2), the deformed end of the Ford's bumper punctured the van's fuel tank, permitting the gasoline to escape onto the roadway. The two occupants escaped from the Oldsmobile just before the gasoline vapors ignited and engulfed the van and Oldsmobile in fire. None of the six occupants in the Ford survived.
