HIGHWAY ACCIDENT REPORT

CENTRAL TEXAS BUS LINES, INC.,
CHARTER BUS, STATE ROUTE 7
NEAR JASPER, ARKANSAS
JUNE 5, 1980

NTSB-HAR-81-1

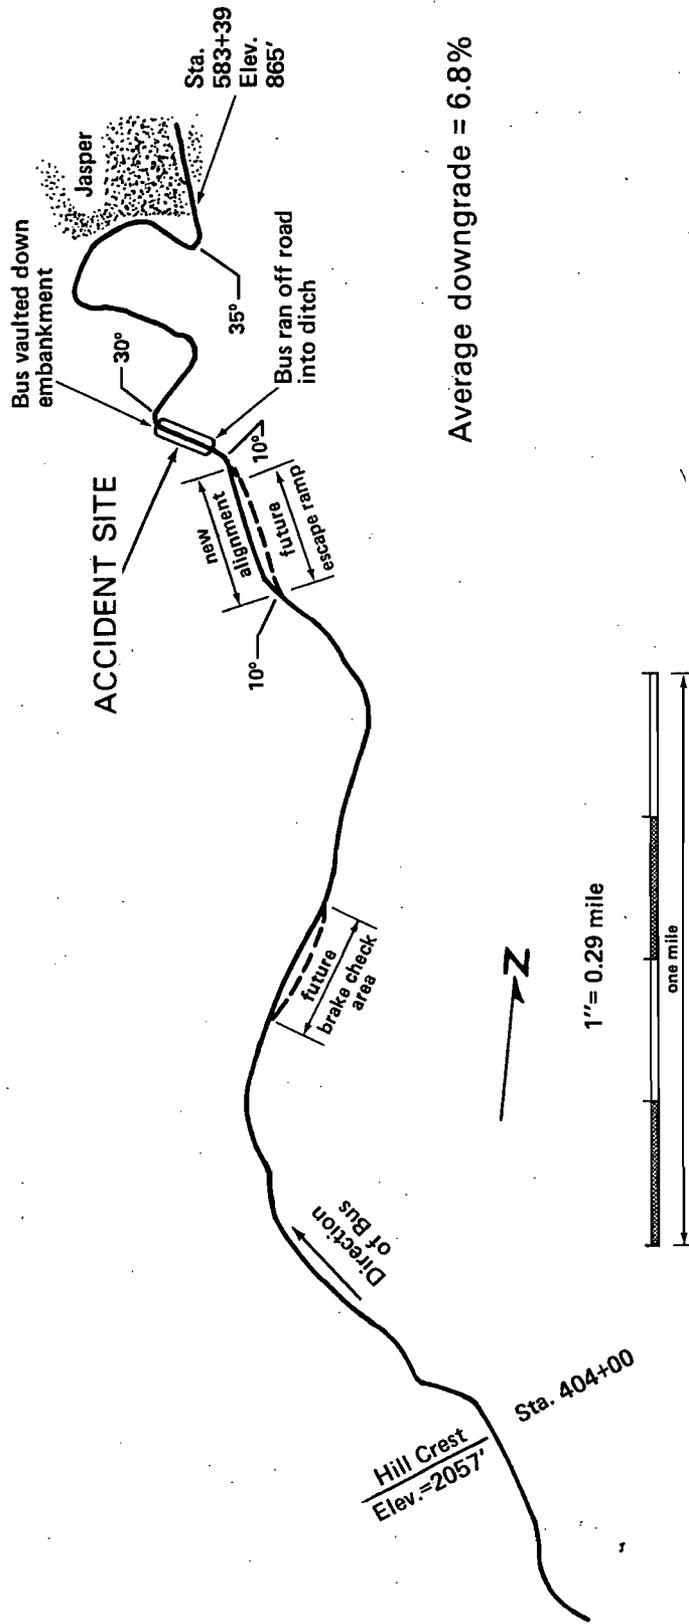
Figure 10.--Plan view of roadway.

The accident site was about 2.2 miles north of the hillcrest. (See figure 10.) The State had recently completed construction of a brake check area 0.9 mile north of the hillcrest, but the area was neither marked, signed, nor in use at the time of the accident. The brake check area was to be opened when a vehicle escape ramp under construction 1.1 miles farther north was completed. The ramp was being built on the existing alignment of Route 7, and the roadway had been realigned west of and roughly parallel to the ramp. The detour was opened to traffic the day before the accident. (See figures 11 and 12.)
