# NATIONAL TRANSPORTATION SAFETY BOARD

## HIGHWAY ACCIDENT REPORT

HERMAN DUVALI TRACTOR-POLE SEMITRAILER/  
S.L.&B ACADEMY, INC., SCHOOLBUS COLLISION  
U.S. ROUTE 45, NEAR WAYNESBORO, MISSISSIPPI  
OCTOBER 12, 1981

NTSB-HAR-82-2

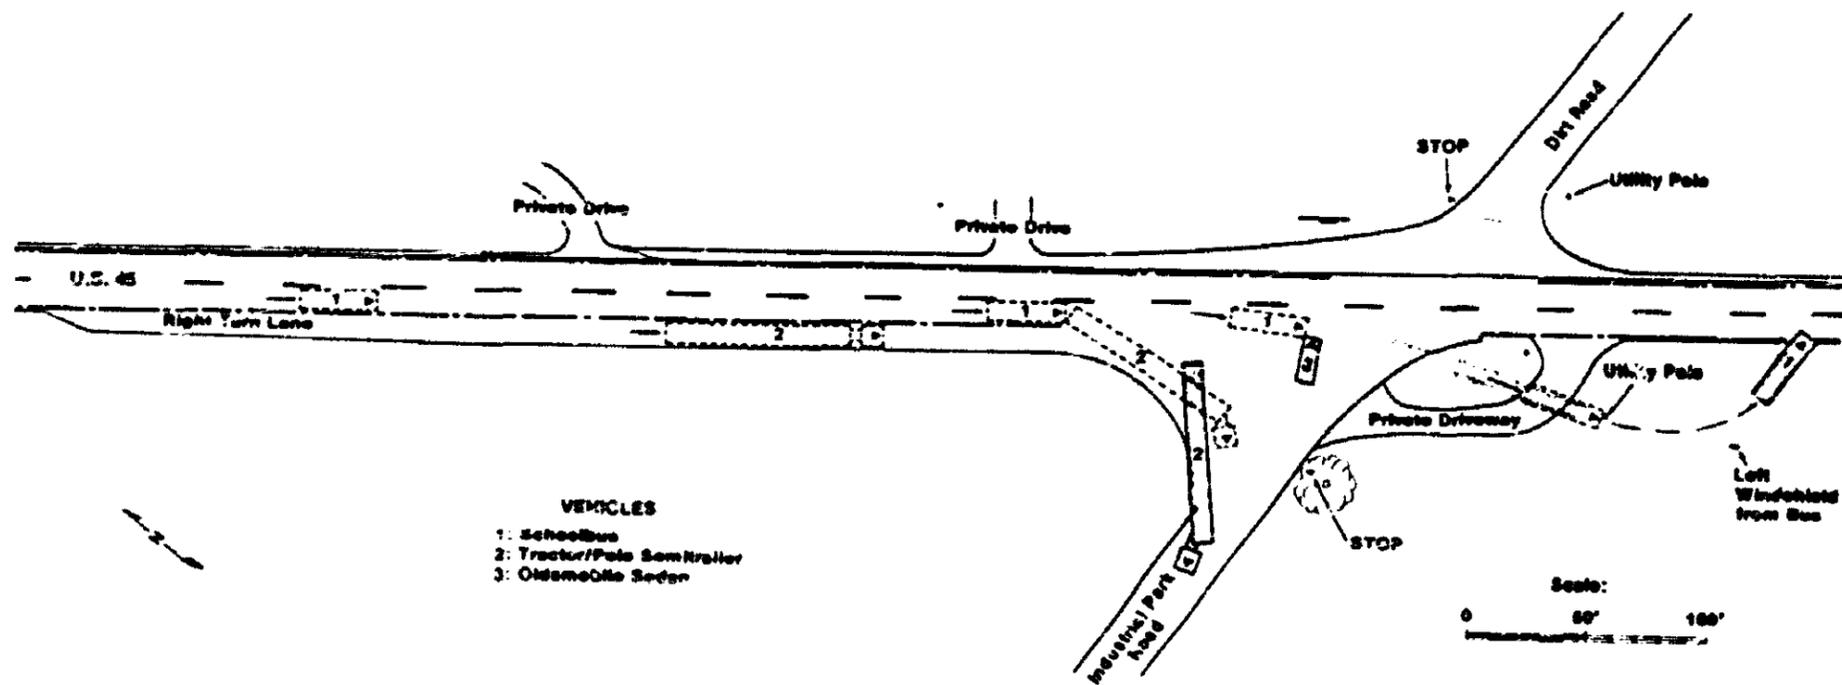
Figure 1.--Plan view of accident site.

As the truck traveled through the central part of the city, it stopped at a red traffic light. The truckdriver stated that he looked in the truck's rearview mirror and noticed the schoolbus stopped directly behind his vehicle. After the light turned green, both vehicles continued south on U.S. 45 with the schoolbus following the logging truck. According to the truckdriver, as he approached the intersection of U.S. 45 and Industrial Park Road, about 1 mile south of the Waynesboro corporate limits, he began to decelerate from a speed of about 50 mph, turned on his right turn signal, and moved into a right turn lane which extends about 400 feet north of the intersection. (See figure 1.)

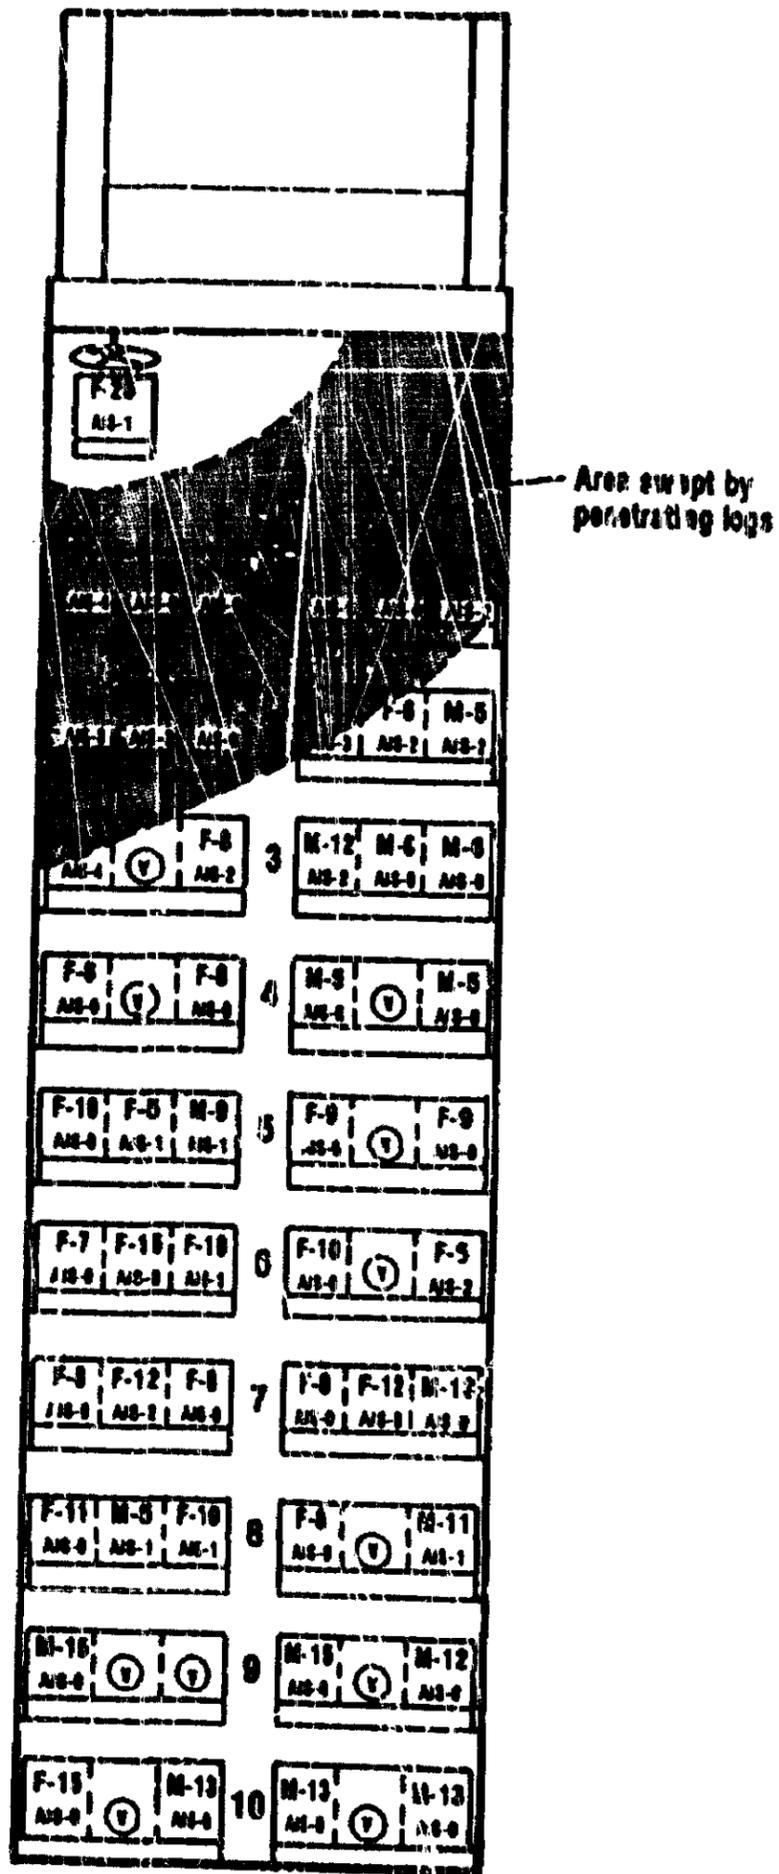
Figure 13.--Bus occupant seating diagram, injury classification, and age.

The bus was subjected to three separate impacts, the second and third of which were minor. During the initial (bus-to-logs) impact, the ends of at least three logs penetrated the right windshield of the bus, swept diagonally through the right front side of the passenger area, and, in the case of one log, pierced the left side panel at approximately the third passenger seat from the front. All three fatalities and the more seriously injured surviving passengers were sitting in the area traversed by the logs. (See figure 13.) Evidence indicates that several passengers including the three fatalities were subjected to direct contact with the logs. Because parents of the surviving passengers refused to permit any interviews with the student passengers, it could not be learned what action any of them may have taken to prevent or reduce injury.
