Highway Accident Report - Pacific Intermountain  
Express Tractor Cargo Tank Semitrailer Eagle/  
F. B. Truck Lines, Inc., Tractor Lowboy  
Semitrailer Collision and Fire, U.S. Route 50  
Near Canon City, Colorado, November 14, 1981

(U.S.) National Transportation Safety Board  
Washington, DC

22 Jun 82

1. Report No. NTSB-HAR-82-3		2. Government Accession No. PB82-916203		3. Recipient's Catalog No.	
4. Title and Subtitle Highway Accident Report—Pacific Intermountain Express Tractor Cargo Tank Semitrailer/Eagle F.B. Truck Lines, Inc. Tractor Lowboy Semitrailer, Collision and Fire, U.S. Route 50, Near Canon City, Colorado, November 14, 1981.				5. Report Date June 22, 1982

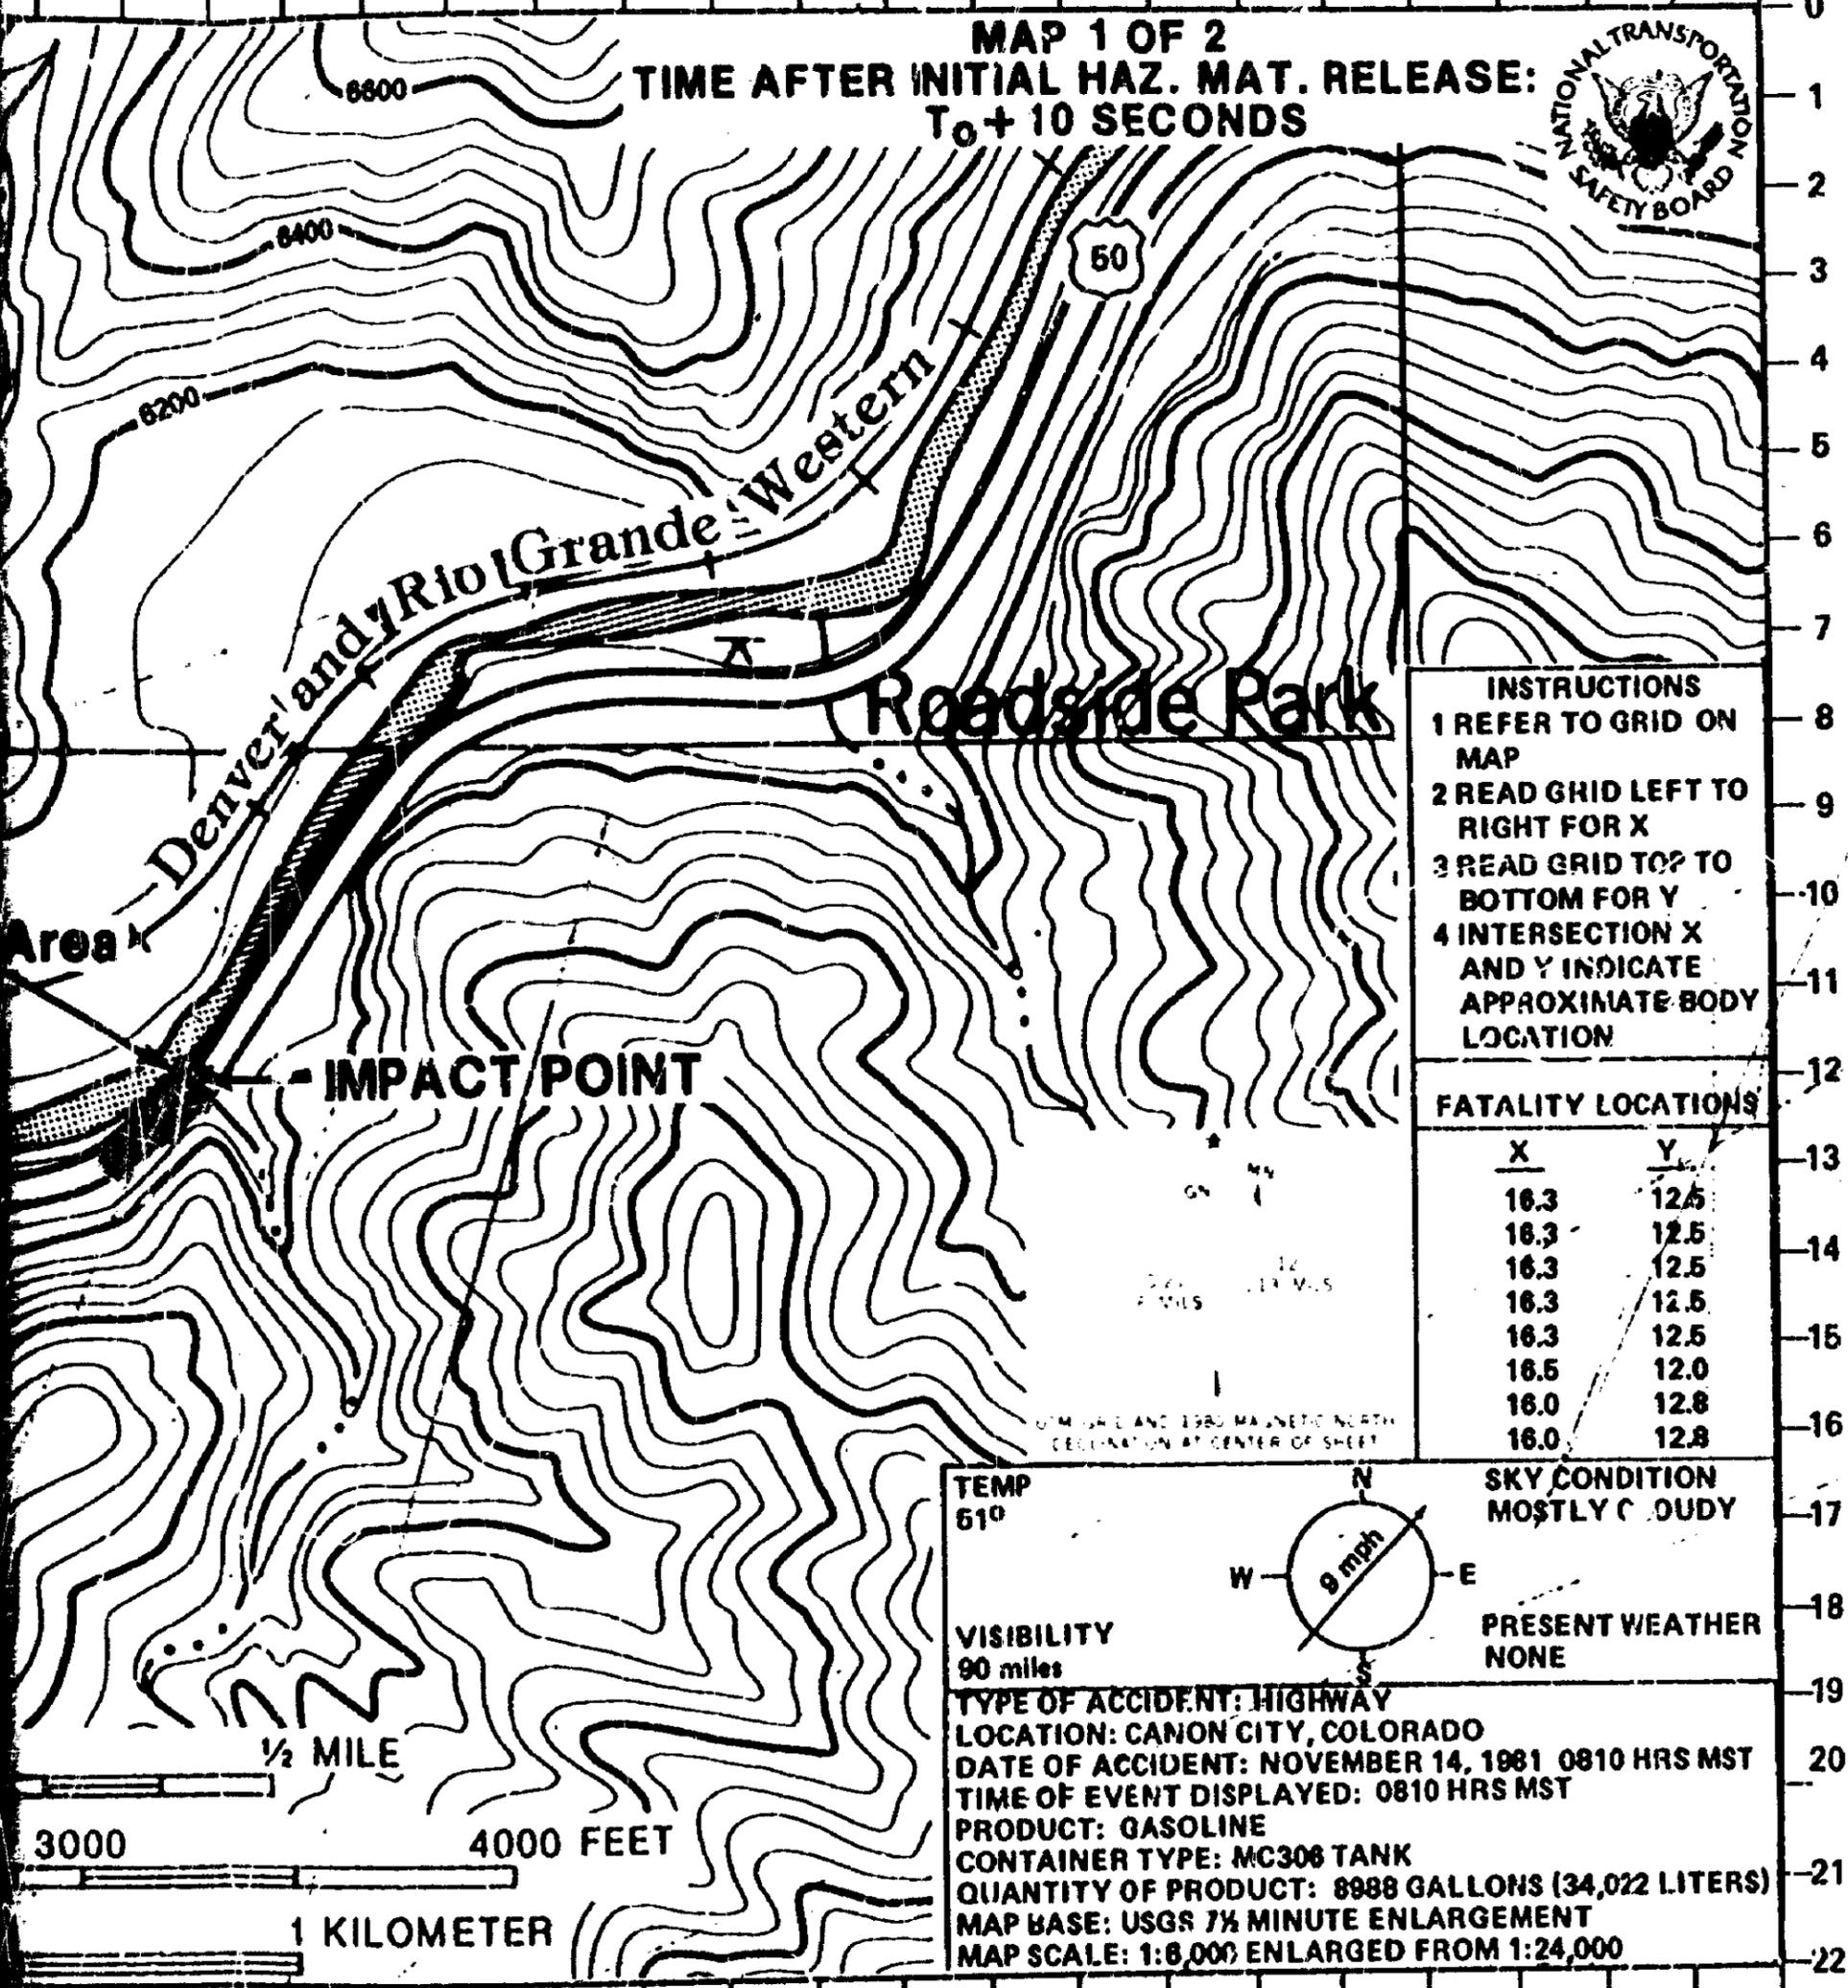
MAP 1 OF 2

TIME AFTER INITIAL HAZ. MAT. RELEASE:  
T<sub>0</sub> + 10 SECONDS

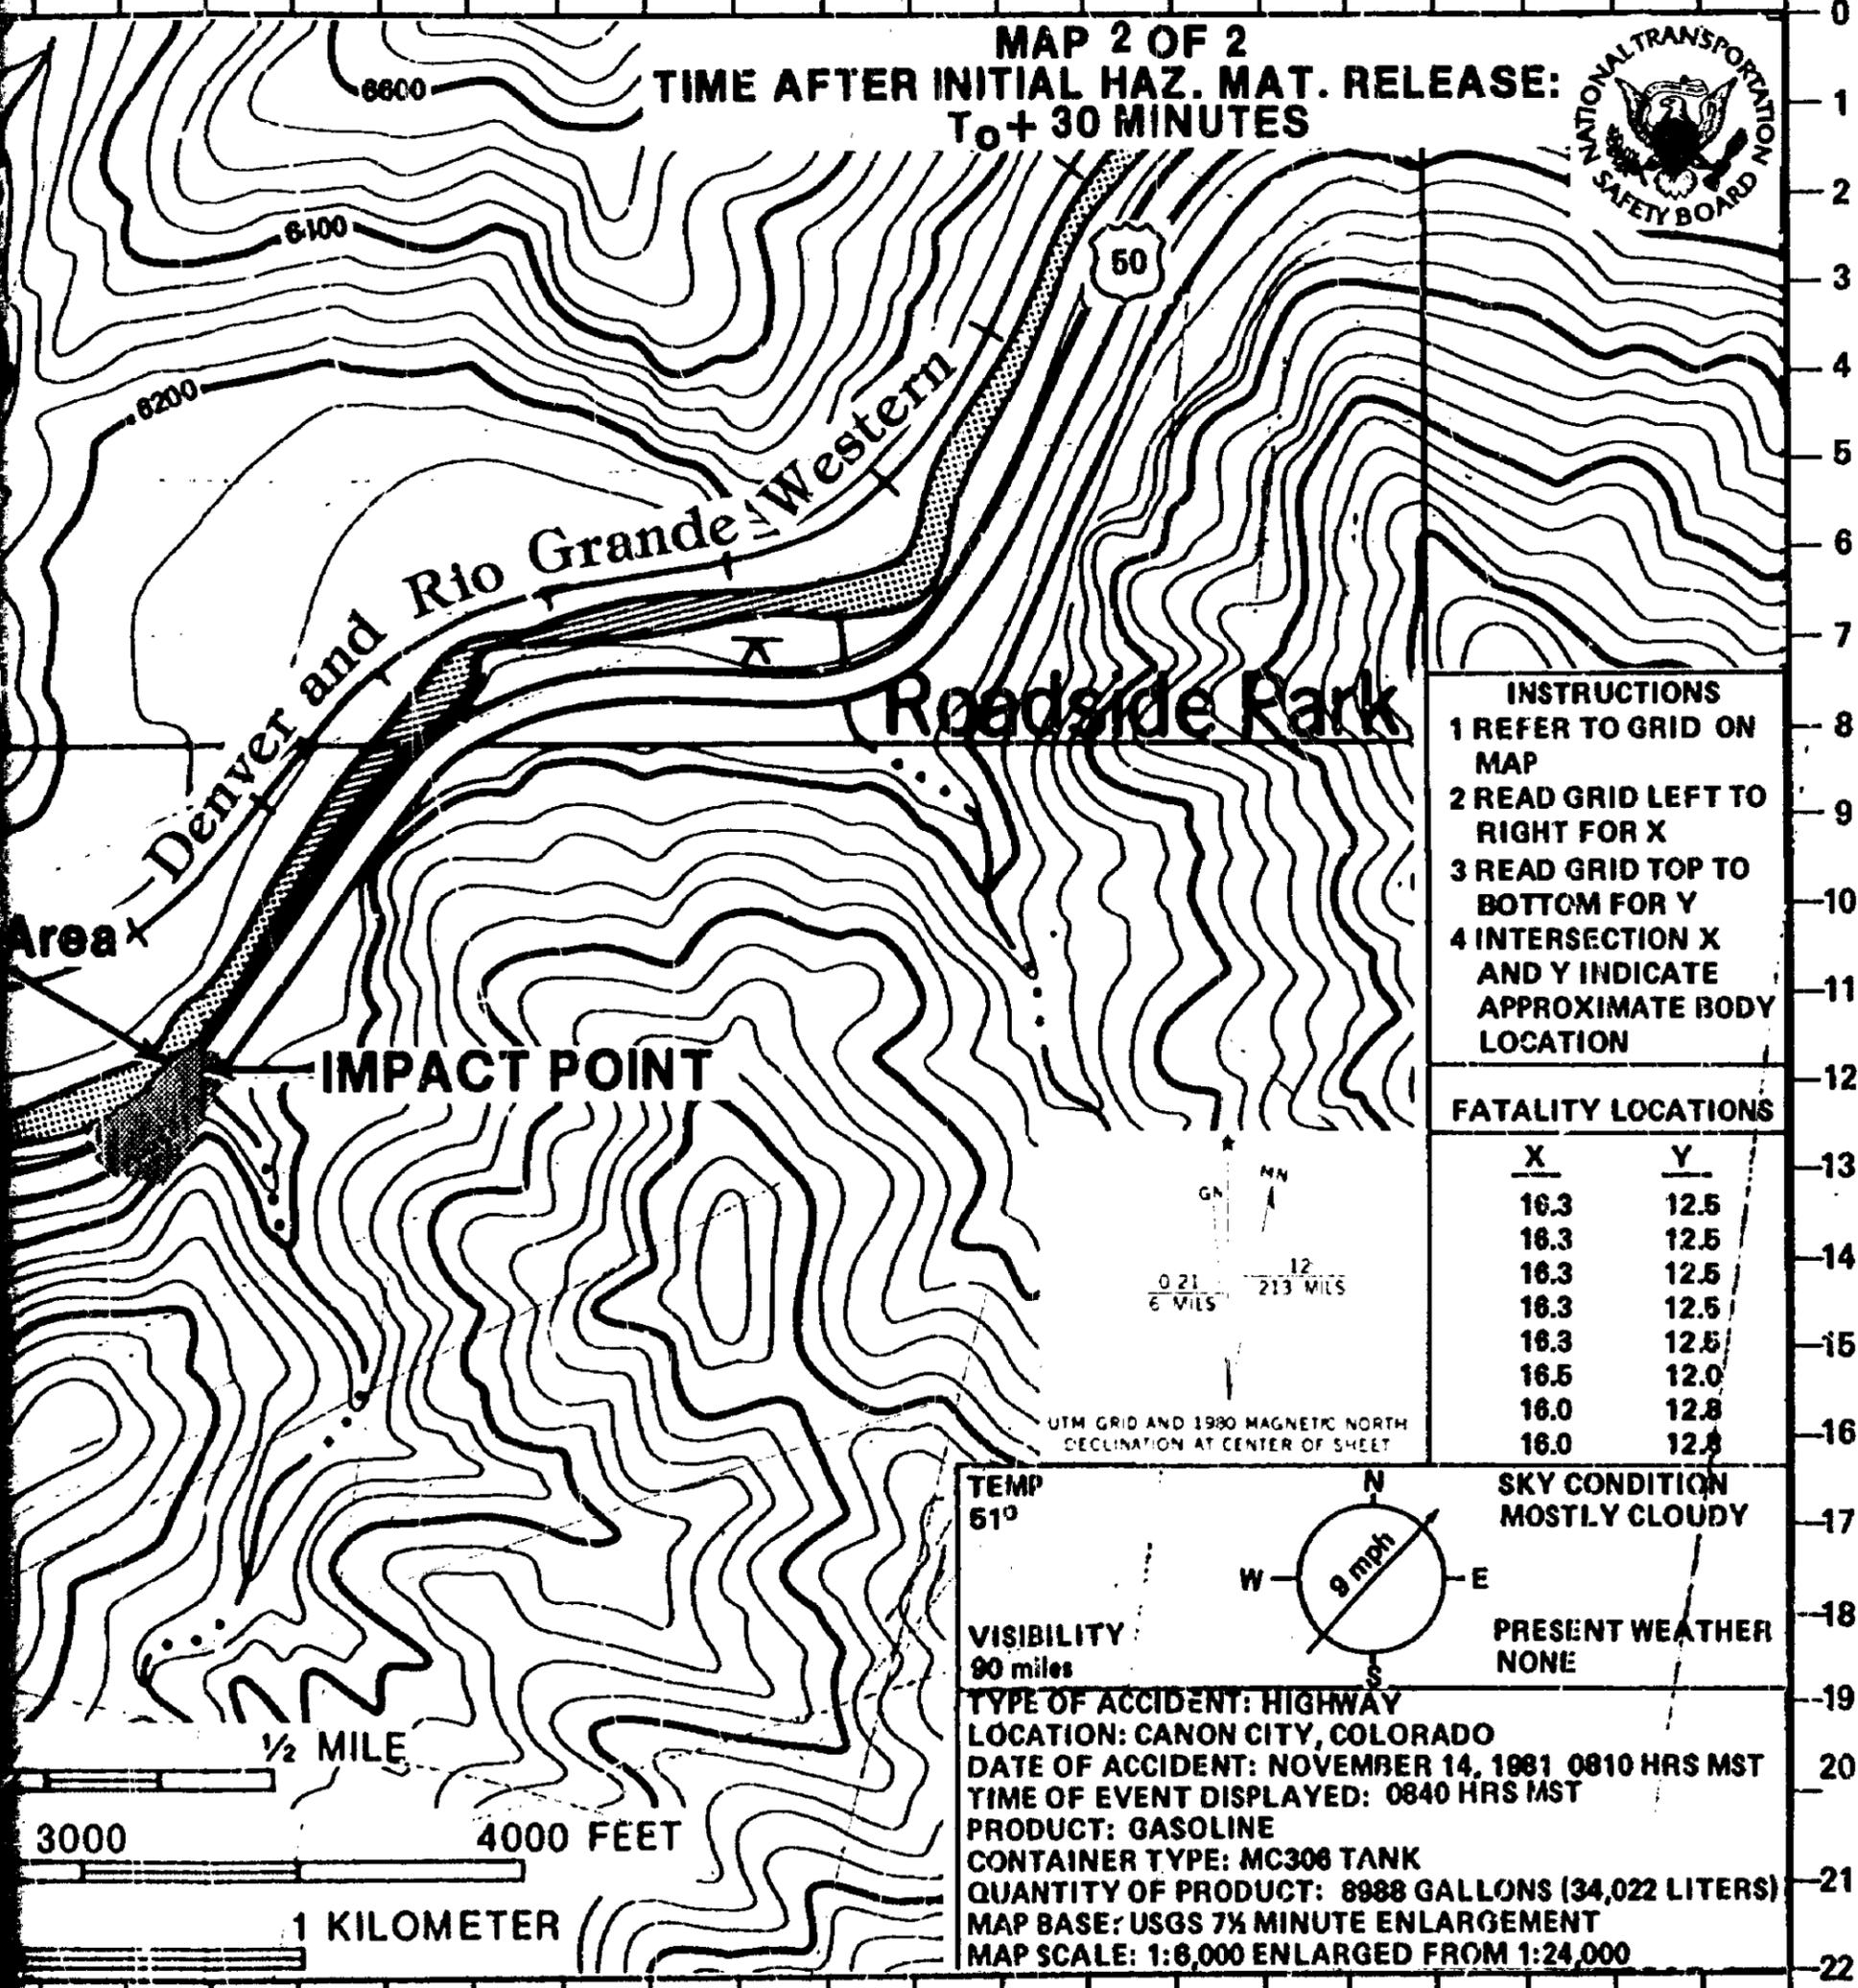
**MAP 2 OF 2**  
**TIME AFTER INITIAL HAZ. MAT. RELEASE:**  
**T<sub>0</sub> + 30 MINUTES**

TYPE OF ACCIDENT: HIGHWAY  
LOCATION: CANON CITY, COLORADO  
DATE OF ACCIDENT: NOVEMBER 14, 1981 0810 HRS MST  
TIME OF EVENT DISPLAYED: 0840 HRS MST  
PRODUCT: GASOLINE  
CONTAINER TYPE: MC306 TANK  
QUANTITY OF PRODUCT: 8988 GALLONS (34,022 LITERS)  
MAP BASE: USGS 7 1/2 MINUTE ENLARGEMENT  
MAP SCALE: 1:8,000 ENLARGED FROM 1:24,000
