Highway Accident Report - Collapse of a  
Suspended Span of Interstate Route 95  
Highway Bridge over the Mianus River  
Greenwich, Connecticut, June 28, 1983

(U.S.) National Transportation Safety Board  
Washington, DC

19 Jul 84

1. Report No. NTSB/HAR-84/03		2. Government Accession No. PB84-916203		3. Recipient's Catalog No.	
4. Title and Subtitle Highway Accident Report— Collapse of a Suspended Span of Interstate Route 95 Highway Bridge Over the Mianus River, Greenwich, Connecticut, June 28, 1983				5. Report Date July 19, 1984

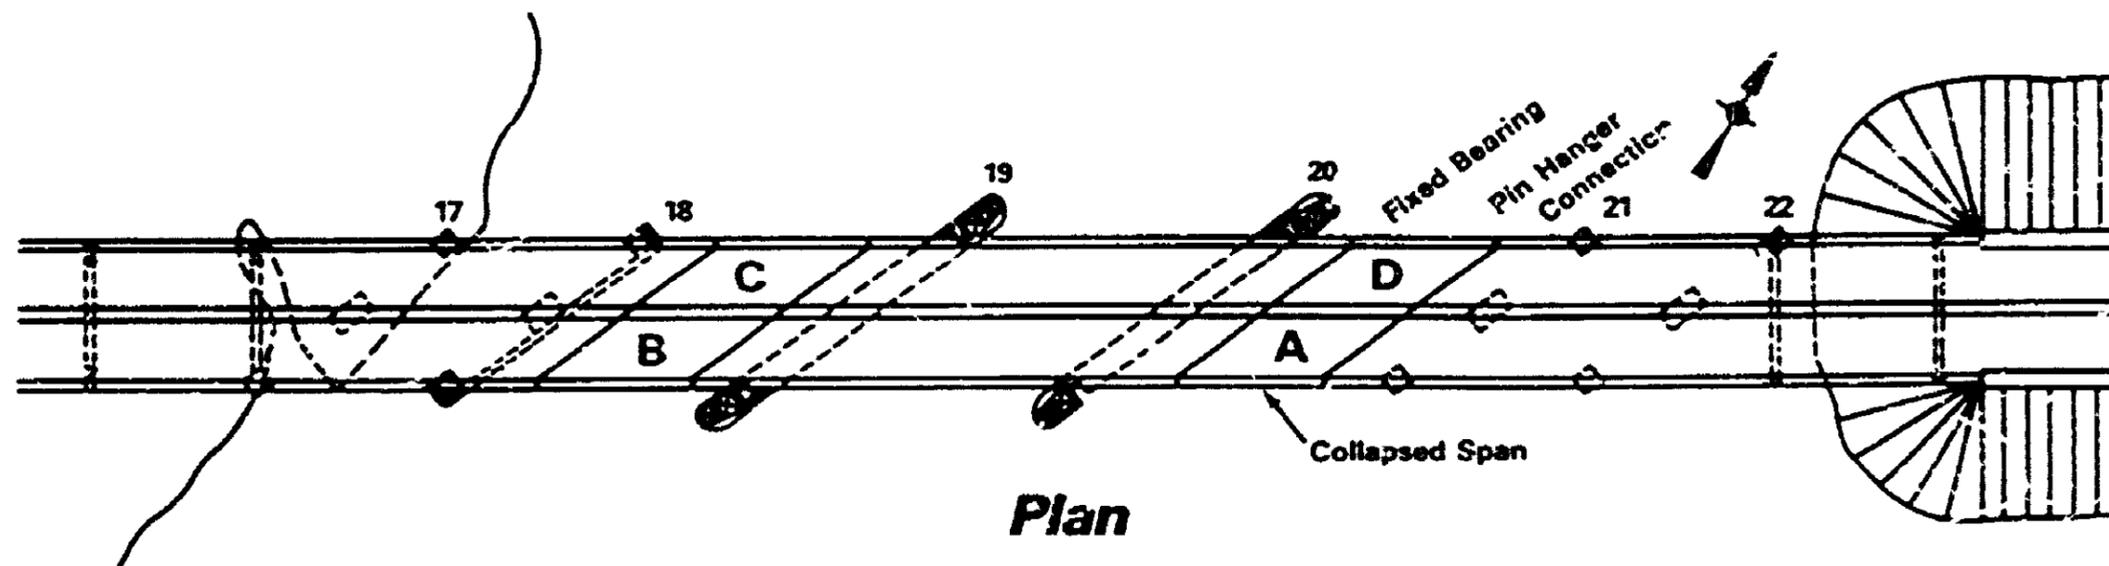
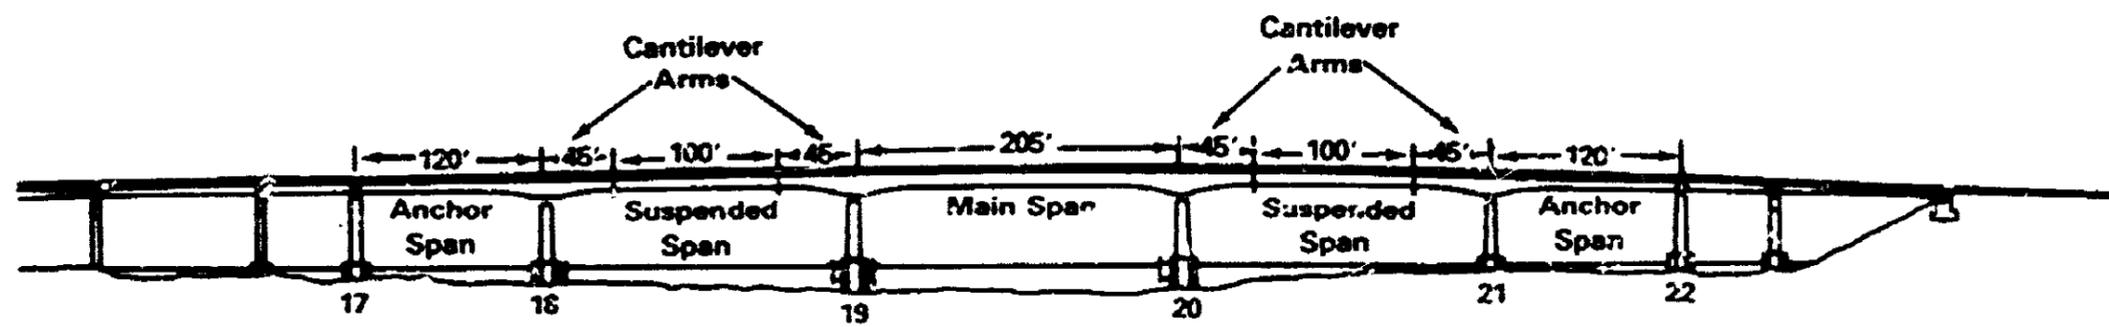
Figure 4.—Plan view (top) and longitudinal view (bottom) of the Mianus River bridge. (Note that the skew of piers 17 through 22 is not depicted in the longitudinal view.)

General.—The span that fell (identified as span A in figure 4) was the most easterly of the two suspended spans in the eastbound traffic lanes. It had been attached to the cantilever arms of adjacent spans by pin and hanger assemblies at its northeast and

Span alignment.--Postaccident inspection of the westbound suspended span adjacent to the fallen span (span D in figure 4) did not show any misalignment. Postaccident inspection of the adjacent suspended spans between piers 18 and 19 (spans B and C in figure 4) revealed that they were out of alignment vertically and horizontally. The railing of the remaining eastbound suspended span (span B) was about 1/2 inch lower than the railing of the cantilever arm at the southwest corner of the span. (See figure 11.) Also, the parapet was lower. In addition, measurements of the interlocking fingers at the expansion joint showed the fingers of the suspended span to be 1/2 to 9/16 inch below the fingers of the cantilever arm in the south side of the roadway. The westbound span was similarly misaligned vertically. The bridge railing parapet, slip joint, and interlocking fingers of the expansion joint were 1/2 to 9/16 inch lower than the corresponding railing and fingers of the cantilever arm. The fingers on the suspended span were darker than the fingers on the cantilever arm, and it was evident that the sunken fingers had not been polished recently by contact with motor vehicle tires.

**Drainage.**—Postaccident inspection of the suspended spans between piers 18 and 19 (spans B and C in figure 4) showed severe clogging of the grating formed by the interlocking fingers along the outer curb line. On the eastbound span, the joint was fully packed with sand, debris, and pieces of wood for about 1 1/2 feet from the curb toward the center of the roadway. A plant about 6 inches tall was growing out of this debris in the curb line of the westbound span. There was no vegetation on the eastbound span, but debris had collected about 1 inch deep near the curb. There was still an opening in the curb slip joint, and it appeared that water could pass through the curb slip joint on both spans.

**Corrosion.**—Postaccident inspection of the suspended spans between piers 18 and 19 (spans B and C in figure 4) revealed a light-colored rust between the interlocking fingers of the expansion joints of both spans which were in contact. Inspection of the area where the expansion joint had existed between the fallen span and the cantilever arm of the anchor span revealed that the interlocking fingers mounted on the fallen span had the same type of light-colored rust intermittently along the sides of the widest parts of the fingers. The fingers on the cantilever arm showed similar light-colored rust. The areas on which the rust appeared were consistent with the rust marks having been made by the fingers of the suspended span pressing against those of the cantilever arm and attempting to move the cantilever arm to the south.

Postaccident inspection of the pin and hanger assemblies of the suspended spans between piers 18 and 19 (spans B and C in figure 4) revealed that the inner pin caps were generally much less dished than the outer pin caps. Gaps between girder webs and hangers, particularly at the lower pin caps, were evident and generally correlated with the dishing of the pin caps. The normal design would allow for a 5/8-inch gap. The largest gap between the web and hangers was found to be 1 3/8 inch to 1 1/2 inch at the outer pin and hanger assembly at the eastbound span. Inspection of the lower pin at the southwest corner of the eastbound span revealed that the rust buildup and the offset position of the pin relative to the hanger were so pronounced that no reading could be obtained. The pin and hanger assembly was relieved of its load, and the pin cap was removed for closer inspection. The retaining nut was burned off in order to free the pin cap. When the pin cap was removed, black rust flowed out of the connection. (See figure 12.) The Chief of the Review and Analysis Branch, Bridge Division of the FHWA who witnessed the pin cap removal testified at the public hearing: "...there is no way that I would have ever believed or conceived that the amount of deterioration behind that pin cap would have been there. I never in my wildest days have seen that amount of deterioration, and I don't think short of taking that pin cap off, anyone else could judge that that would be the case."

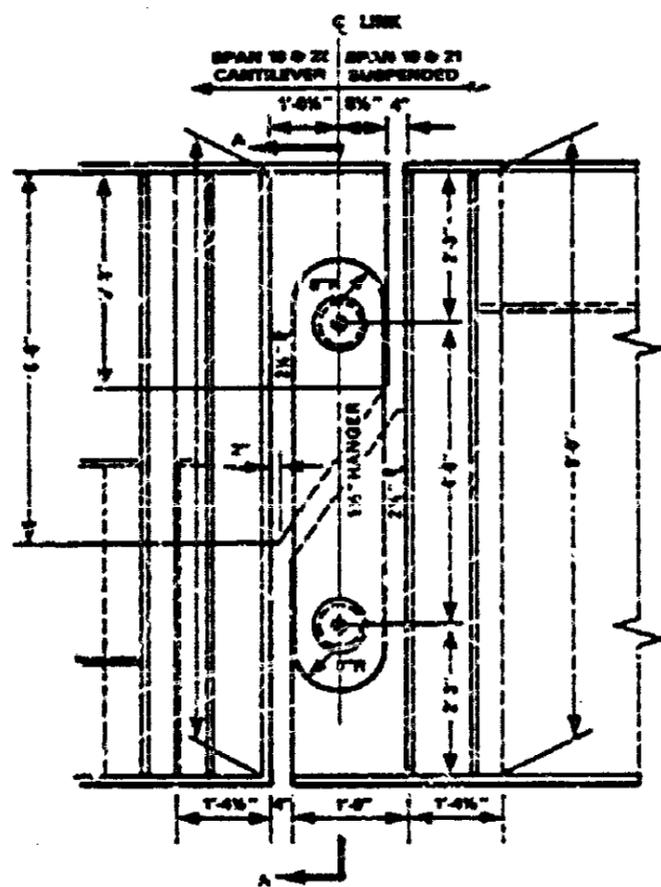
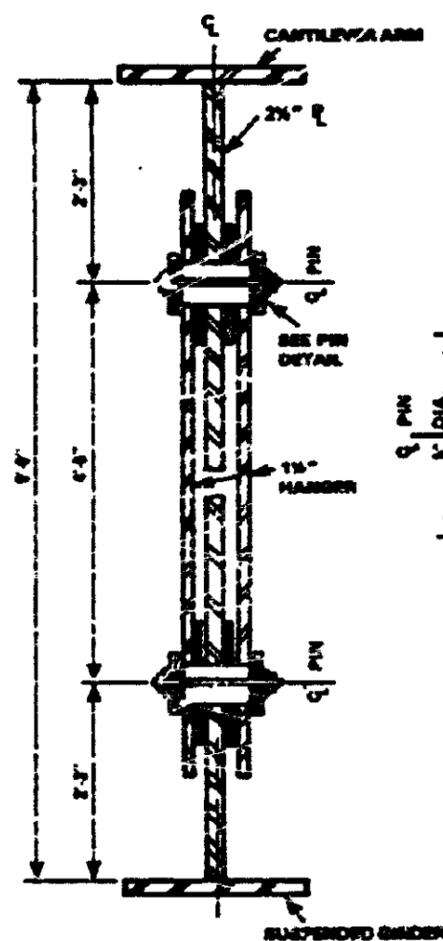
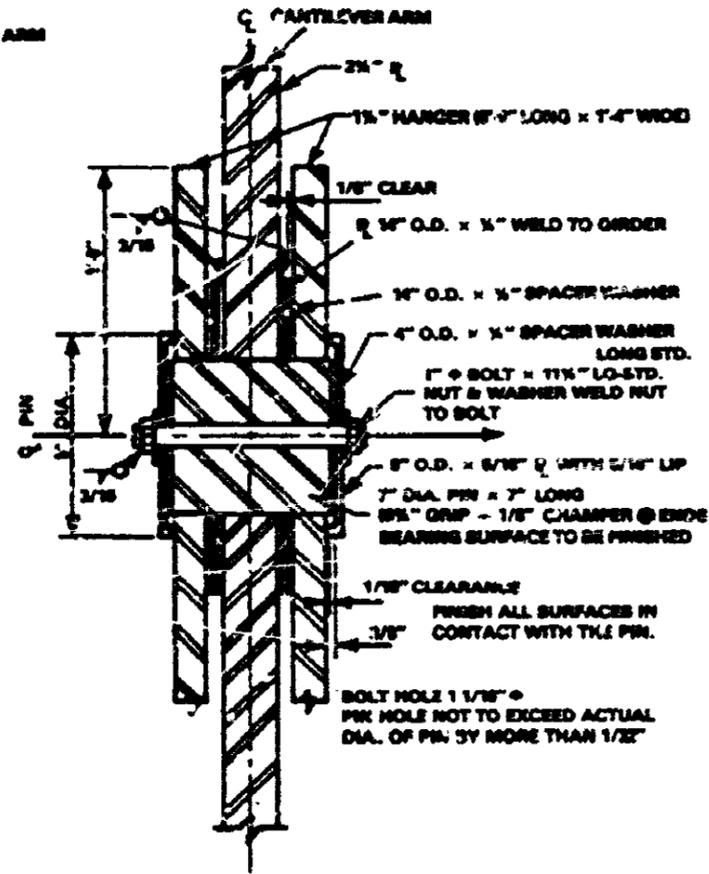
**Suspended spans.**—The four suspended spans (marked A, B, C, and D in figure 4) are connected at one end to the cantilever arms of the anchor spans with a pin and hanger assembly. (See figure 5.) The pins are cylinders, 7 inches long and 7 inches in diameter. The pins have a 6 3/4-inch-wide grip with a 1/8-inch-wide chamfer at each end. Through the center of each pin is an 11 1/4-inch-long, 1-inch-diameter bolt. The upper pin passes through and is centered on the web of the cantilever arm; the lower pin passes through and is centered on the web of the suspended span. The clearance between the pin and the hole in the web, according to the design, was not to exceed 1/32 inch. The pin caps are 2 inches larger in diameter than the pins and completely cover the ends of the pins and the holes in the hangers. The ends of the pins and the hanger bearing surfaces cannot be seen once the caps are bolted in place. There is nominally a clearance of 1/16 inch between the pin caps and the hanger surfaces. The web of each girder at the pin and hanger assembly is 9 feet deep and 2 1/2 inches thick.

Figure 5.—Detail of pin and hanger assembly.

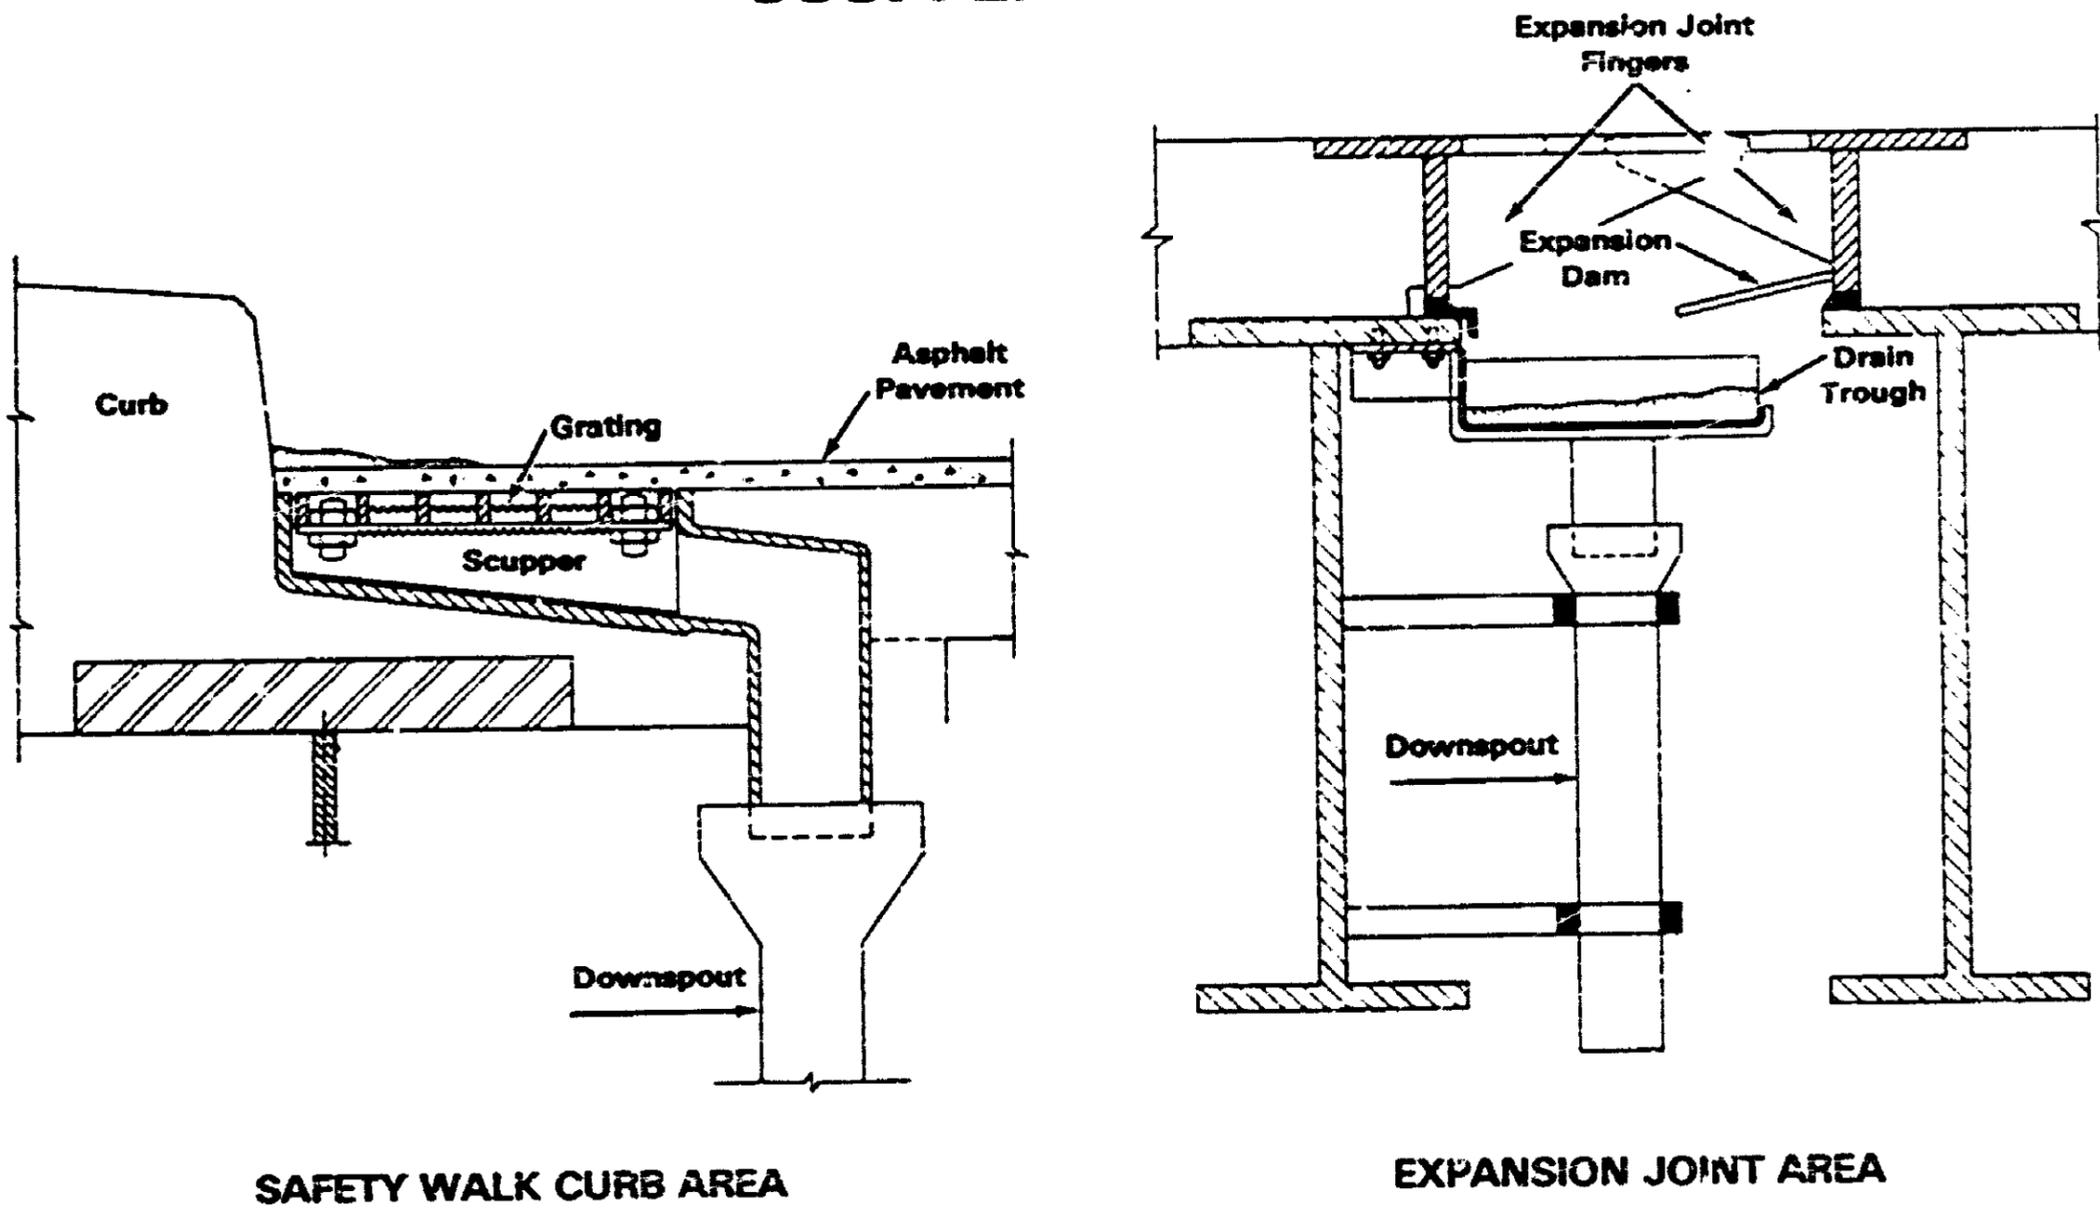
# SCUPPER DETAIL

**Drainage.**--The drainage system on the bridge was designed to carry water, debris, and deicing salt away from the structural parts of the bridge and the pin and hanger assemblies in order to minimize corrosion. The drainage system consists of curb drains (scuppers) in the gutter line of the roadway. Between piers 1 and 16, scuppers are installed in the south side gutter line only. Between piers 16 and 23, which includes the suspended spans, the scuppers are installed on both sides of the eastbound and westbound roadways. The grates in these scuppers are installed below the level of the road surface and channel road surface water into downspouts, which funnel the water onto the land below or allow it to free-fall into the river. The system was designed so that only a small amount of the surface water would run through the expansion joints into the troughs where it would be channeled to a scupper at the median barrier. (See figure 6.)

Figure 6.—Detail of drainage system.
