Highway Accident Report
Tractor-Semitrailer/Station Wagon
Runaway, Collision, and Fire
Van Buren, Arkansas, June 21, 1985

(U.S.) National Transportation Safety Board
Washington, DC

1. Report No. NTSB/HAR-86/03		2. Government Accession No. PB86-916203		3. Recipient's Catalog No.	
4. Title and Subtitle Highway Accident Report -- Tractor-Semitrailer/Station Wagon Runaway, Collision, and Fire, Van Buren, Arkansas, June 21, 1985				5. Report Date August 8, 1986

**TRACTOR-SEMITRAILER/STATION WAGON
RUNAWAY, COLLISION, AND FIRE
VAN BUREN, ARKANSAS
JUNE 21, 1985**

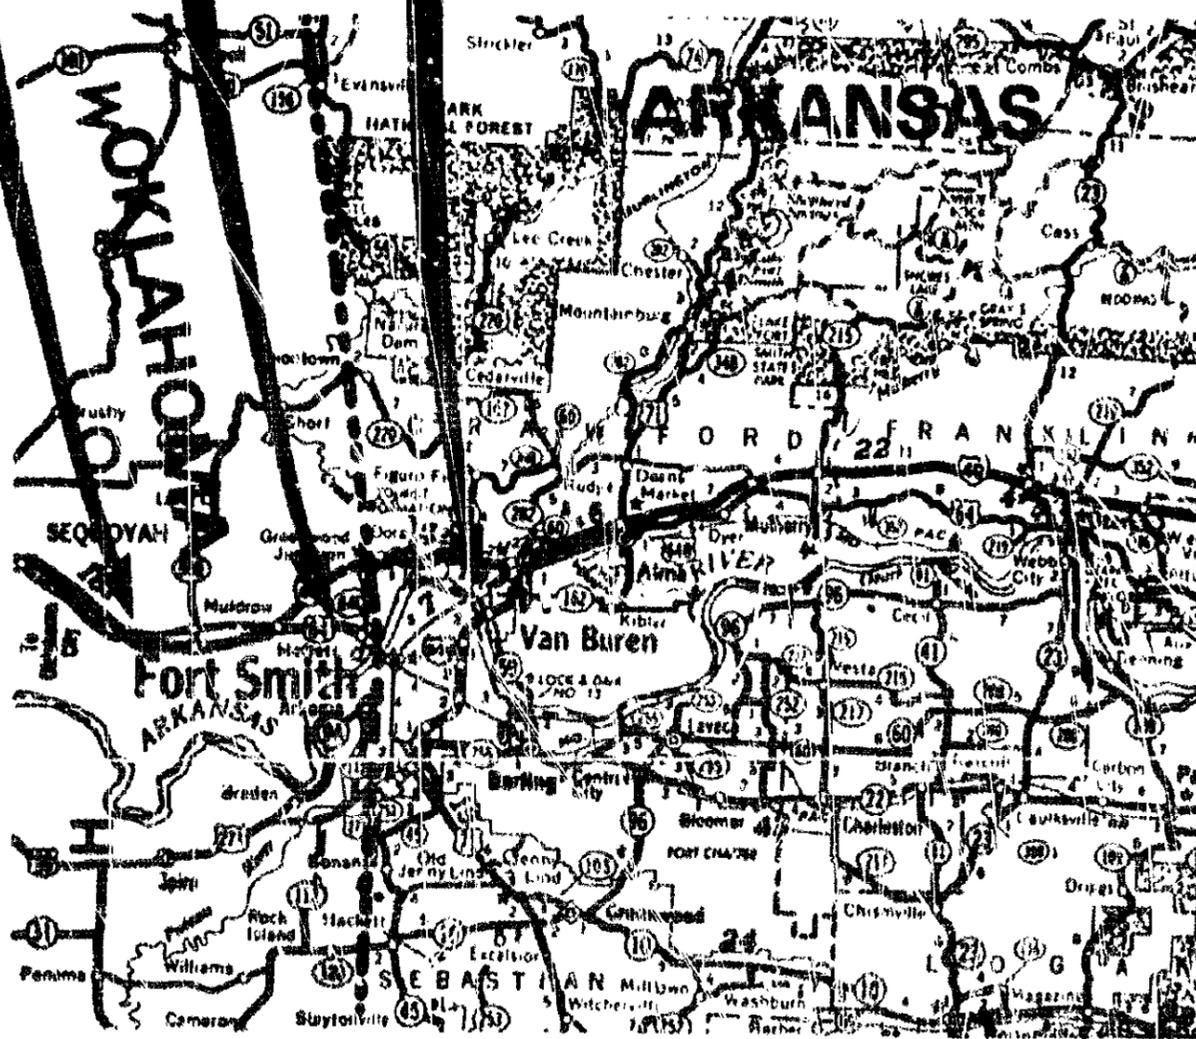
Figure 1.--Fort Smith, Arkansas, area.

B) EXIT 64E FROM I-40 WHERE TRACTOR-SEMITRAILER WAS INSTRUCTED TO ENTER FORT SMITH. THE TRUCK DRIVER PASSED THE 64E EXIT AND CONTINUED EAST TO S.R. 59

C) CRASH SITE ON S.R. 59 IN DOWNTOWN VAN BUREN, ARKANSAS
