Highway Accident Report - Schoolbus-Loss of  
Control and Collision with Guard Rail and Sign  
Pillar, U.S. Highway 70 near Lucas and Hunt Road  
St. Louis County, Missouri, November 11, 1985

(U.S.) National Transportation Safety Board  
Washington, DC

14 Apr 87

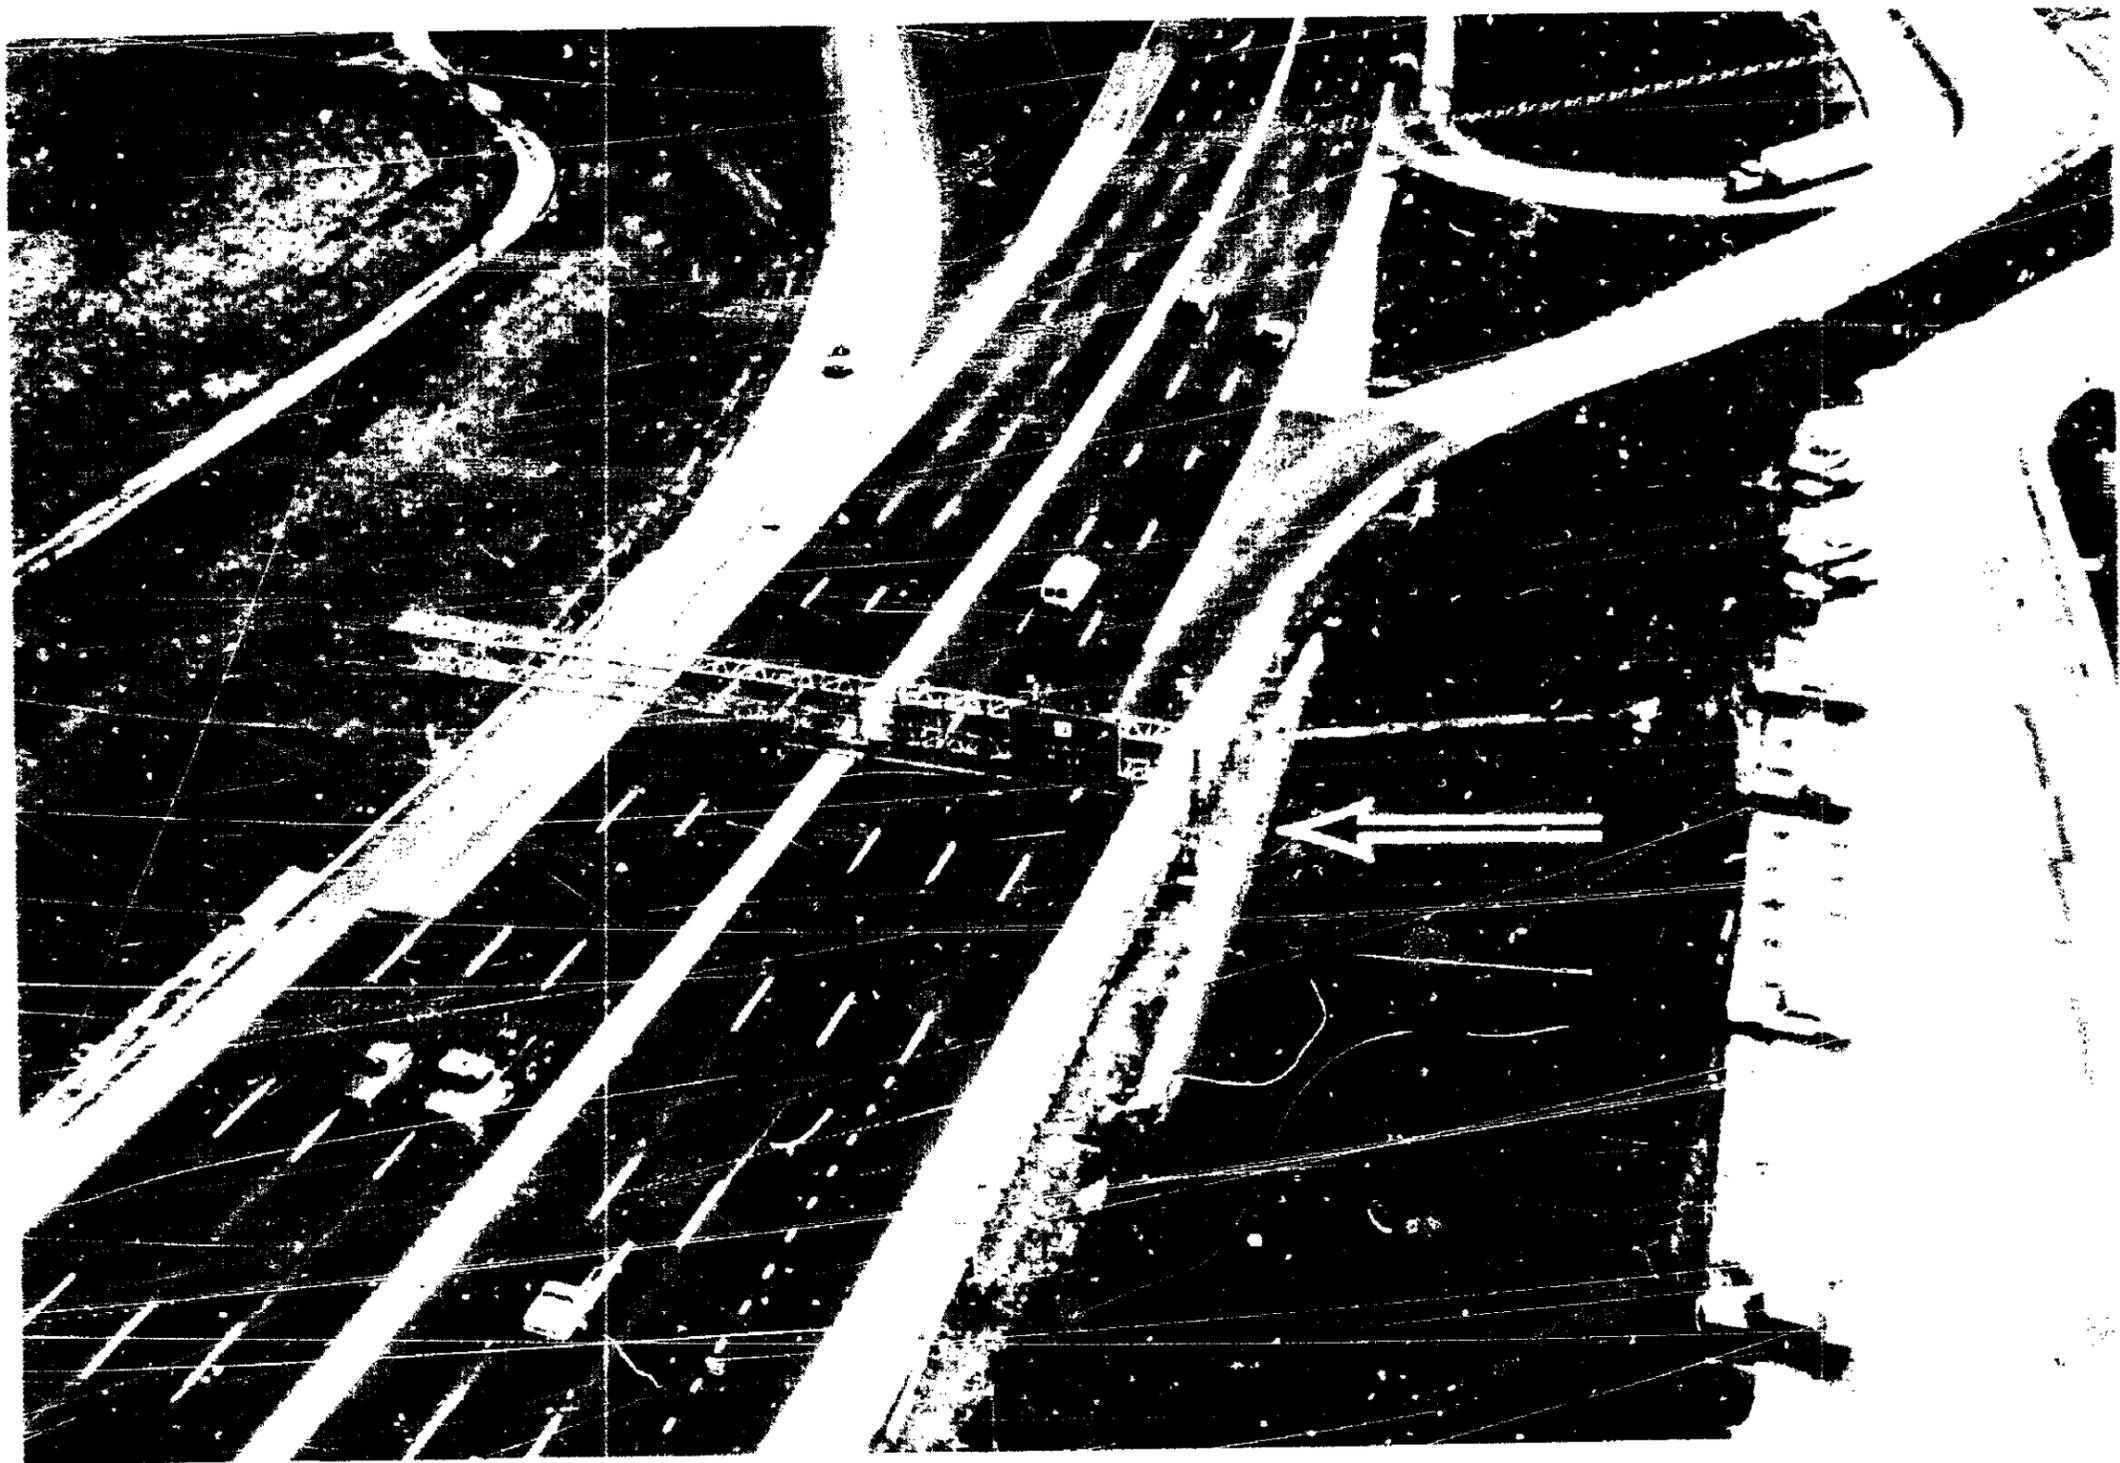
Figure 1.—Aerial view of Lucas and Hunt Road interchange with I-70. (Arrow indicates accident site.)

At about 2:43 p.m., as schoolbus A-522 was approaching the Lucas and Hunt Road exit from eastbound I-70 (see figure 1), several of the occupants reported that the schoolbus was running alongside a green Volkswagen which was to the left of the schoolbus. Nine of the surviving occupants stated that at this point the schoolbus driver yelled out ". . . do you want me to hit him [or it]?" or ". . . do you want me to run him off the road?" At least one, and possibly several, of the schoolbus occupants screamed "Yes" and others screamed "No."

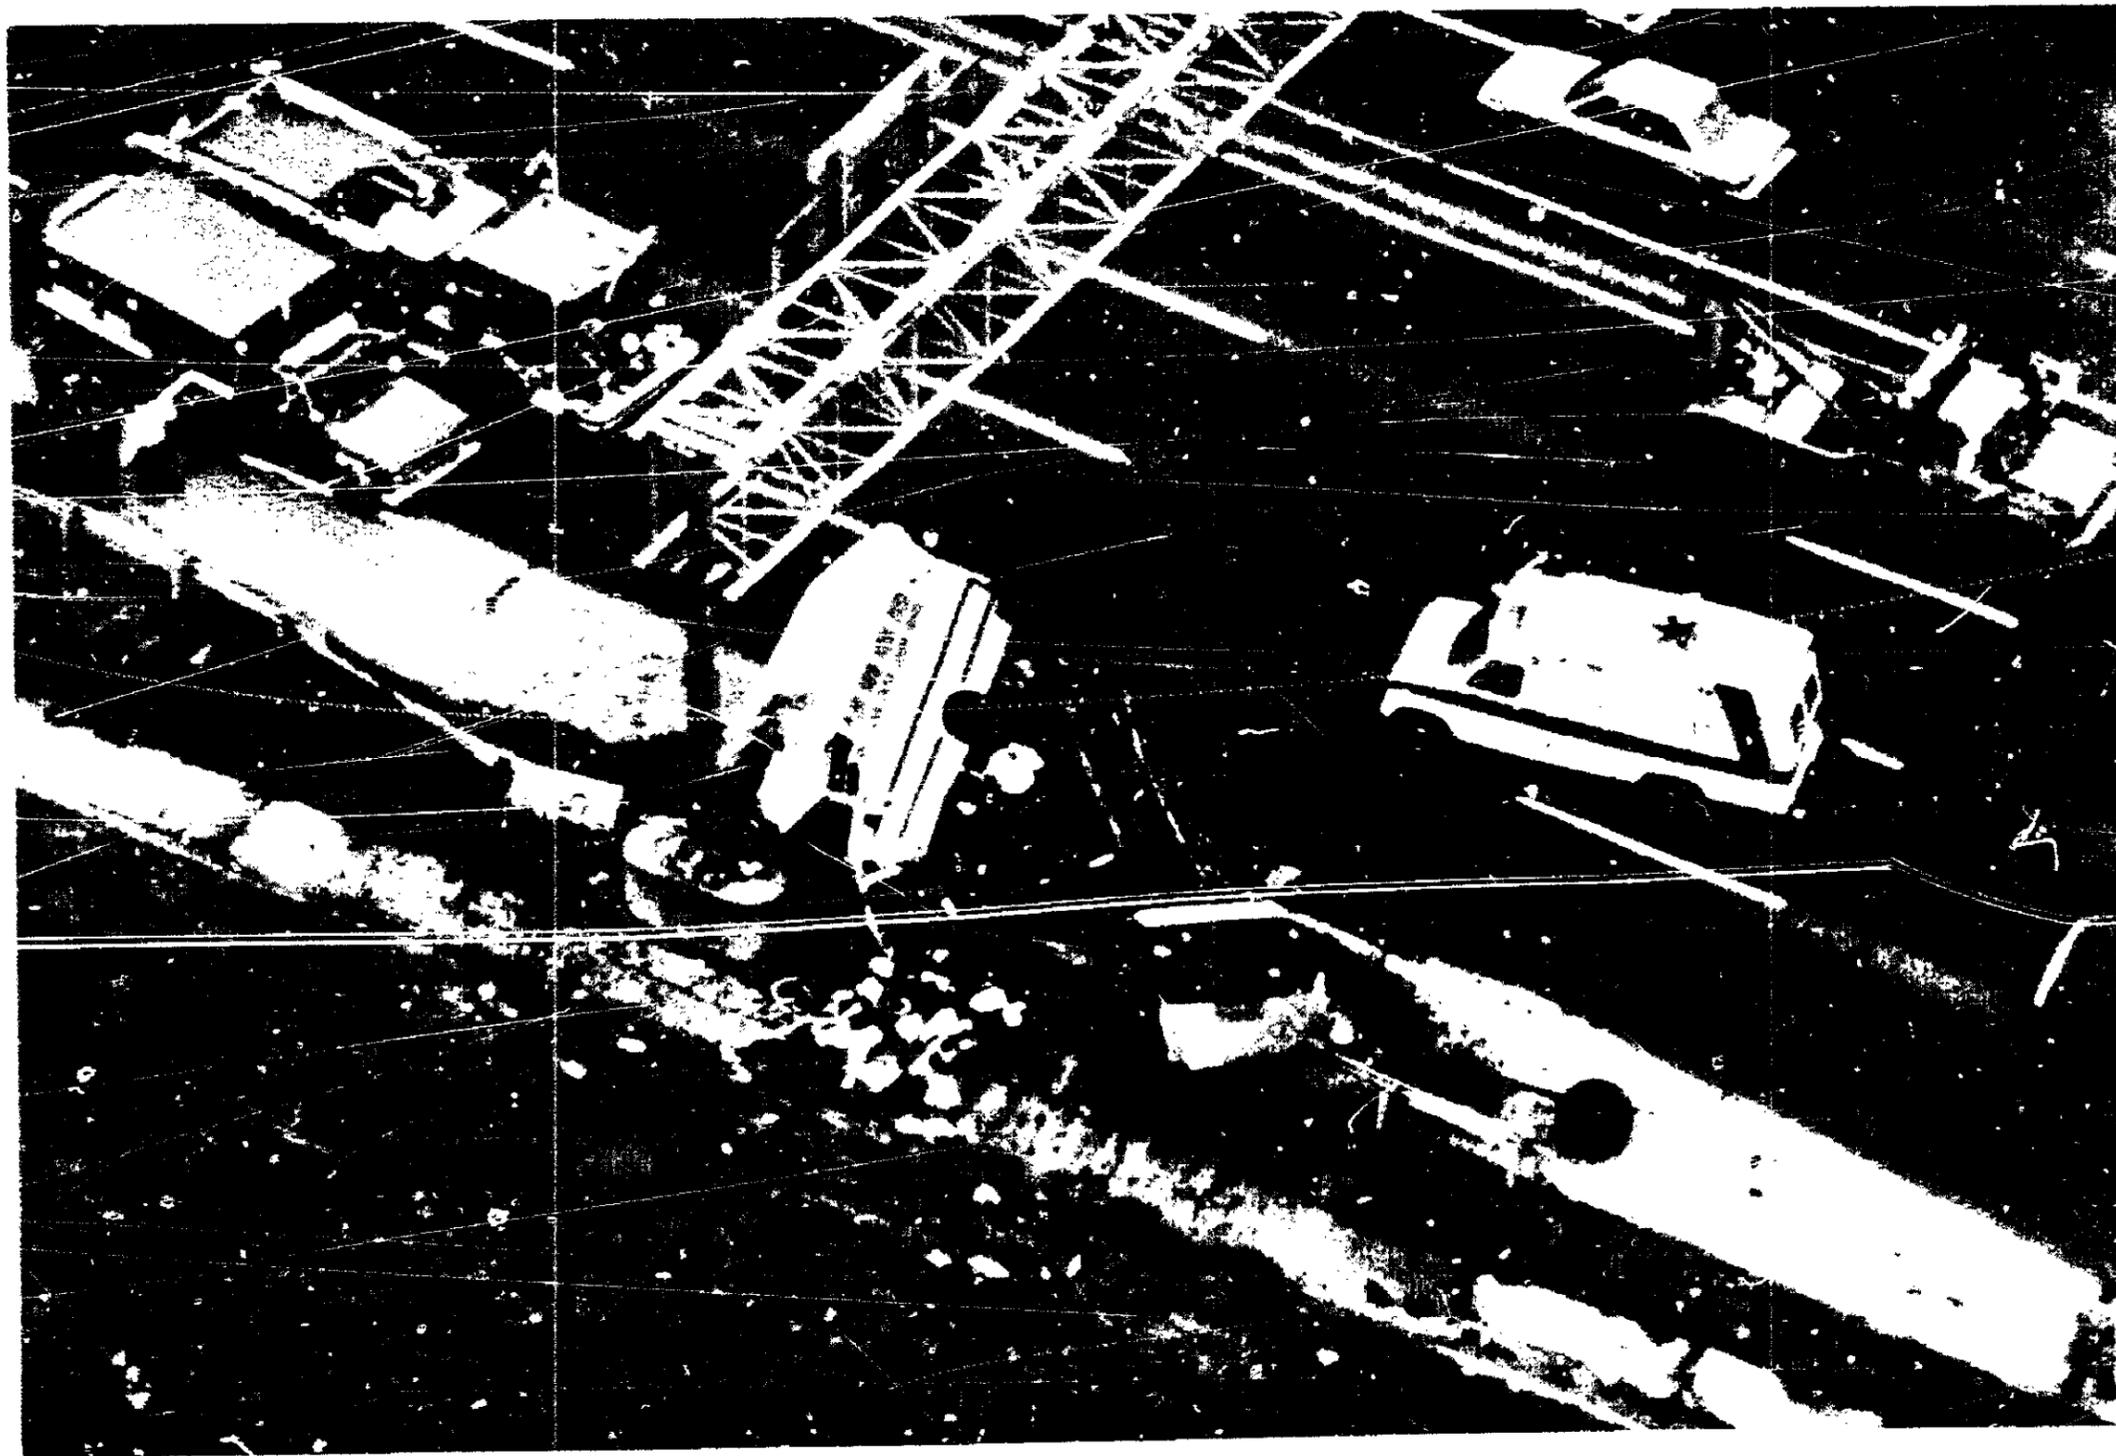
The schoolbus body and the steering axle separated from the chassis during the collision. The schoolbus body rotated almost 90° clockwise around the sign pillar and came to rest blocking the right eastbound shoulder and the Lucas and Hunt Road exit lane next to the sign pillar. The right front of the chassis overrode the guard rail and came to rest east of the sign support pillar blocking the right eastbound shoulder and part of the exit lane to Lucas and Hunt Road. The steering axle came to rest east of the chassis on the eastbound shoulder. (See figures 2 and 3.) The weather was cloudy and the pavement was dry. The schoolbus did not catch fire.

Figure 2.—Aerial view of accident site.

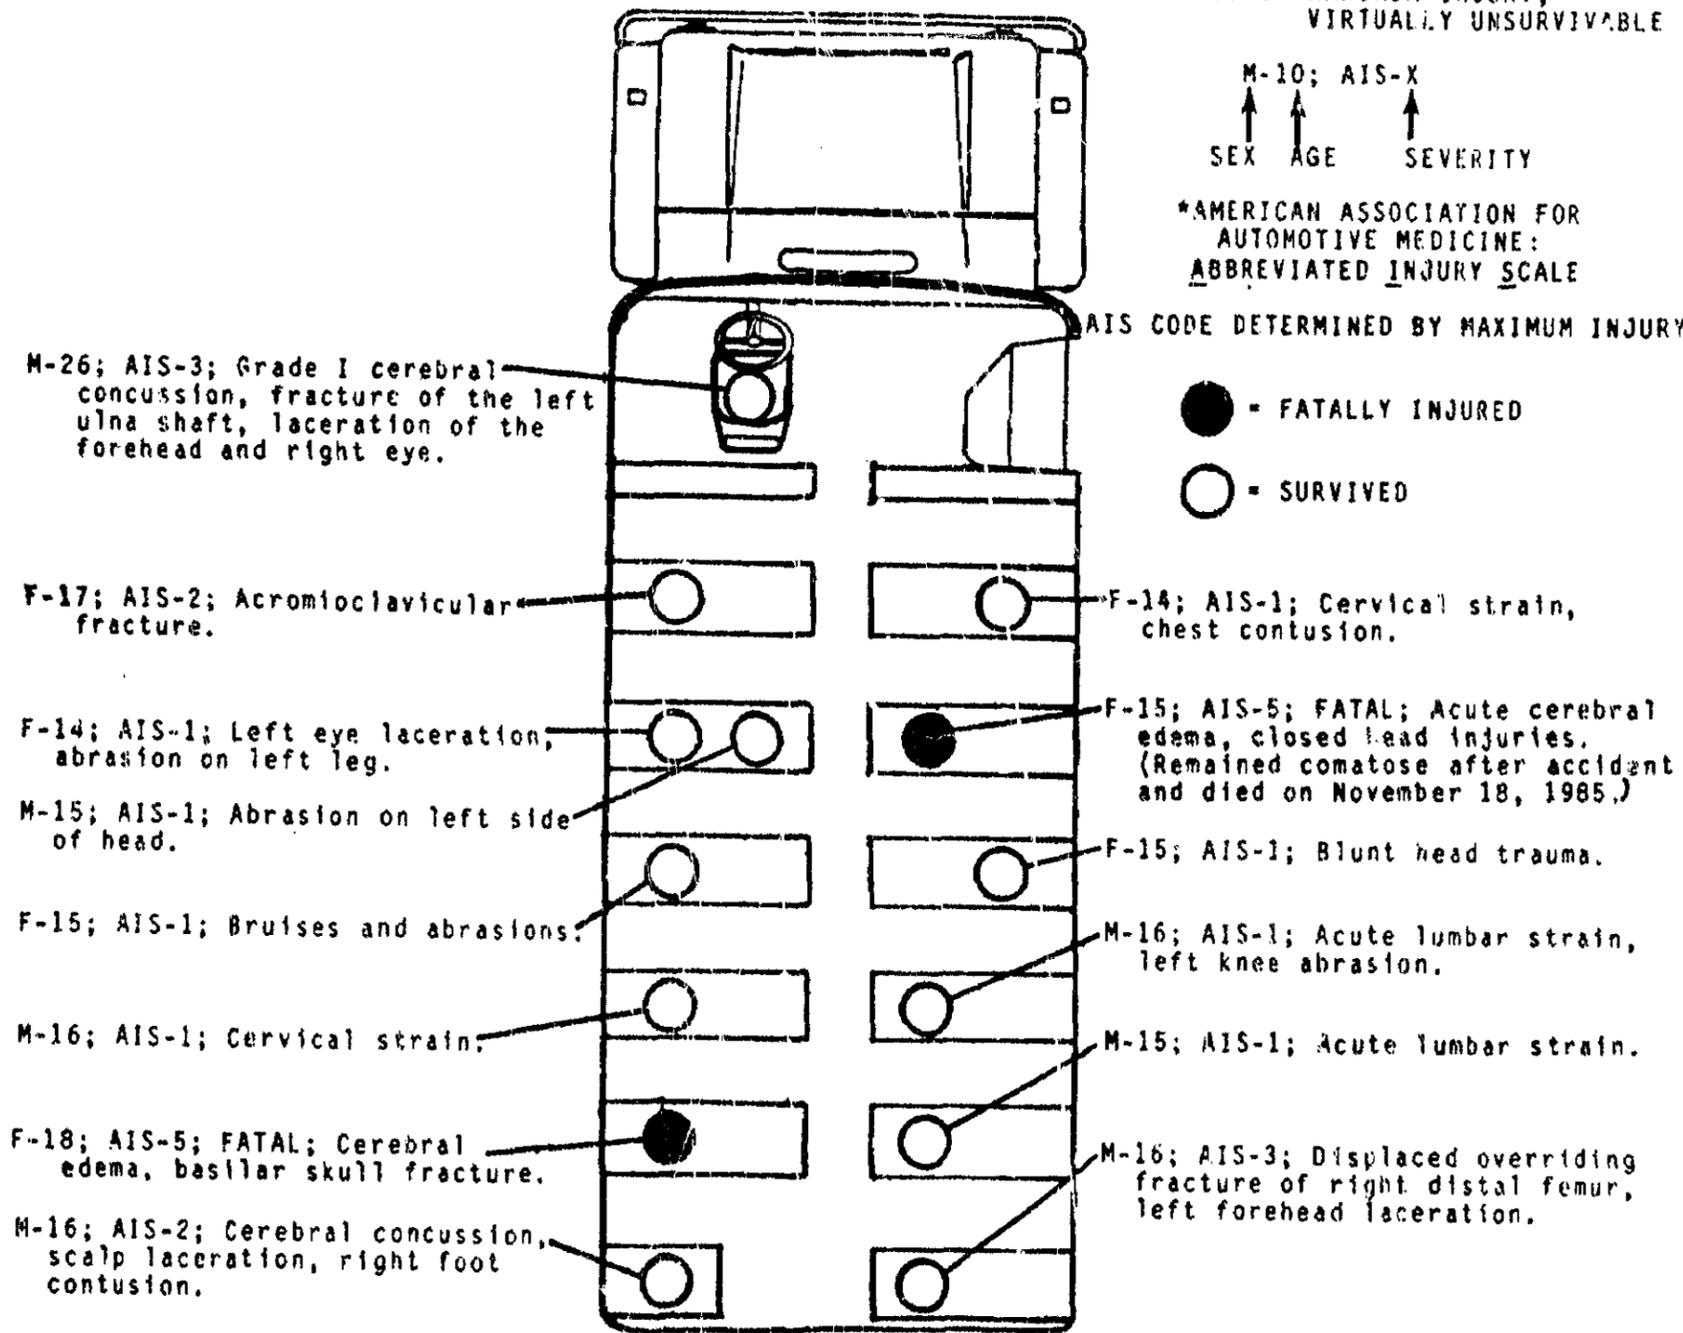
One student sustained critical injuries and was pronounced dead at 3:12 p.m. on the day of the accident. Another student sustained critical injuries, remained comatose after the accident, and died on November 18, 1985. The schoolbus driver and one student sustained serious injuries, and the remaining students sustained minor to moderate injuries.

The schoolbus driver, who reported that he was secured in the driver's seat by his lap belt, sustained serious injuries including a concussion, a fracture of the left ulna, and facial lacerations. The surviving schoolbus passengers sustained minor to serious injuries including fractures, concussions, lacerations, contusions, abrasions, and cervical and lumbar strains. (See figure 12.)

Figure 12.--Schoolbus occupant seating and injury chart.
