Highway Accident Report: Pickup Truck/Church  
Activity Bus Head-on Collision and Fire near  
Carrollton, Kentucky, May 14, 1988

(U.S.) National Transportation Safety Board  
Washington, DC

28 Mar 89

1. Report No. NTSB/HAR-89/01	2. Government Accession No. PB89-916201	3. Recipient's Catalog No.	
4. Title and Subtitle Highway Accident Report--Pickup Truck/Church Activity Bus Head-on Collision and Fire near Carrollton, Kentucky, May 14, 1988		5. Report Date March 28, 1989

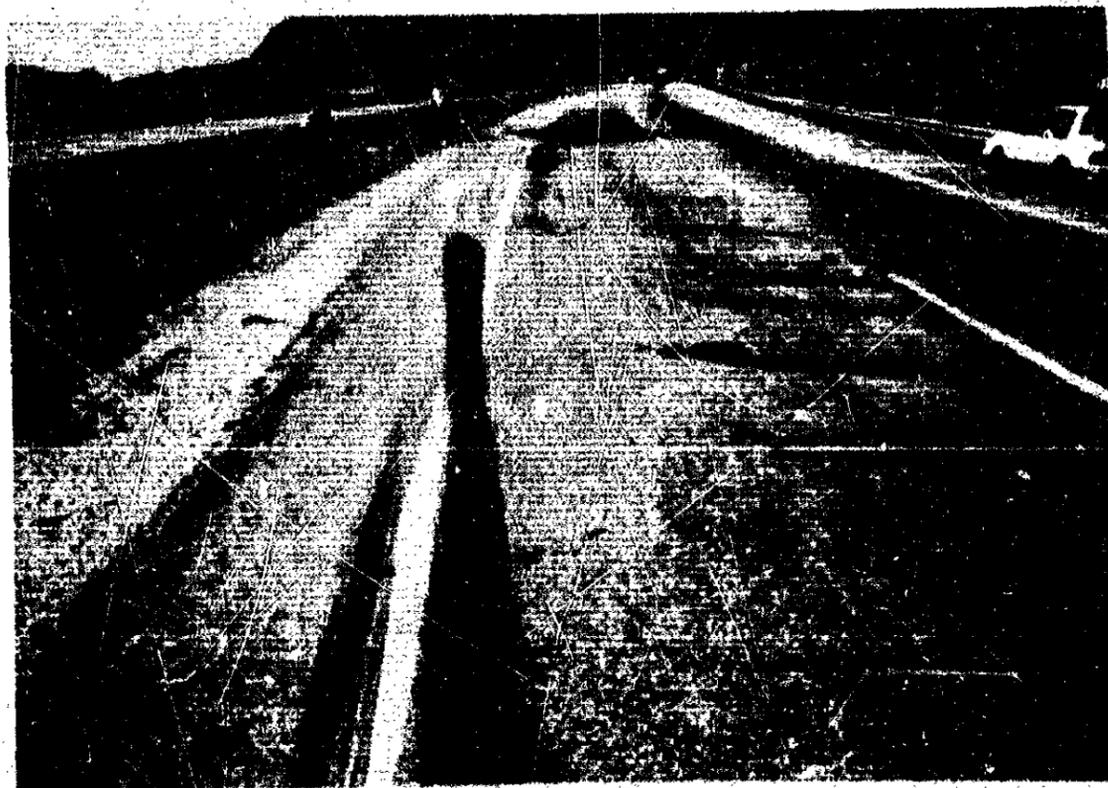
Figure 10.--Highway site

pickup truck (about 78 feet), a scrapemark and tiremark appeared. Faint segments of a tiremark extended diagonally from the right lane to the left shoulder. Four deep tire tracks in the grassy median strip continued in the same path as the tiremark. The heaviest burn area on the pavement appeared to be under the bus in an area about 5 to 12 feet from the front of the bus and from the center of the bus to the right side. Also, several deep impressions were found in the burned pavement. (See figure 10.)

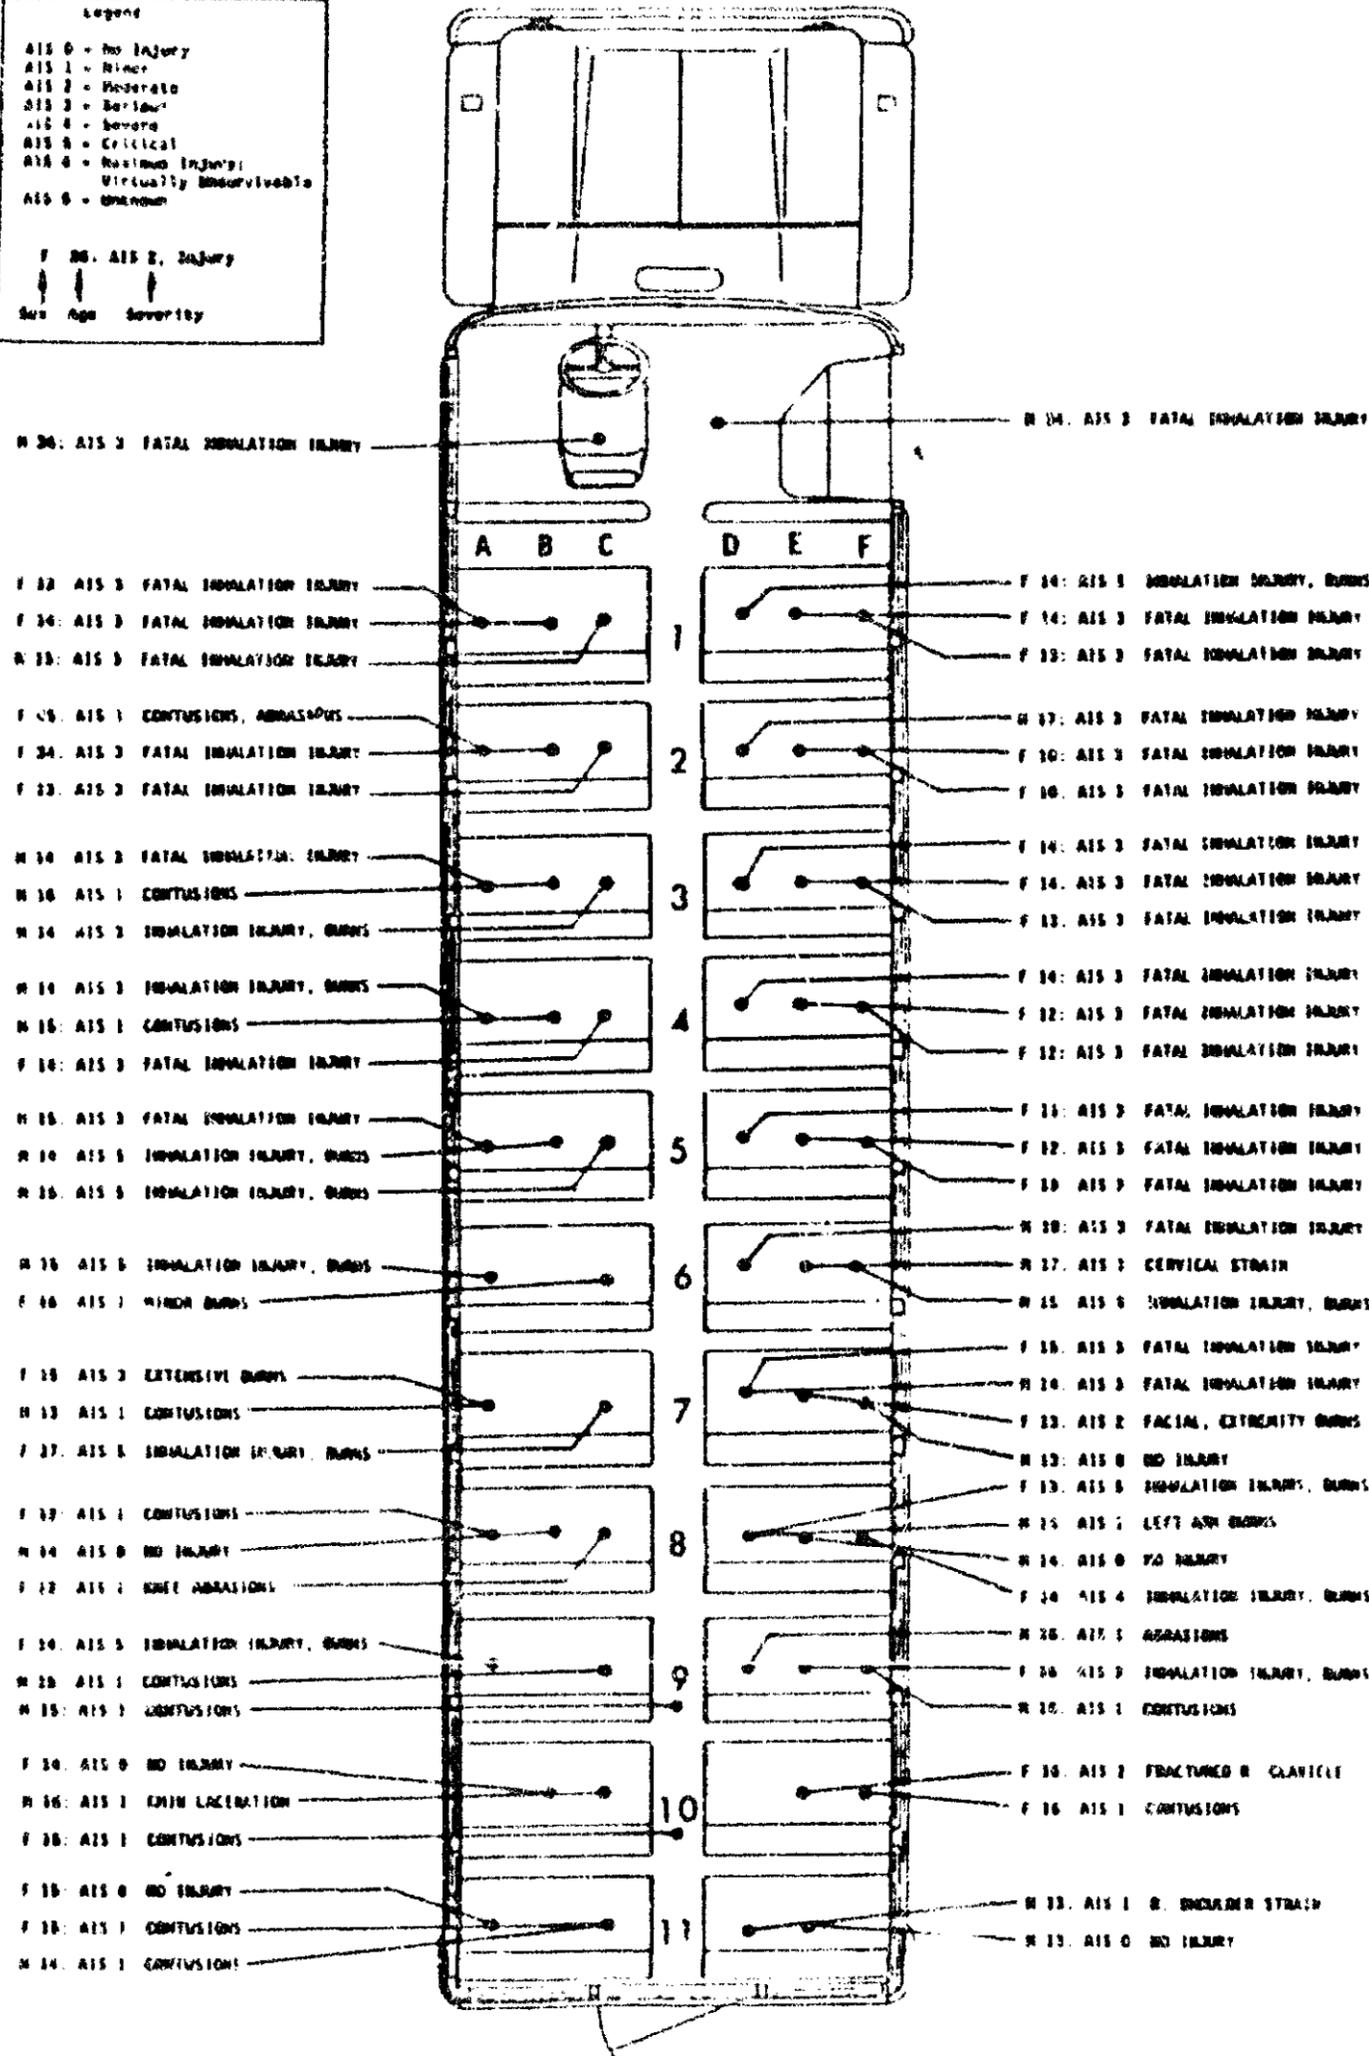
Figure 11. Bus seating and injury chart.

Twenty-seven bus occupants, including the busdriver were fatally injured. Thirty-four bus passengers, including one adult, sustained minor to critical injuries. Six bus passengers were not injured. The most seriously injured passengers sustained thermal burns on the head, neck, shoulders, and arms as a result of the fire. A number of the survivors were treated for smoke inhalation (acute respiratory distress) and corneal burns. While several passengers said they struck the seatbacks in front of them during the impact, none received any serious or incapacitating injuries from the collision. However, many passengers received minor injuries while attempting to exit the bus. (See figure 11.)
