Highway Accident Report: Collision of Levy County, Florida  
School Bus and Airdrome Tire Centers, Inc.  
Truck near Bronson, Florida, August 28, 1987

(U.S.) National Transportation Safety Board, Washington, DC

1 May 89

1. Report No. NTSB/MAR-89/02	2. Government Accession No. PB89-916202	3. Recipient's Catalog No.	
4. Title and Subtitle Highway Accident Report-- Collision of Levy County, Florida School Bus and Airdrome Tire Centers, Inc., Truck near Bronson, Florida, August 28, 1987		5. Report Date May 1, 1989

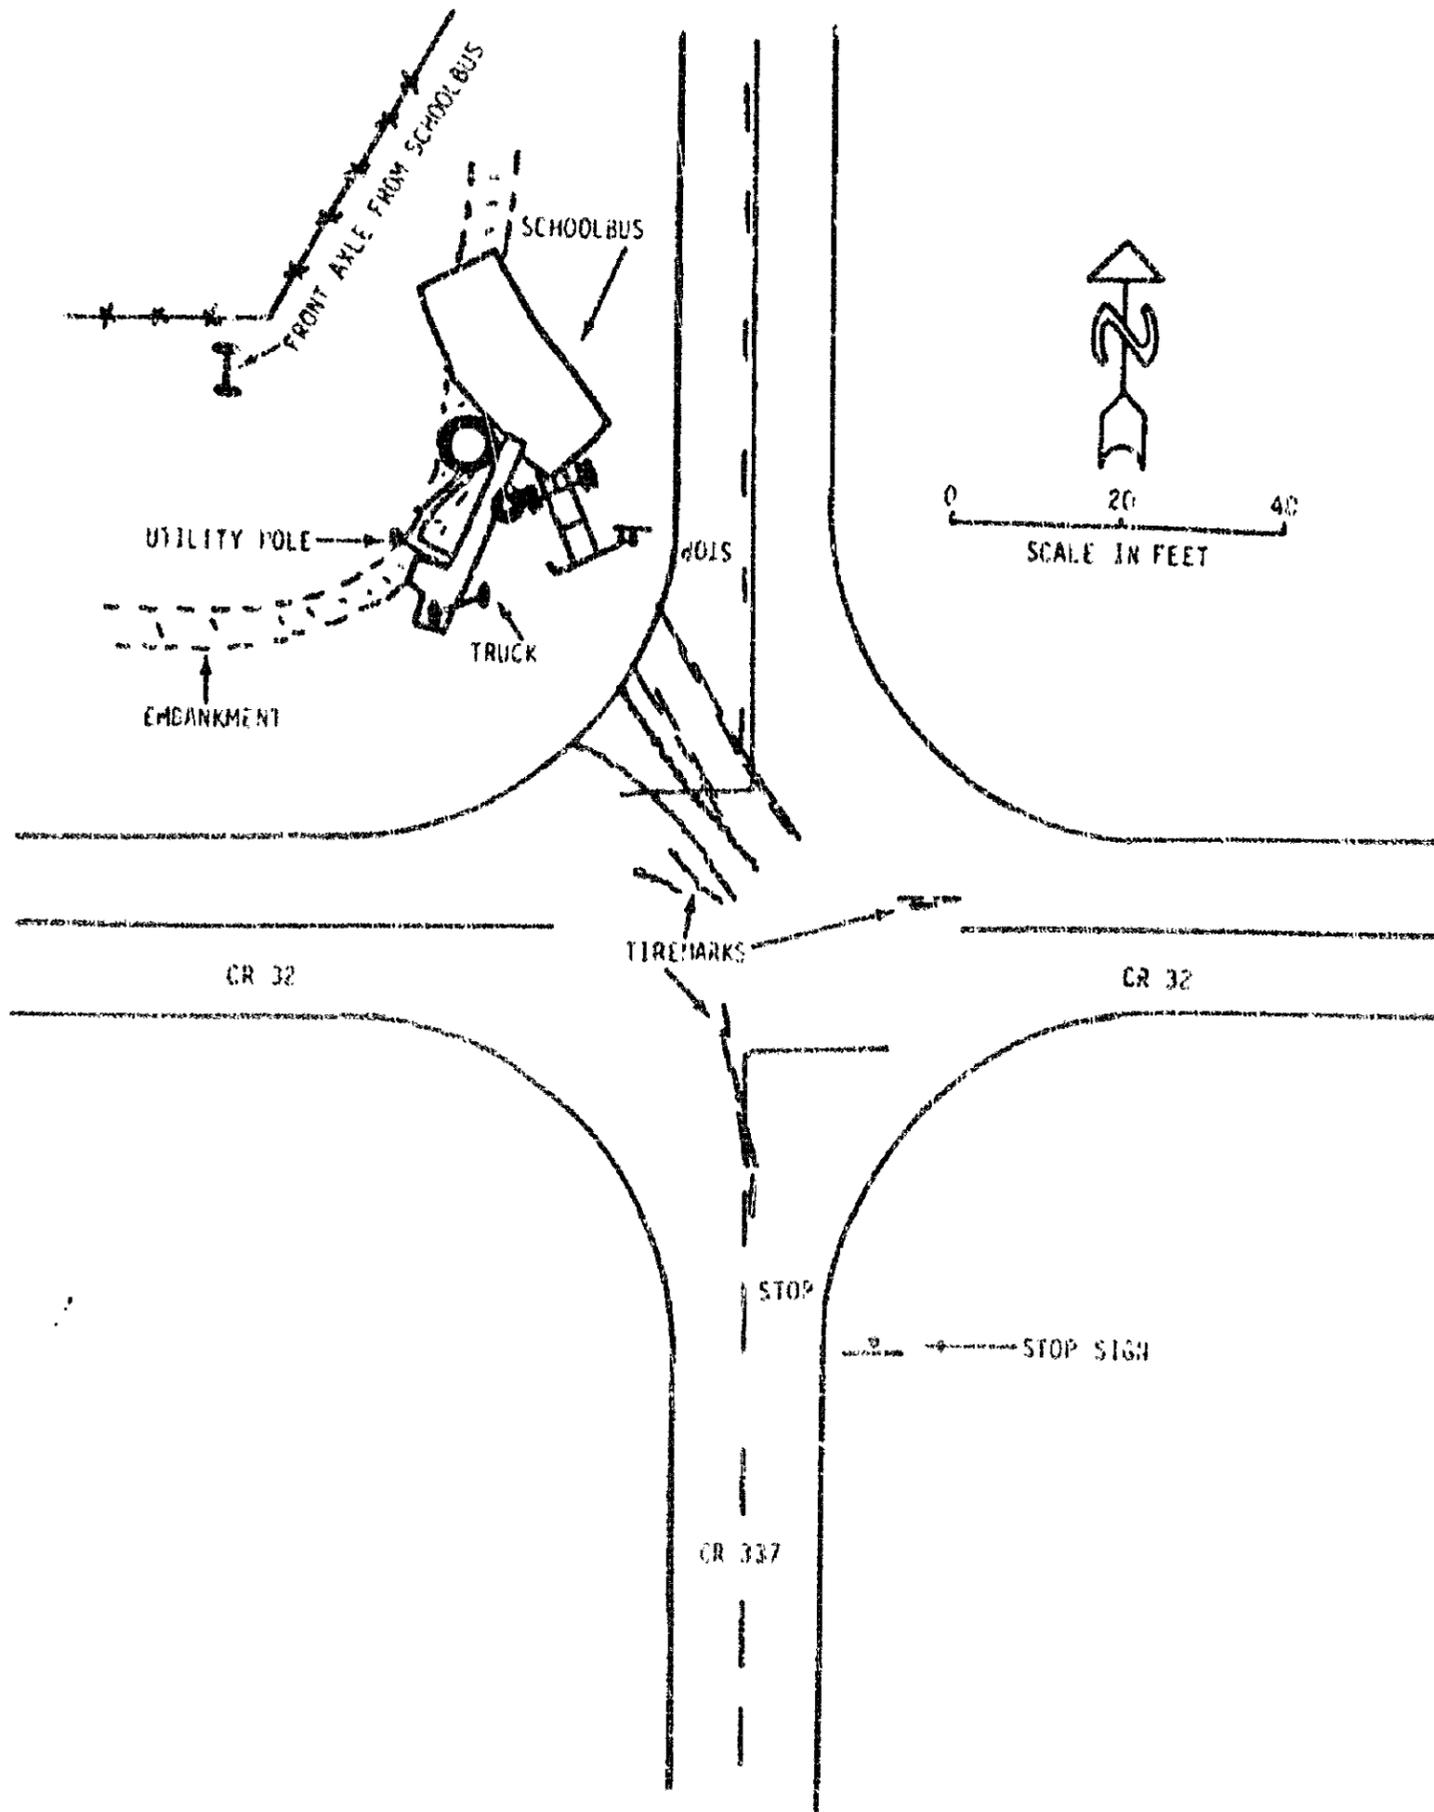
Figure 1.--Plan view of the accident site

At 2:50 p.m. on August 28, 1987, a 1982 school bus owned and operated by the School Board of Levy County (Florida), transporting 2 adult aides and 19 special education students ages 4 to 18, was traveling westbound on Levy County Road (CR) 32 when it collided with an Airdrome Tire Centers, Inc., two-axle flatbed truck. The truck was traveling northbound on Levy CR 337 and had failed to stop for a stop sign at the intersection of the two county roads. The weather was clear and the pavement was dry.

After the right-angle collision, the truck rotated about 130° counterclockwise, rolled over 90° to the right, and came to rest northwest of the intersection with its rear bumper positioned above and between the longitudinal frame members of the school bus chassis. The school bus rotated clockwise and came to rest upright northwest of the intersection. (See figures 1 and 2.) At its final rest position, the right rear of the school bus body was partially off the chassis and had shifted forward about 10 1/2 feet. (See figure 3.) The front of the school bus body came to rest against an embankment northwest of the intersection with the front portion of the roof collapsed about 12 feet forward and down over the engine compartment. (See figure 4.) A small fire that had started in the school bus engine compartment after the collision was extinguished by rescuers.

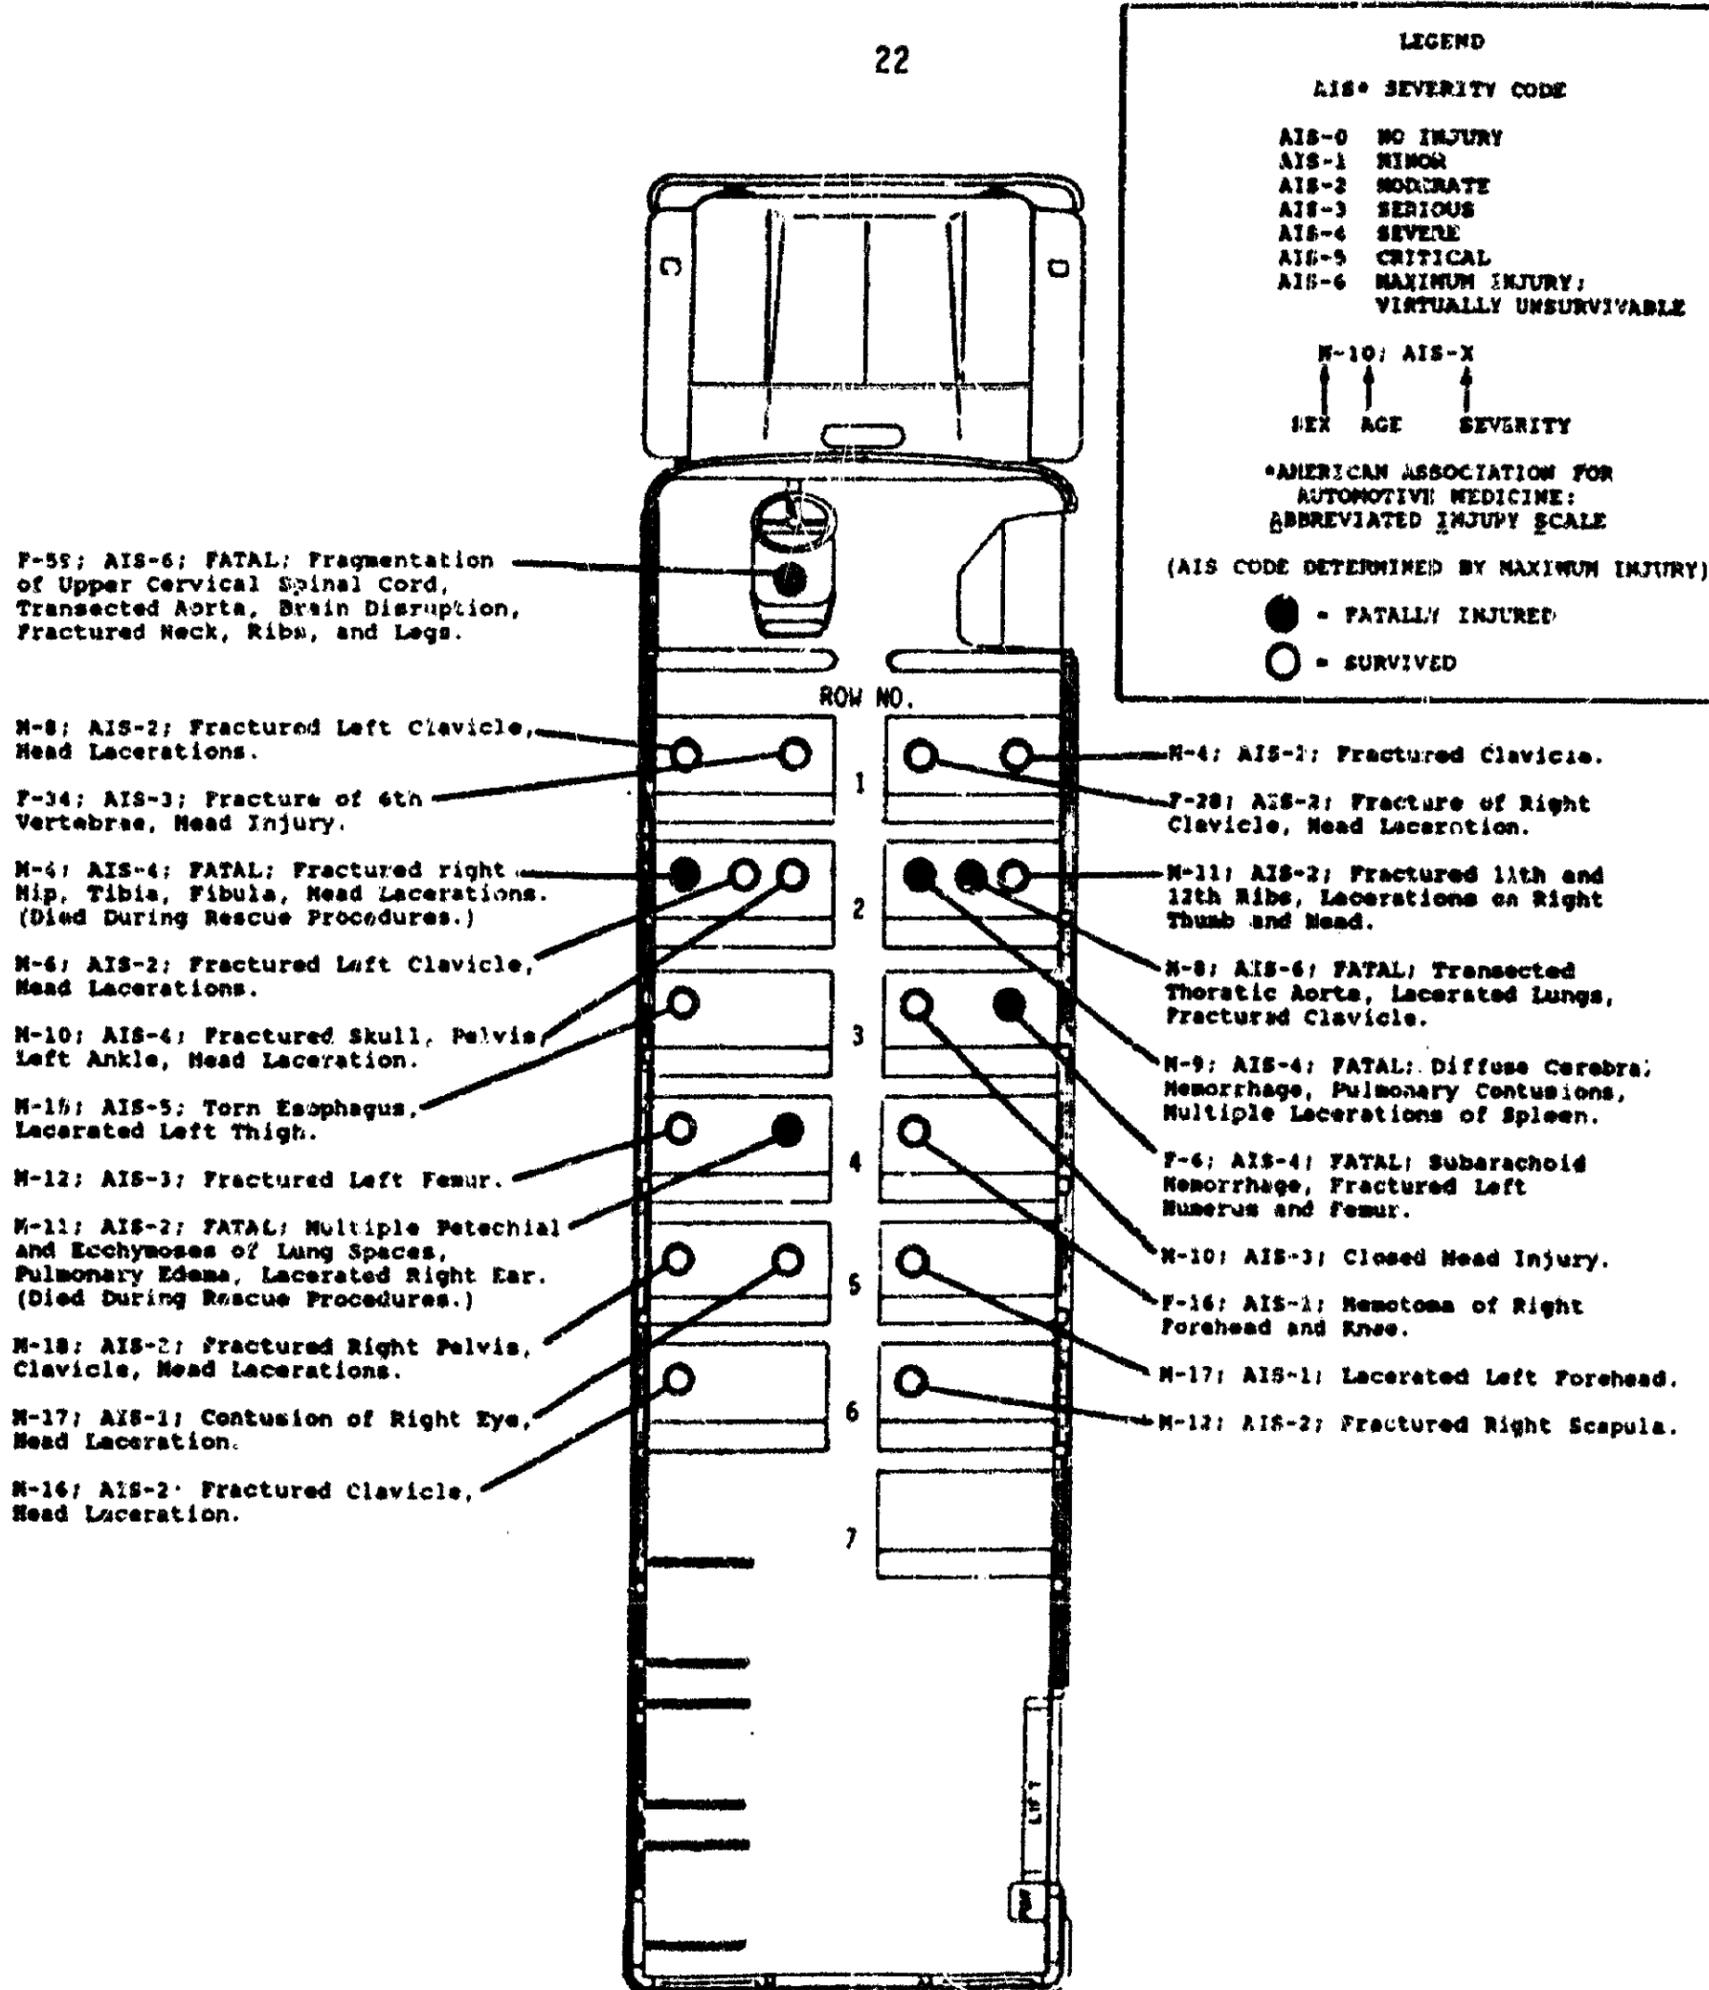
Figure 14.--School bus occupant seating and injury chart

vital organs, multiple fractures, scalpine and subarachnoid hemorrhages, pulmonary contusions and edema, exterior lacerations, and ecchymoses of the lung spaces. The surviving school bus occupants sustained fractures, lacerations, internal injuries, abrasions, and contusions. (See figure 14.)

The two passengers seated in the second row on the right side closest to the aisle, the one passenger seated in the second seat row on the left side who died during rescue procedures, and the one passenger seated in the third row on the right side sustained fatal blunt force traumatic injuries. These fatally-injured passengers received injuries at the AIS-4 (severe) or AIS-6 (virtually unsurvivable) levels on the abbreviated injury scale. (See figure 14.)
