Highway Accident Report: Greyhound Lines, Inc., Intercity
Bus Loss of Control and Overturn Interstate Highway 65 in
Nashville, Tennessee, November 19, 1988

(U.S.) National Transportation Safety Board, Washington, DC

8 Aug 89

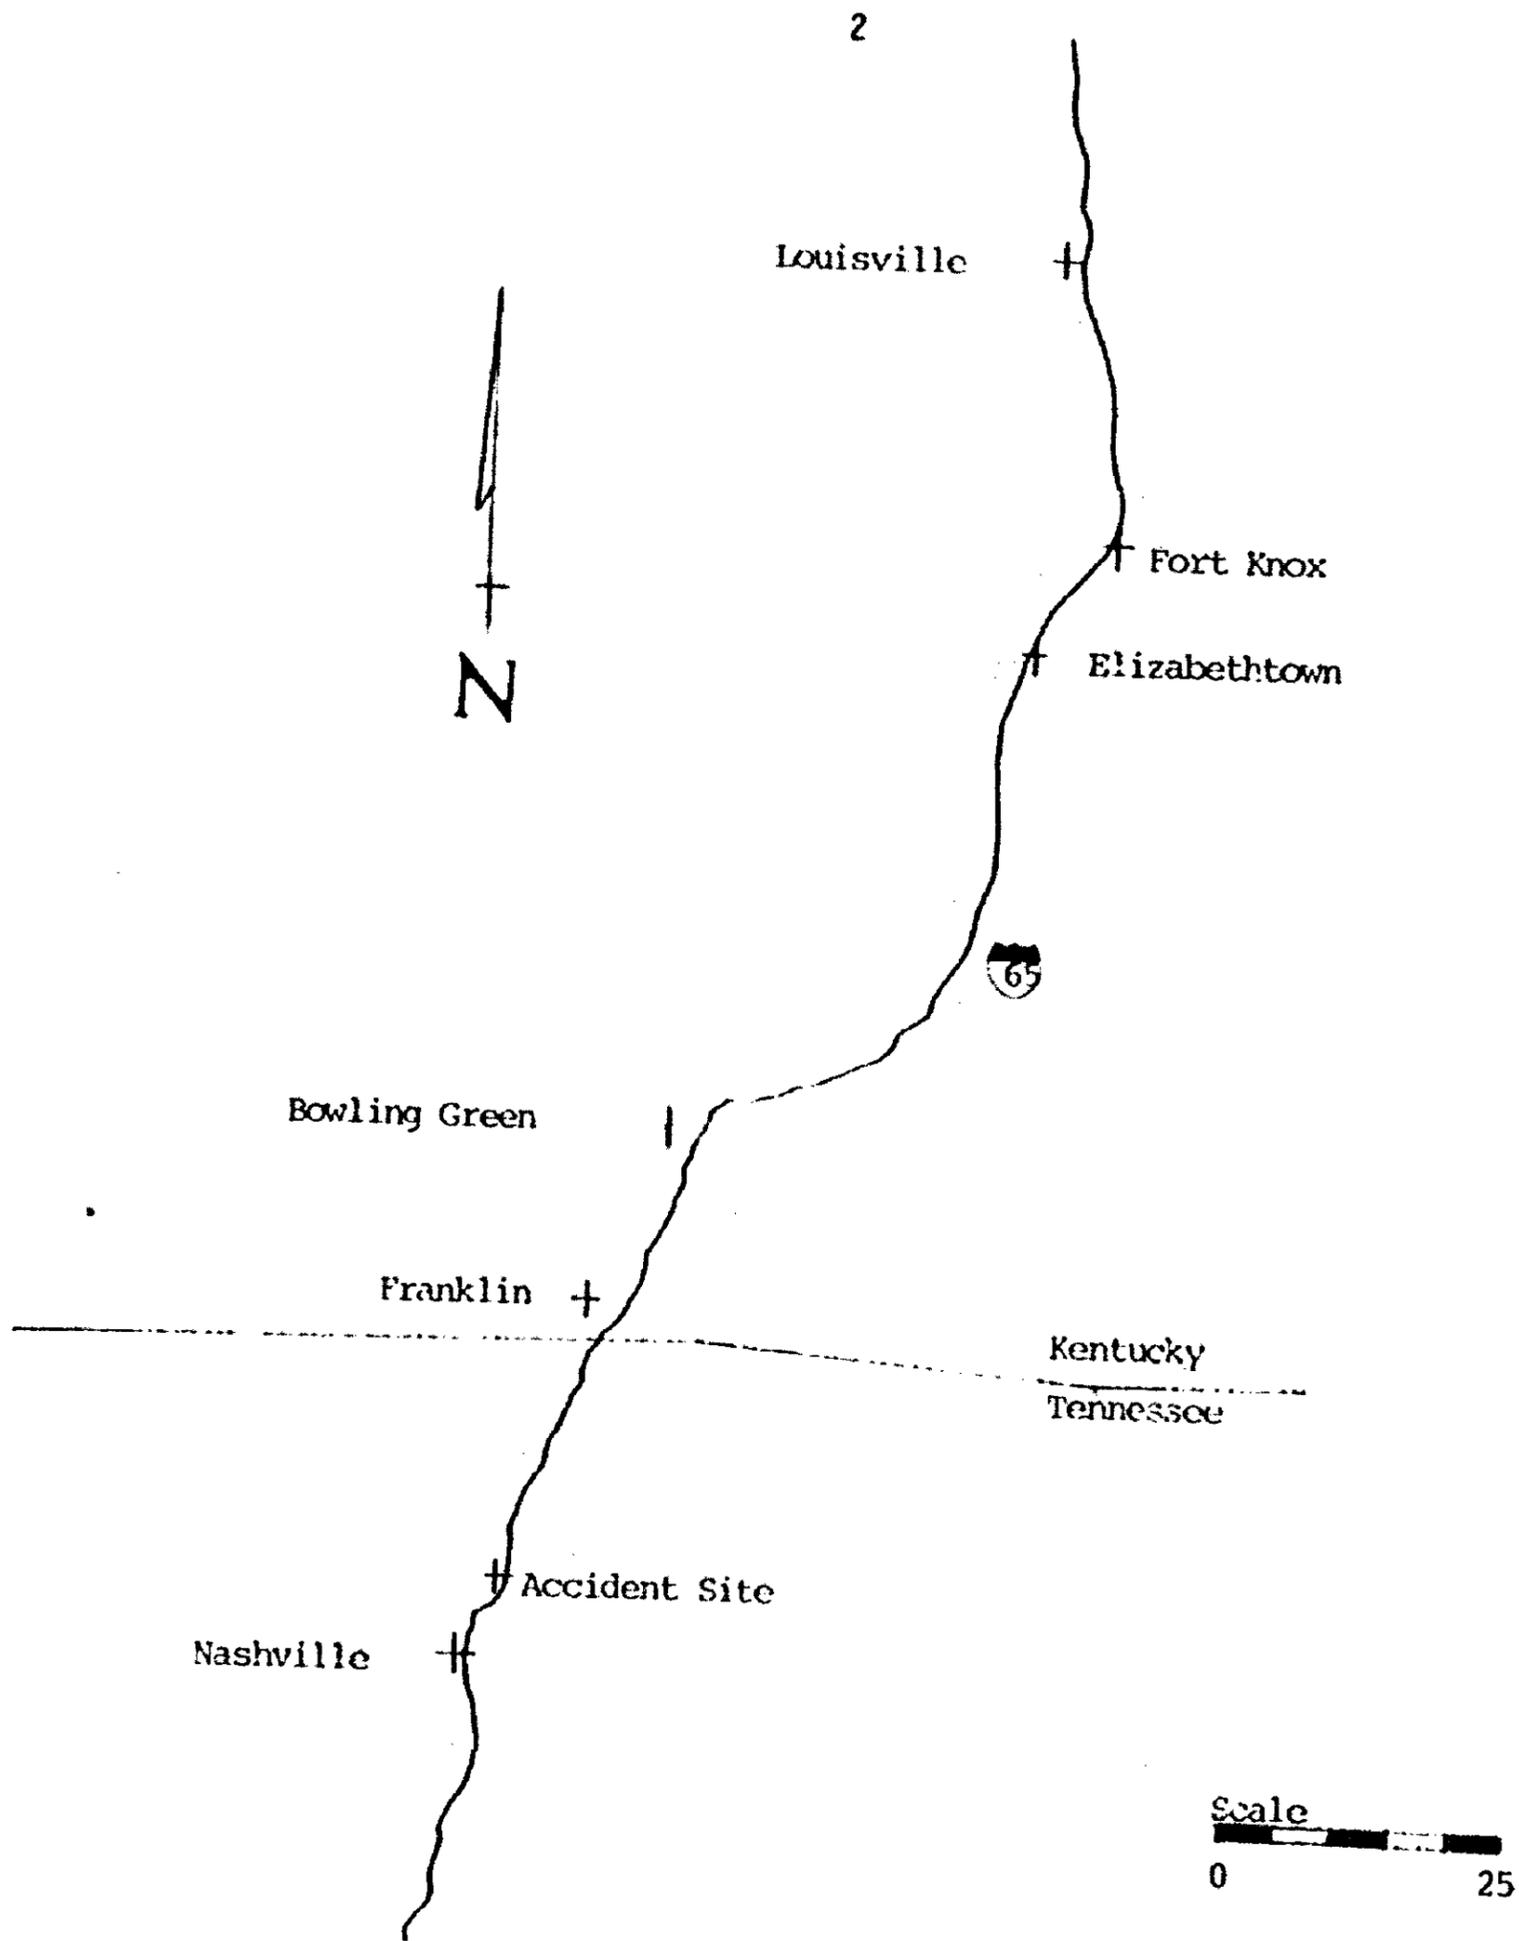
Figure 1.--Map showing bus route and accident location.

The bus arrived in Franklin, Kentucky, the last scheduled stop before Nashville, about 6:05 a.m. It left about 6:15 a.m. with 44 passengers and entered Interstate Highway 65 (I-65). (See figure 1.) Shortly after that, the bus driver directed the bus from the right to the left southbound lane, but he soon returned to the right and remained there. He did so, the bus driver later explained, because rain on the side mirror was limiting his rearward visibility; and also because of the rain, he was uncomfortable maintaining a speed of 55 to 60 mph, which was the speed of traffic in the left lane.
