**NATIONAL  
TRANSPORTATION  
SAFETY  
BOARD**

**HIGHWAY ACCIDENT REPORT**

**MAYFLOWER CONTRACT SERVICES, INC., TOUR BUS  
PLUNGE FROM TRAMWAY ROAD AND OVERTURN CRASH  
NEAR PALM SPRINGS, CALIFORNIA  
JULY 31, 1991**

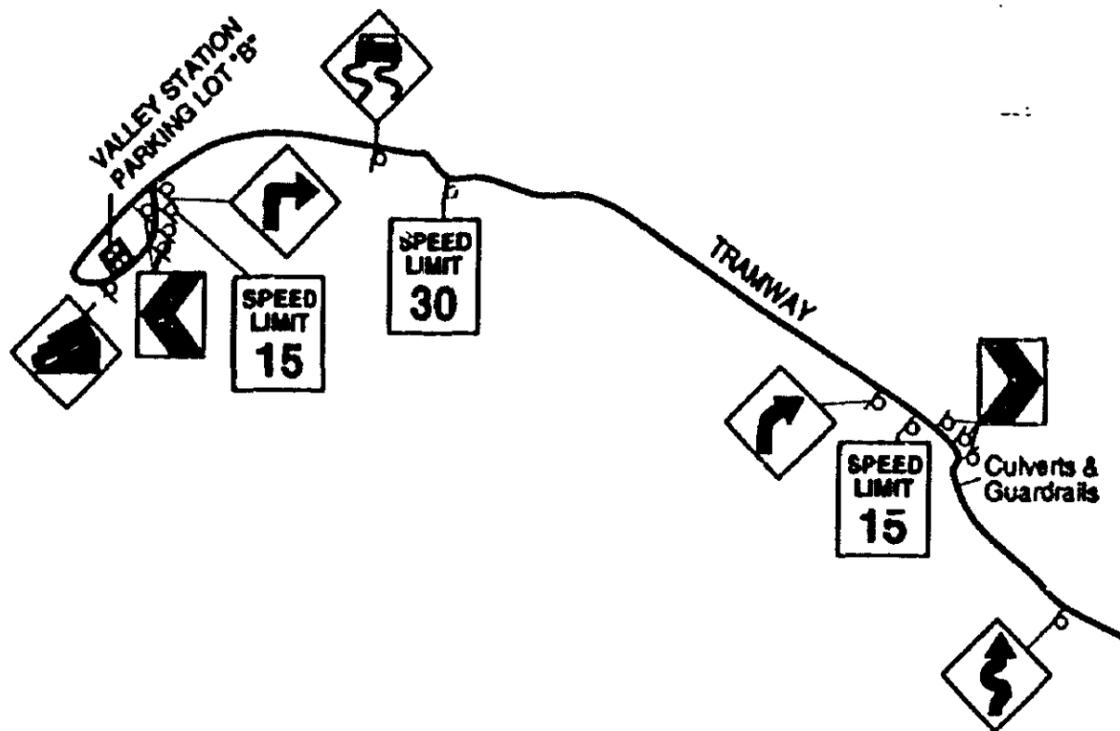
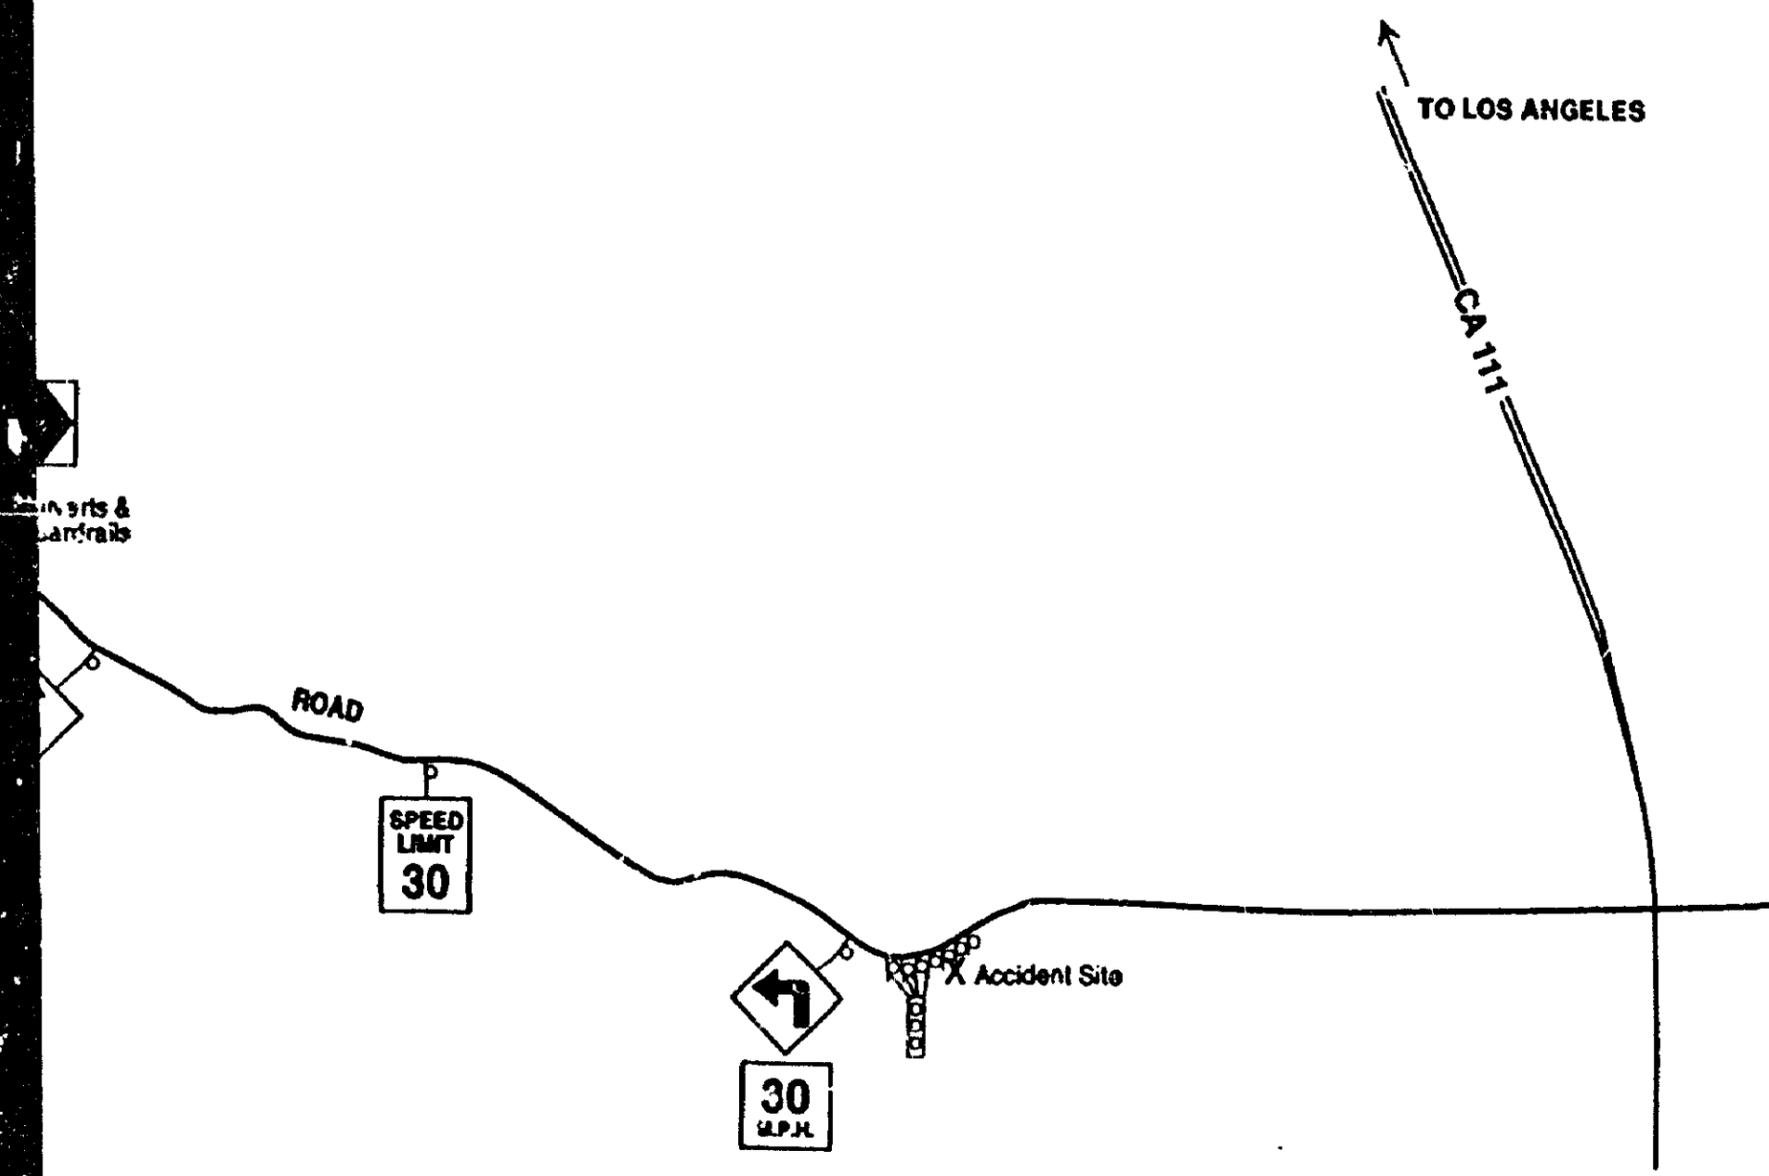
Figure 1. -- Tramway Road schematic.

The special needs busdriver reported that while following the accident bus, he initially noticed nothing unusual as the two vehicles descended the grade. However, about 1.3 miles from the parking lot as they approached a curve, where a guardrail was installed (see figure 1), the accident bus increased its speed. He then saw the accident bus brake lights repeatedly go on and off as the accident bus continued to increase speed and to pull away from his vehicle.

Within the Palm Springs city limits, Tramway Road is owned and maintained by the Mount San Jacinto Winter Park Authority. The 3.7 mile, private, two-lane highway provides access from California Route 111 to the Palm Springs Aerial Tramway Valley Station. The road splits into a one-way loop road just below the valley station to the adjacent parking lots. (See figure 1.)

The special needs busdriver stated that the accident bus started pulling away from his vehicle near a curve where a guardrail was installed, which was 1.3 miles from the tramway parking lot. In addition, several accident bus passengers noticed the bus traveling at an increased speed and reported one passenger slid to the left from the right-side aisle seat partially into the aisle. Being thrown to the left could only occur when the bus was making a right turn; the smallest radius right curve the bus negotiated after leaving the one-way loop road was at the guardrail/culvert. (See figure 1.)

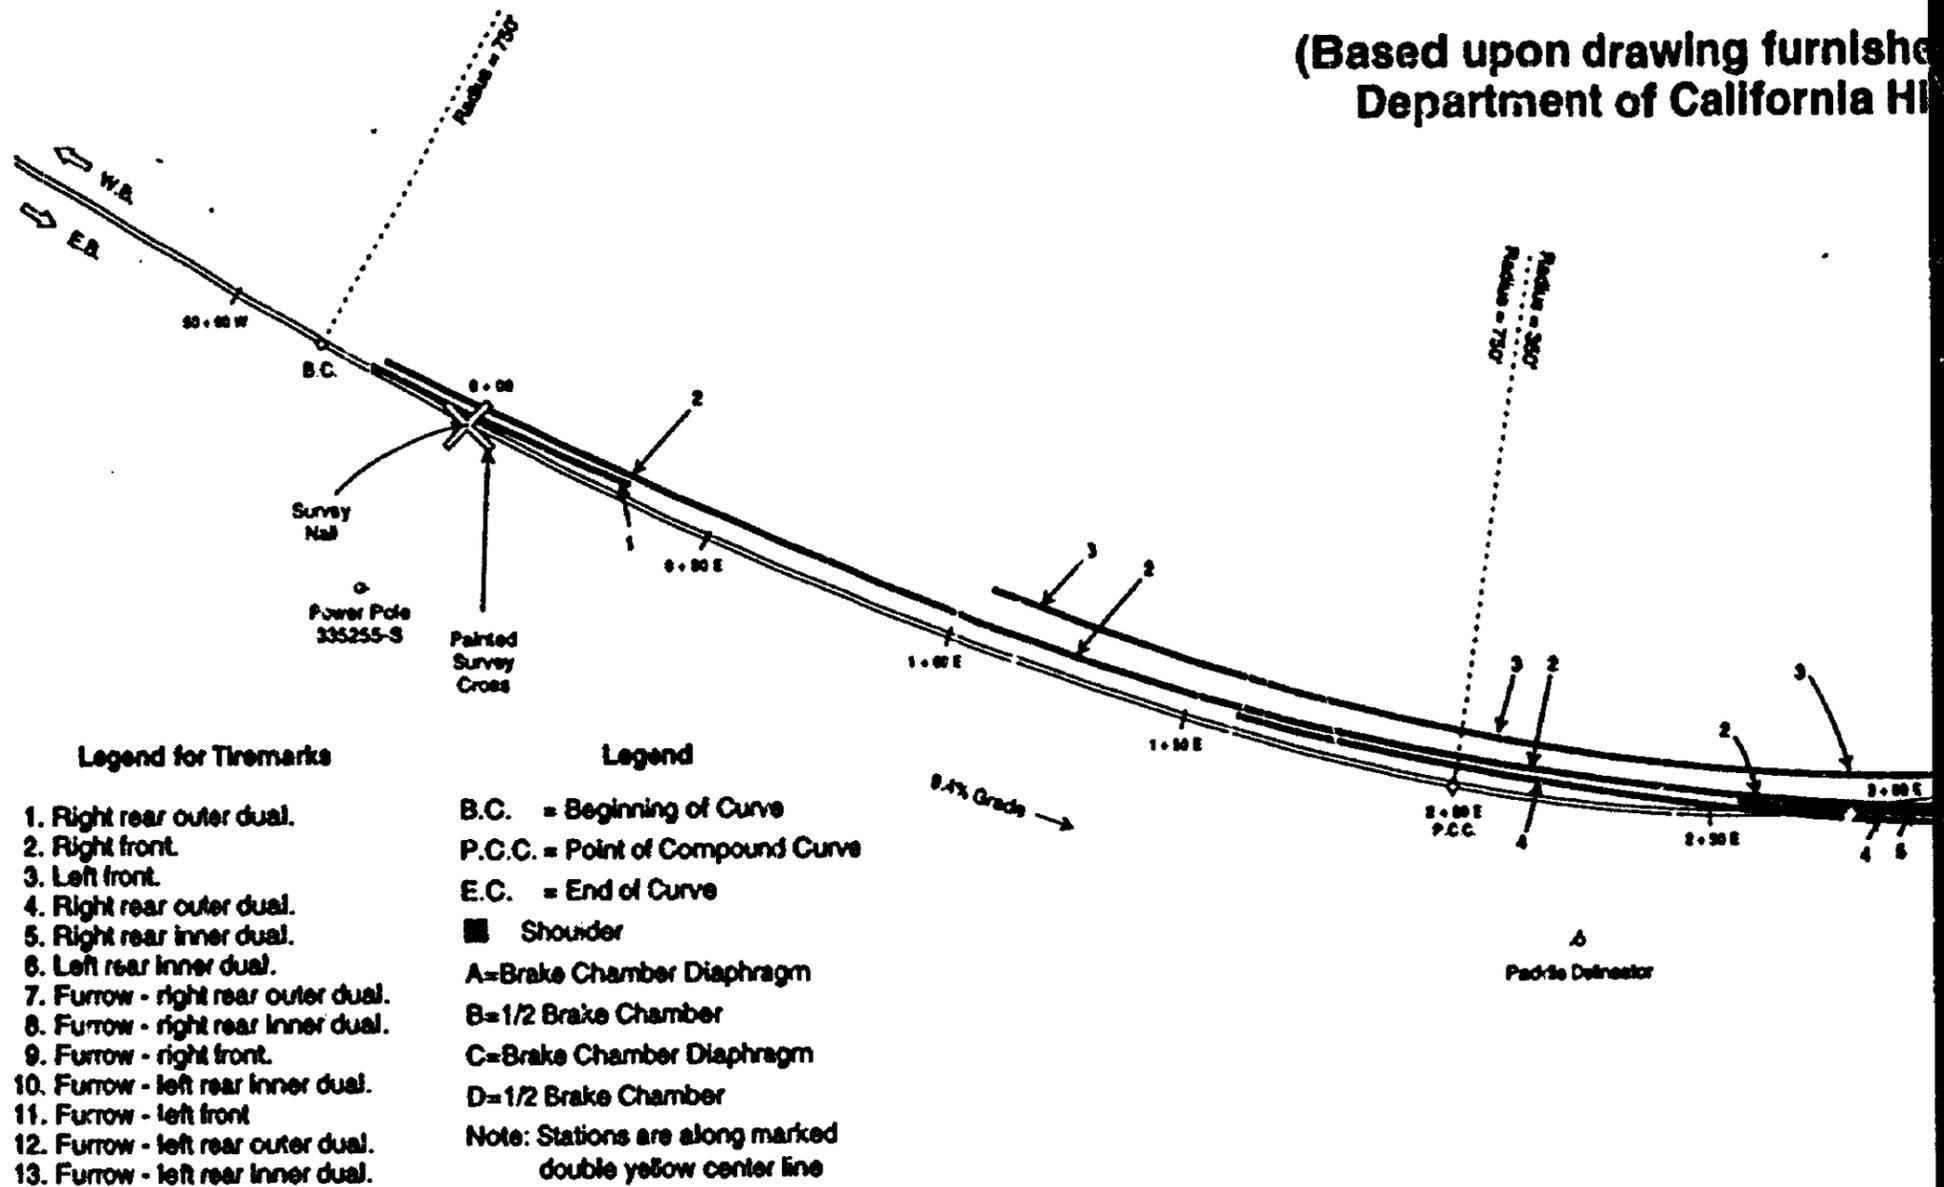
Figure 5. -- Tramway Road

Road Marks.--About 550 feet of striated, curved tire marks attributed to the accident bus began in the opposing traffic lane, crossed over the downhill lane and shoulder, and lead to the embankment where the bus dropped off. The tire marks stopping at the edge of the embankment indicates that the bus dropped off at this point. Site measurements indicate a 40-foot-horizontal and 6-foot-vertical trajectory before the bus came to rest. (See figure 5.)

Speed Estimates.--Using the radius of the yaw marks and the friction coefficient established in the August 1991 test, calculations indicate that the accident bus was traveling about 64 mph where the yaw marks began. Calculations using the horizontal and vertical distances of its fall indicate the bus was traveling about 48 mph when it left the road. (See figure 5.)
