HIGHWAY ACCIDENT REPORT

COLLISION OF SMALL SCHOOL BUS  
AND TRACTOR-SEMITRAILER  
NEAR SNYDER, OKLAHOMA  
NOVEMBER 10, 1993

**Adopted: November 29, 1994  
Notation 6491**

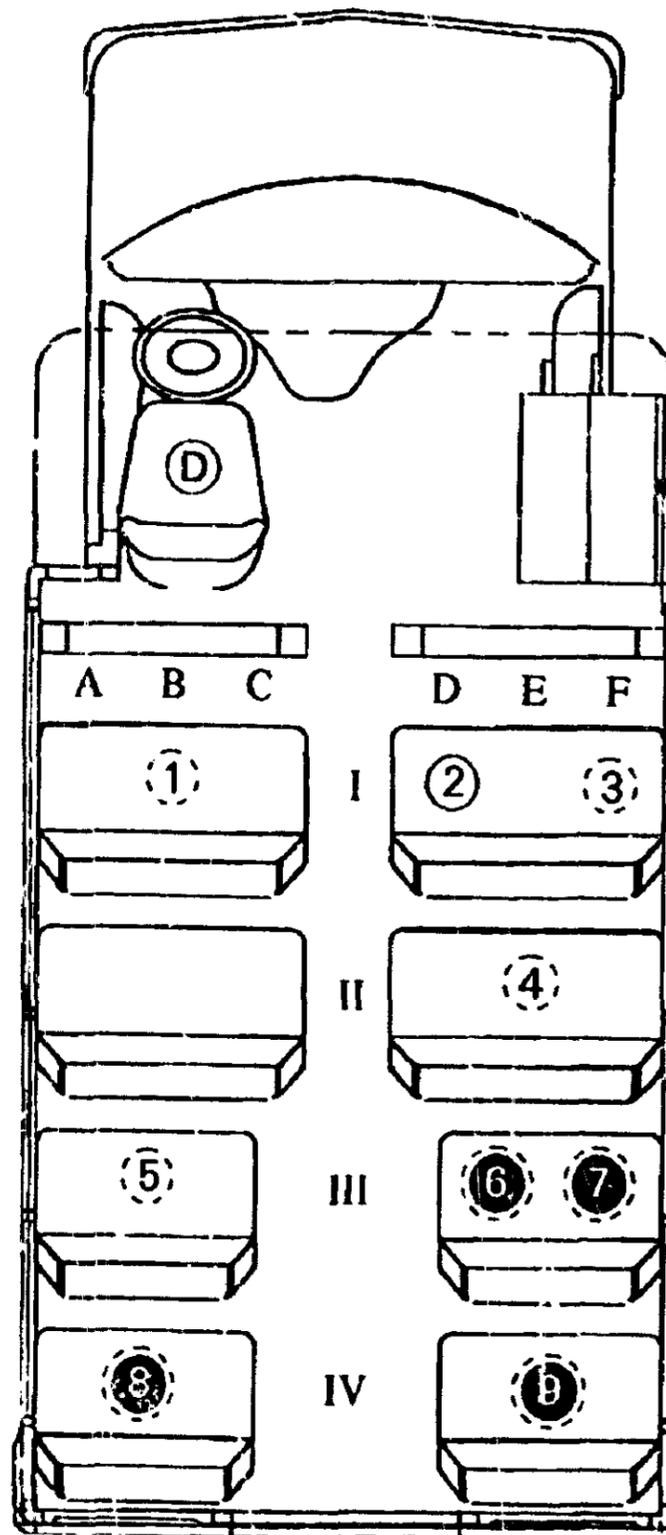
**Passenger #8** F-14 AIS-5 Fatal  
Head injury; contused lung; liver and spleen lacerations; fractured r. clavicle and l. rib

**Passenger #9** M-11 AIS-3 Fatal  
Head injury; l. leg amputation; scalp laceration
