NTSB/HAR-95/01

**NATIONAL TRANSPORTATION  
SAFETY BOARD**

**HIGHWAY ACCIDENT REPORT**

**COLLISION OF AMTRAK TRAIN NO. 88 WITH  
ROUNTREE TRANSPORT AND RIGGING VEHICLE  
ON CSX TRANSPORTATION, INC., RAILROAD  
NEAR INTERCESSION CITY, FLORIDA  
NOVEMBER 30, 1993**

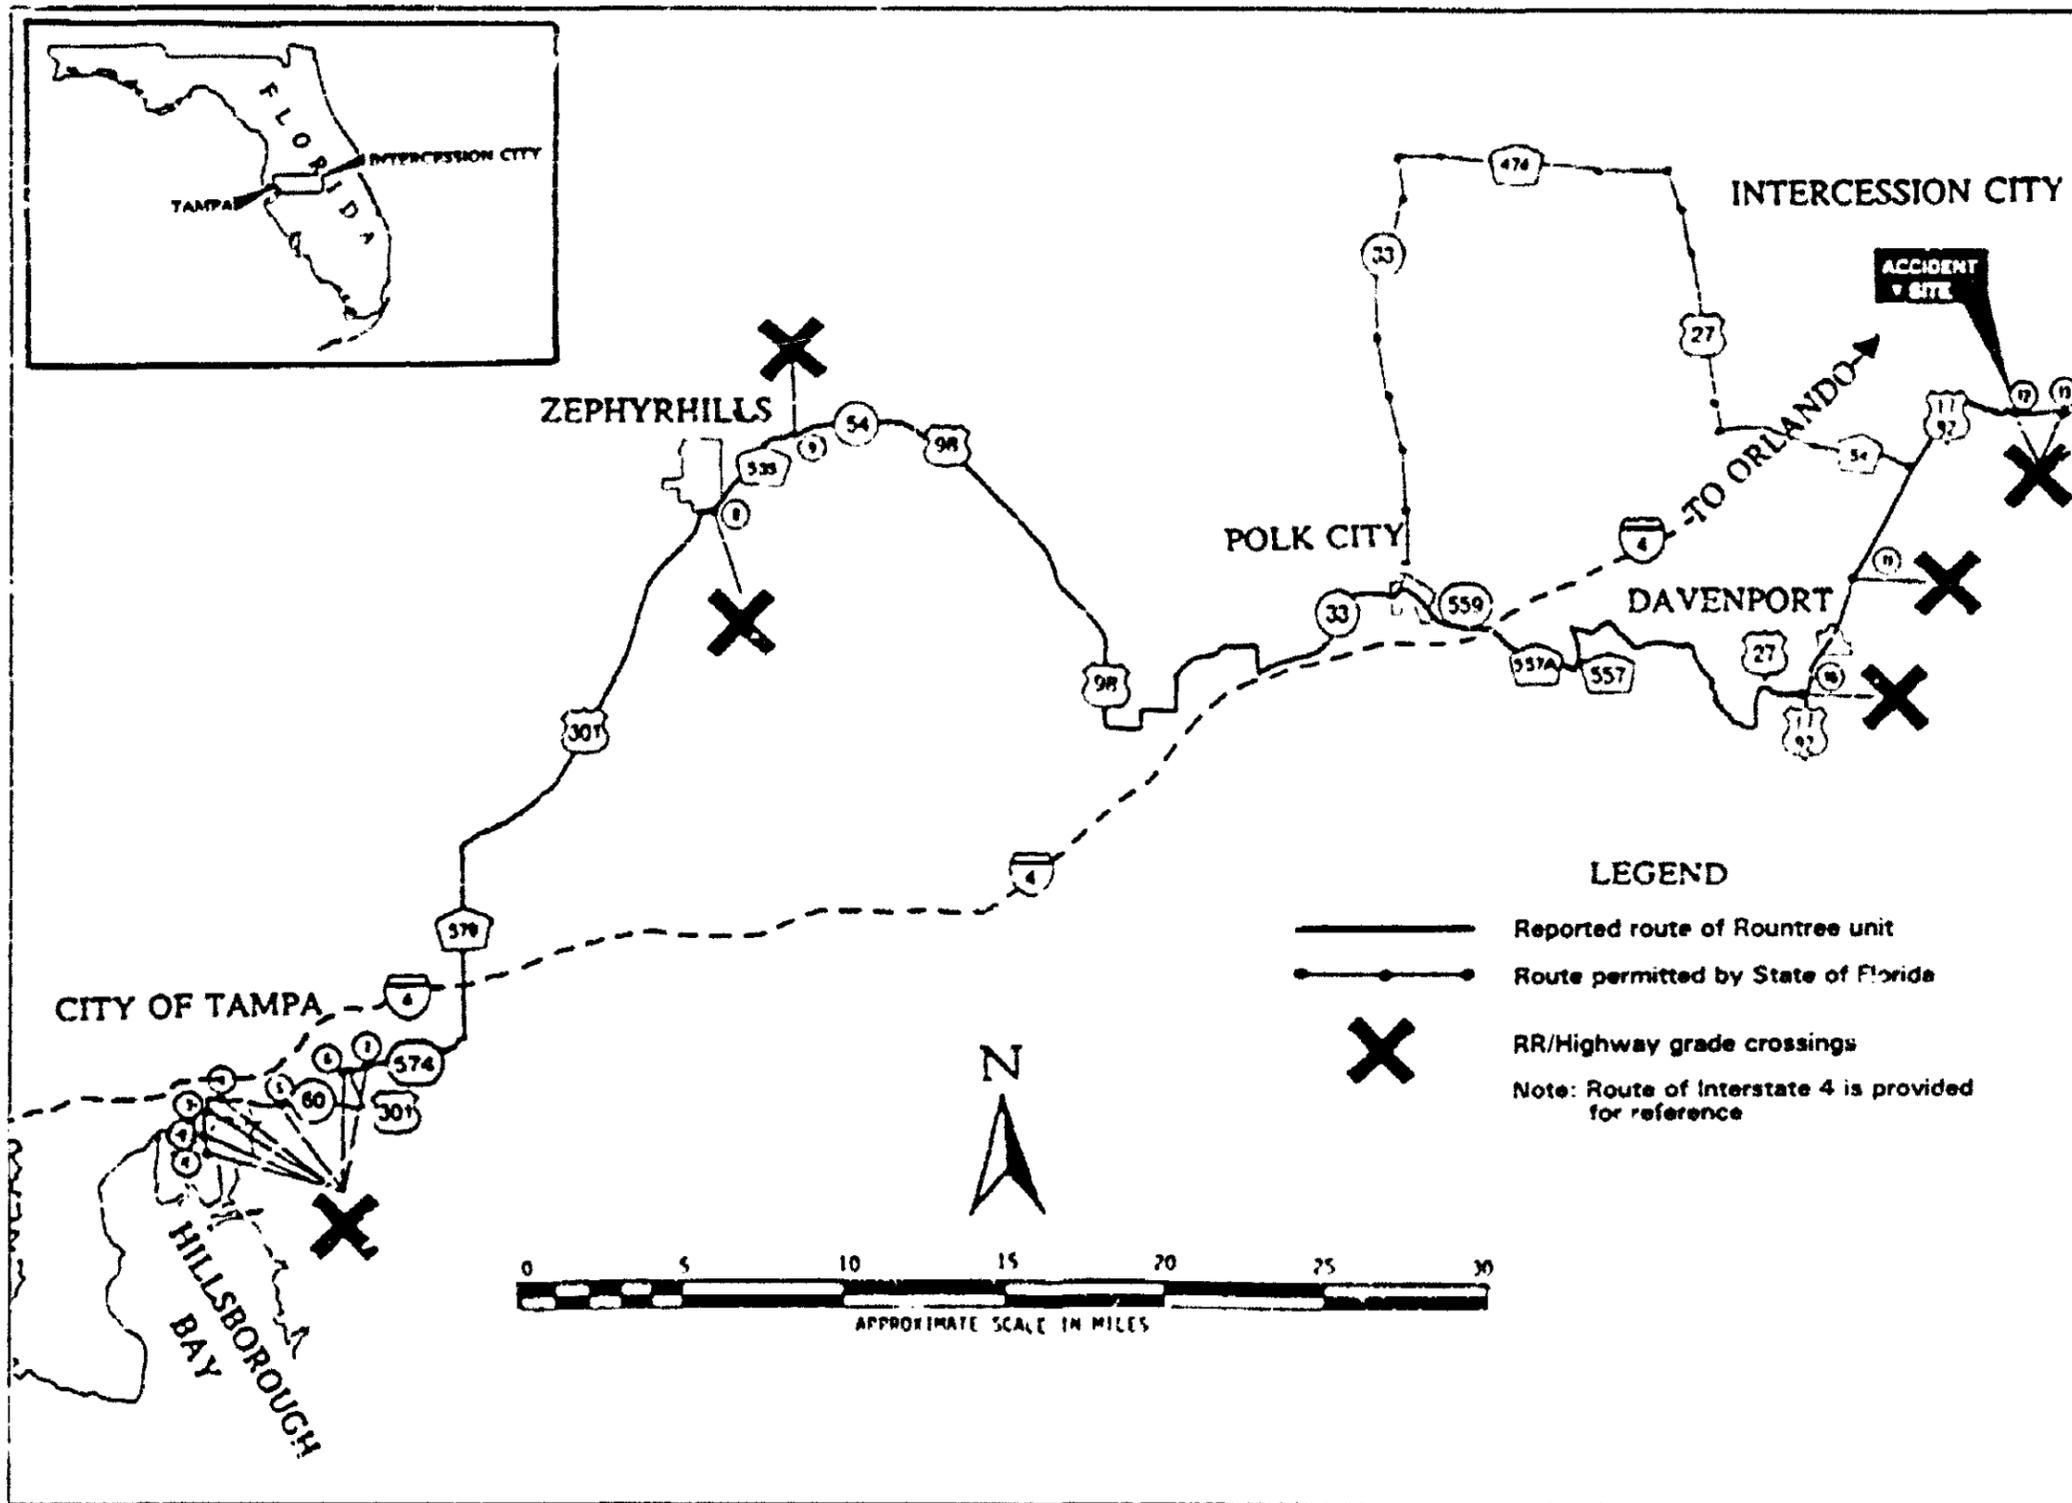
Figure 2.—Route of the Rountree vehicle from Tampa to Intercession City.

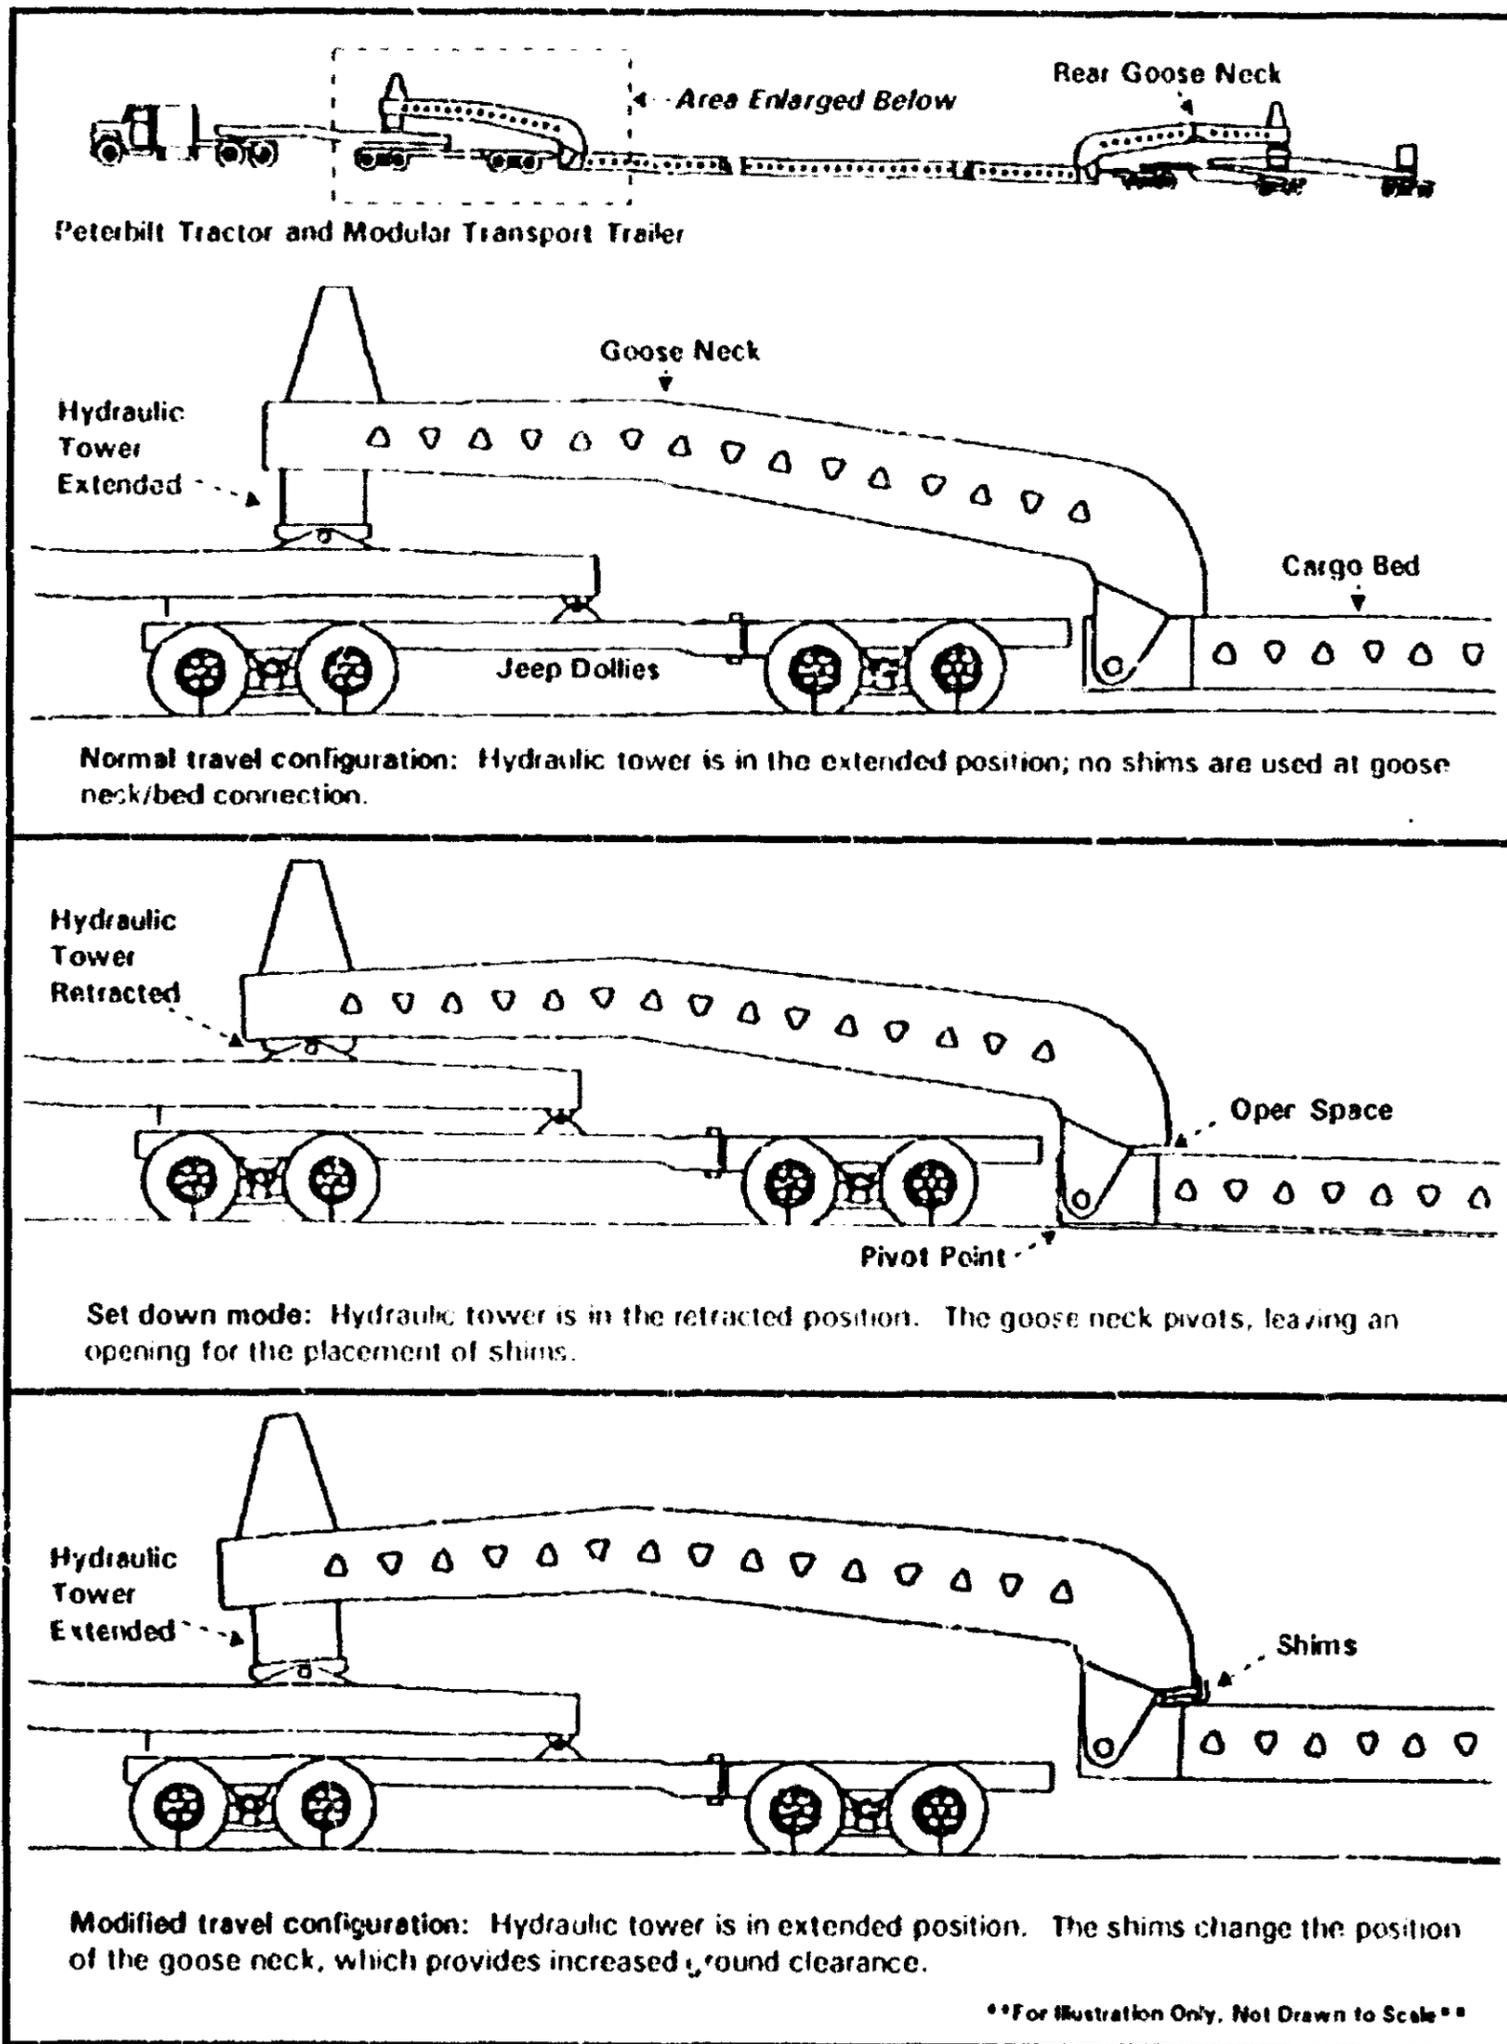
**Modular Transporter.**--The modular transporter (figure 5) was typical of units used by the heavy rigging industry to move oil drilling rigs, earth-moving equipment, heavy transformers, power-generating components, and the like. The manufacturer estimates that about 100 units of this type are in operation throughout the United States. The transporter in the Intersection City accident was a 1992 Trail King with a load-carrying capacity of 110 tons. The transporter had 10 axles, which were equipped with standard S-cam air-mechanical brakes. The cargo bed was supported by two jeep dollies,<sup>10</sup> one forward and one aft.

Figure 5. Drawings show how the front goose neck is shimmed to increase clearance. To raise the cargo bed at the rear of the vehicle, crews shim the rear goose neck.
