**MULTIPLE VEHICLE COLLISION WITH FIRE  
DURING FOG NEAR MILEPOST 118  
ON INTERSTATE 40, MENIFEE, ARKANSAS  
JANUARY 9, 1995**

**SPECIAL INVESTIGATION  
OF COLLISION WARNING TECHNOLOGY**

**HIGHWAY ACCIDENT REPORT**

**National  
Transportation  
Safety Board**

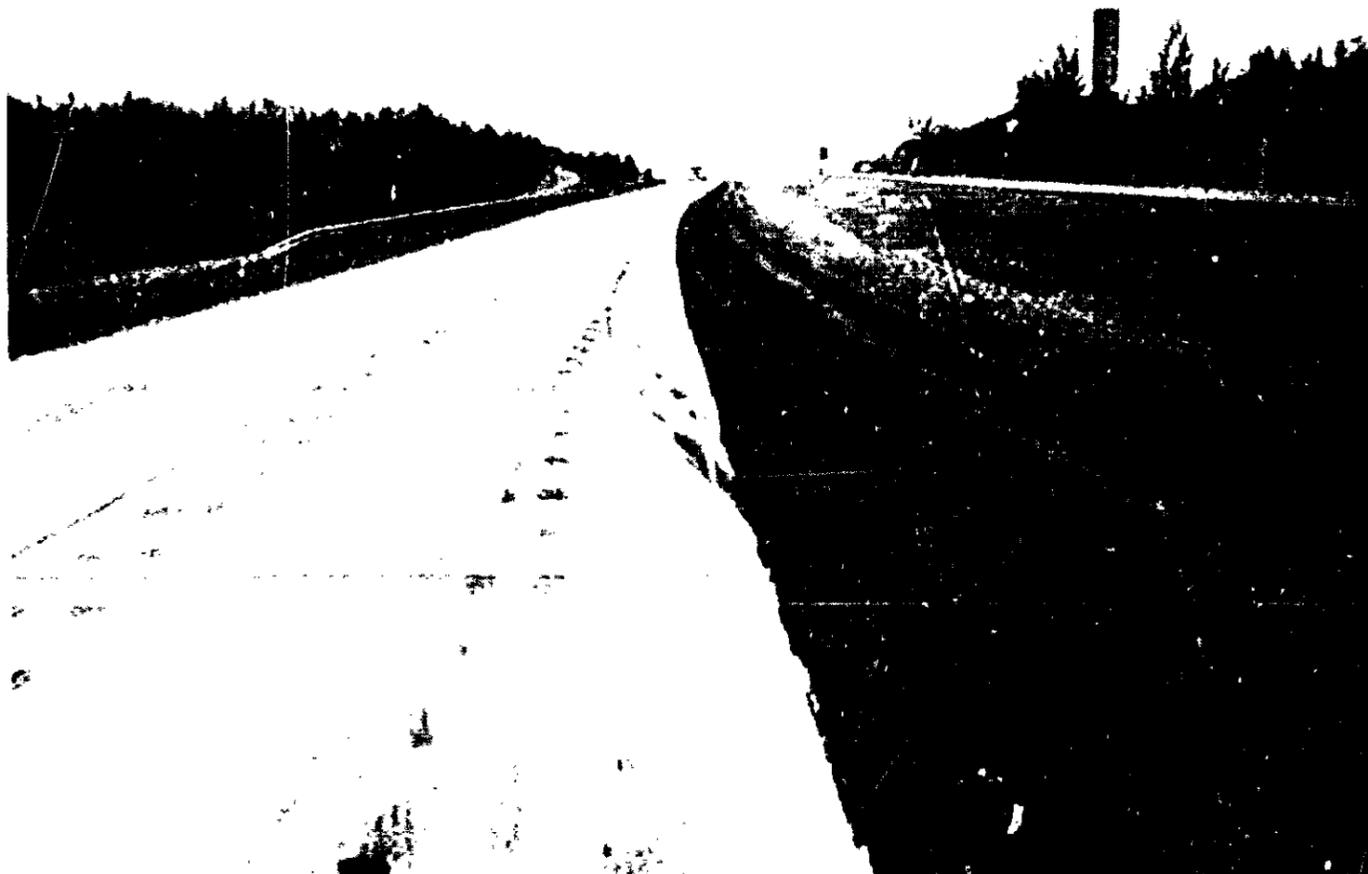
Approaching the accident site, the westbound lanes had a 900-foot vertical curve (hillcrest) transitioning to a 3-percent downhill grade. (See photograph 14 in appendix B.) The crest of the hill was about .5 mile east of the accident site.

**Photograph 14. -- Downgrade approaching accident site  
(viewing back towards east).**
