NTSB/HIR-22/02

Bus Roadway Departure and Rollover

Pala Mesa, California

February 22, 2020

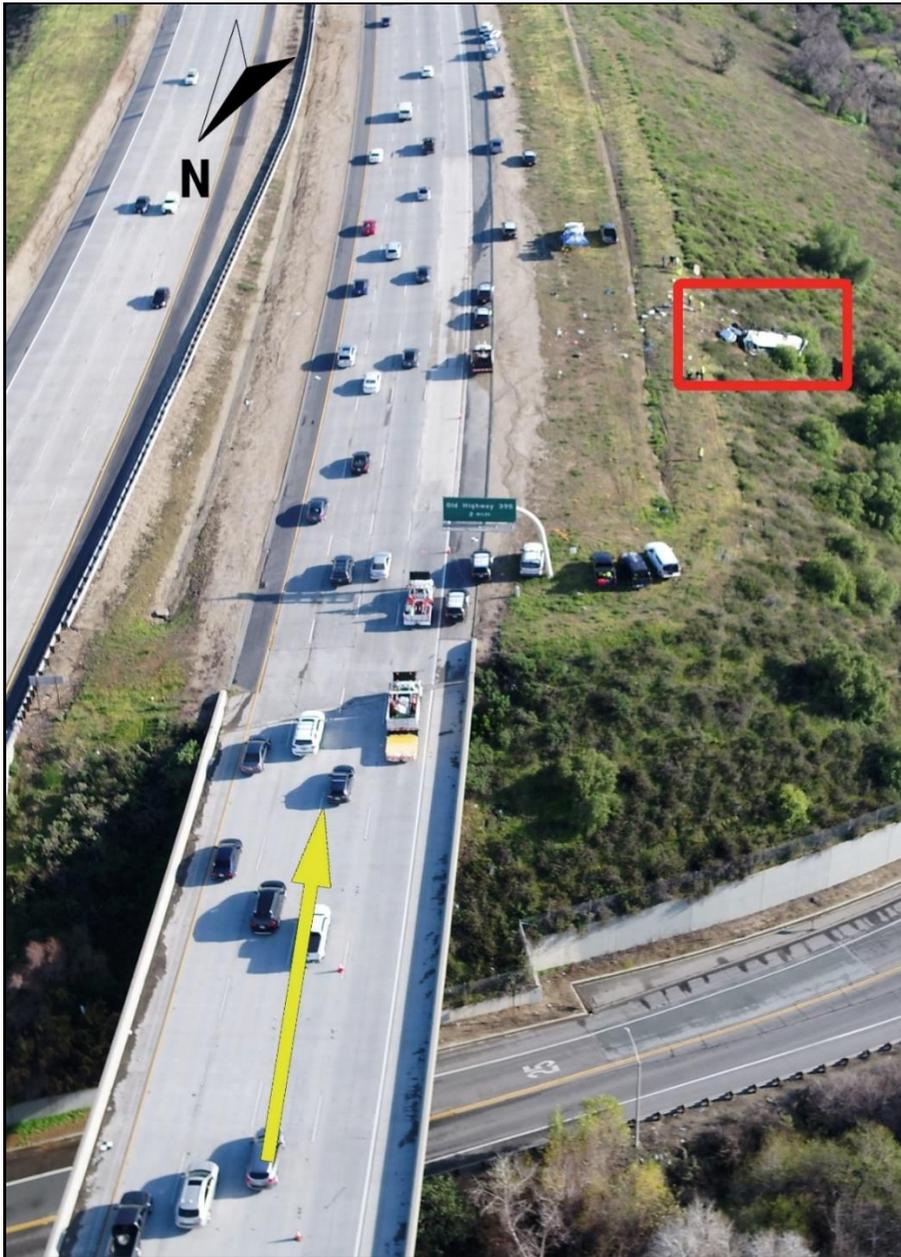
Figure 2. Aerial view of crash area showing bus's southbound direction of travel (yellow arrow) and rest position (enclosed by red rectangle). The bridge crosses over both the San Luis Rey River and Dulin Road. [Note: This figure is not standard-compass-oriented. The bottom of the figure is roughly "north," and the top is roughly "south."] (Source: California Highway Patrol [CHP] with NTSB modifications)

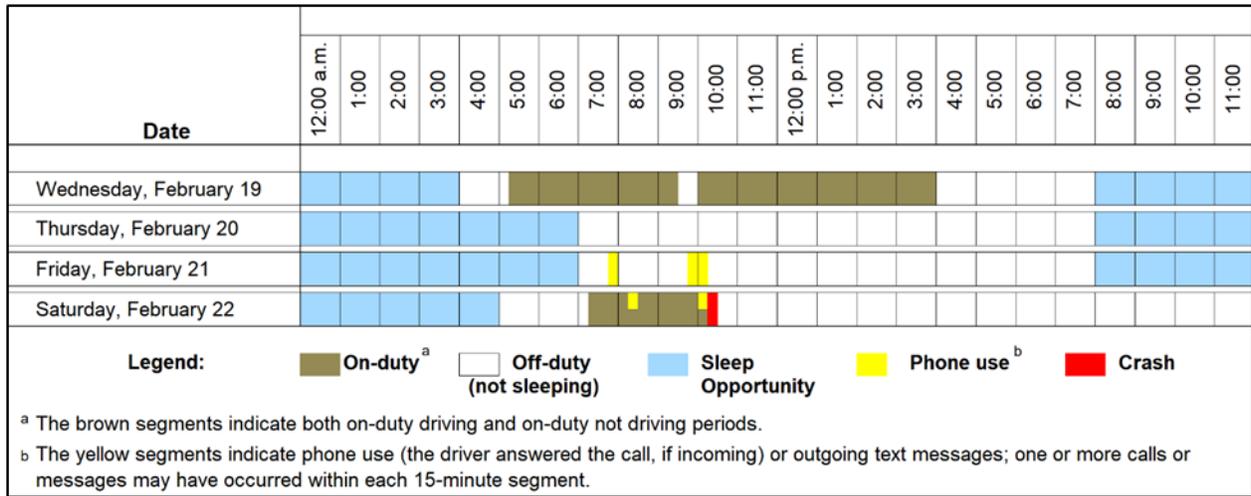
occurred 20 minutes later, about 15 minutes after resuming the trip from Temecula to San Ysidro. Although he was using his cell phone at various times that day, his phone records (calls and texts through short message service [SMS]) indicate that he was not using it at the time of the crash.⁴¹ Figure 10 shows the driver’s activities in the 3 days before and on the day of the crash.

Figure 10. Precrash activities of bus driver, February 19-22, 2020.
