May 3, 2023

HIR-23-07

Improving the Identification, Prioritization, and Completion of Follow-up Actions on Bridges with Uncoated Weathering Steel Components

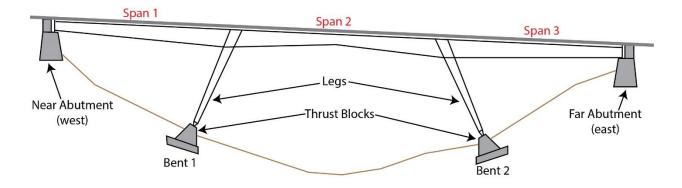
Figure 2. Simplified side view (elevation) of K frame structure. Bents 1 and 2 were composed of two legs each. Only the southwest and southeast legs are visible in this diagram.

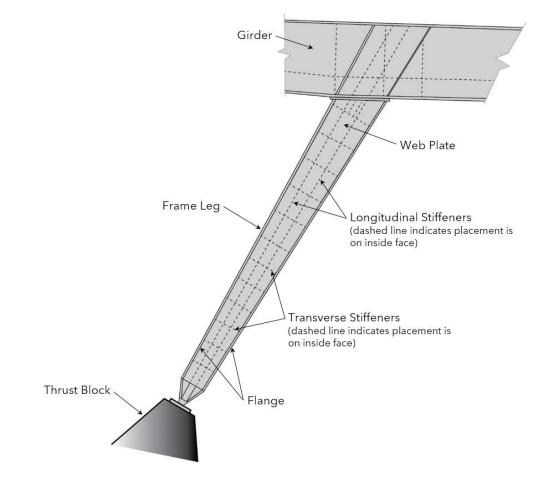
The thickness of the web plates used for the main girder and legs required the use of longitudinal and transverse stiffeners to suppress buckling (see figure 3).⁵
