Highway Investigation Report HIR-25-05

Multivehicle Collision and Postcrash Fire on Interstate 70

Etna, Ohio

November 14, 2023

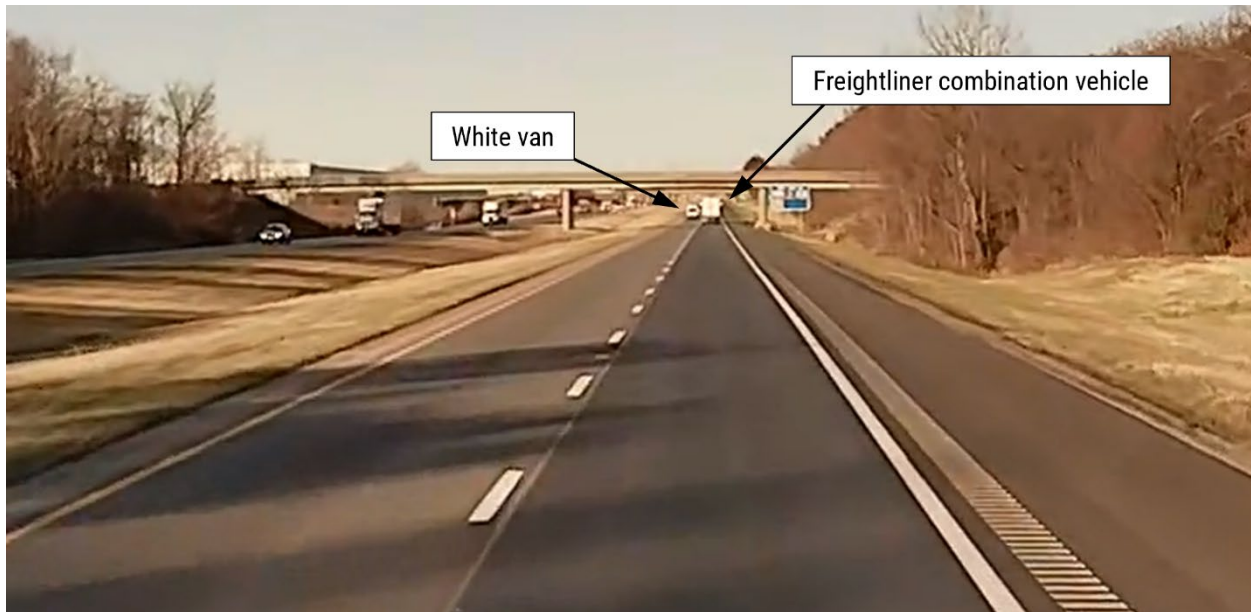
At 9.0 seconds before the collision, a white van, which had initially been traveling in the right lane ahead of the Freightliner combination vehicle, changed lanes into the left lane. The van was not involved in the collision. When interviewed, the van driver told OSHP investigators that he had observed brake lights and vehicles slowing ahead of him and had decided to move to the left lane because traffic there was lighter. The van fully occupied the left lane at 6.9 seconds before the collision (see figure 1). At 2.7 seconds before the collision, the Freightliner moved slightly to the right and its right-side trailer tires appeared to be on the (right) solid white highway edge line when the crash occurred. The video depicted no clear indications of evasive steering or rapid slowing by the Freightliner combination vehicle consistent with emergency braking before the collision. Two seconds after the initial impact, fire was visible underneath and on the left of the Freightliner combination vehicle (see figure 2). About 2 seconds later, the Freightliner began to move onto the right shoulder.

Figure 1. Video still from witness vehicle's forward-facing camera (annotated by NTSB), showing the Freightliner combination vehicle and the white van that moved from the right lane into the left lane, ahead of the Freightliner, about 7 seconds before the crash.

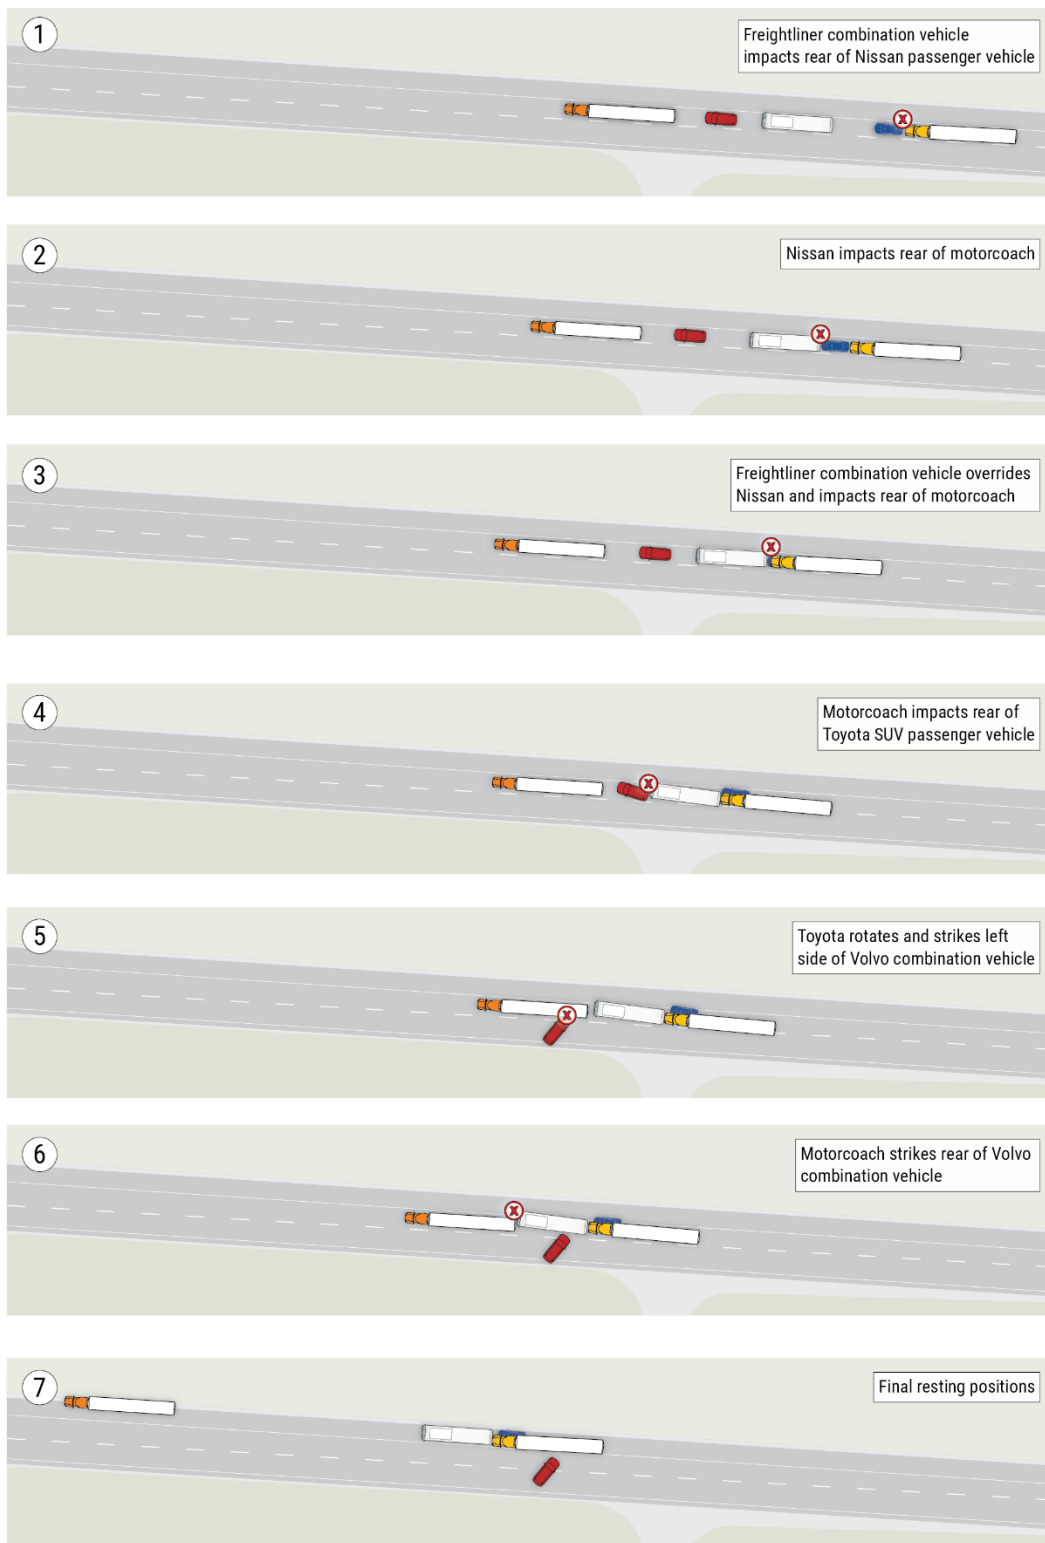
and struck the left side of a 2014 Volvo combination vehicle that was traveling west in the right lane before coming to rest in the left westbound lane. The motorcoach continued traveling forward and struck the rear of the semitrailer of the Volvo combination vehicle. The Toyota and Volvo were each occupied only by their respective drivers. Excluding the Toyota, which remained in the travel lane, the crash-involved vehicles progressed or were moved to the right shoulder.

Figure 3. Sequence of impacts.

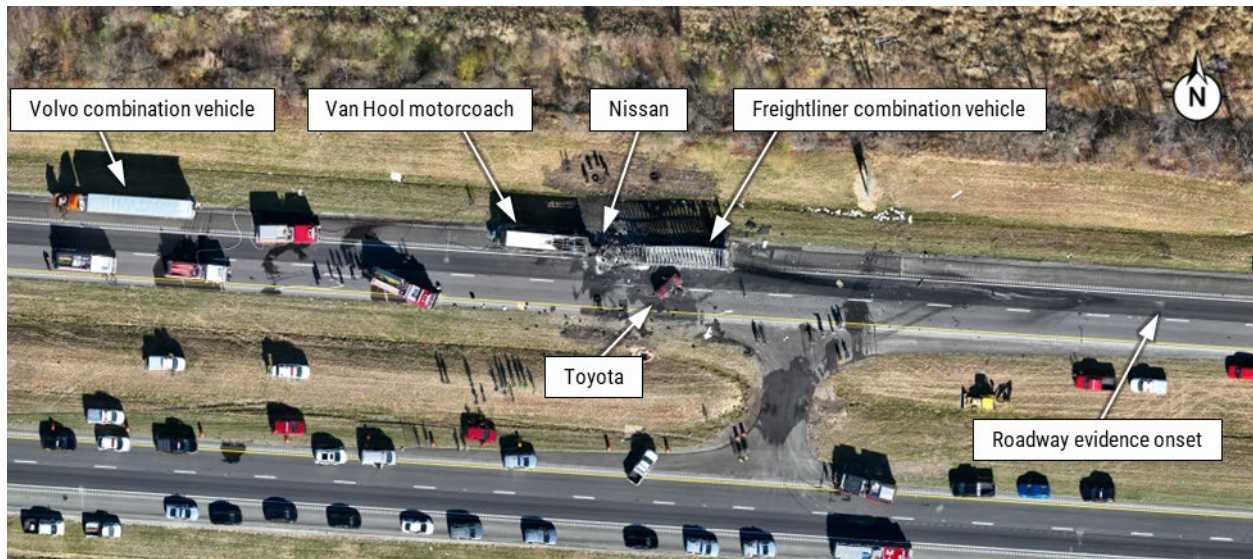
At final rest, the Freightliner combination vehicle was facing west on the right shoulder about 274 feet west of the initial onset of roadway evidence. Scene photographs showed that nearly the entire vehicle occupied the shoulder except for the left wheels of the semitrailer, which were atop the highway edge line. The front of the combination vehicle remained in contact with, and partially intruded into, the rear of the motorcoach. Figure 3 shows the sequence of impacts and figure 4 shows the final rest positions of the vehicles.

Figure 4. Overhead view of crash scene, vehicular positions of rest, and roadway evidence. (Source: Ohio State Highway Patrol; annotated by NTSB)

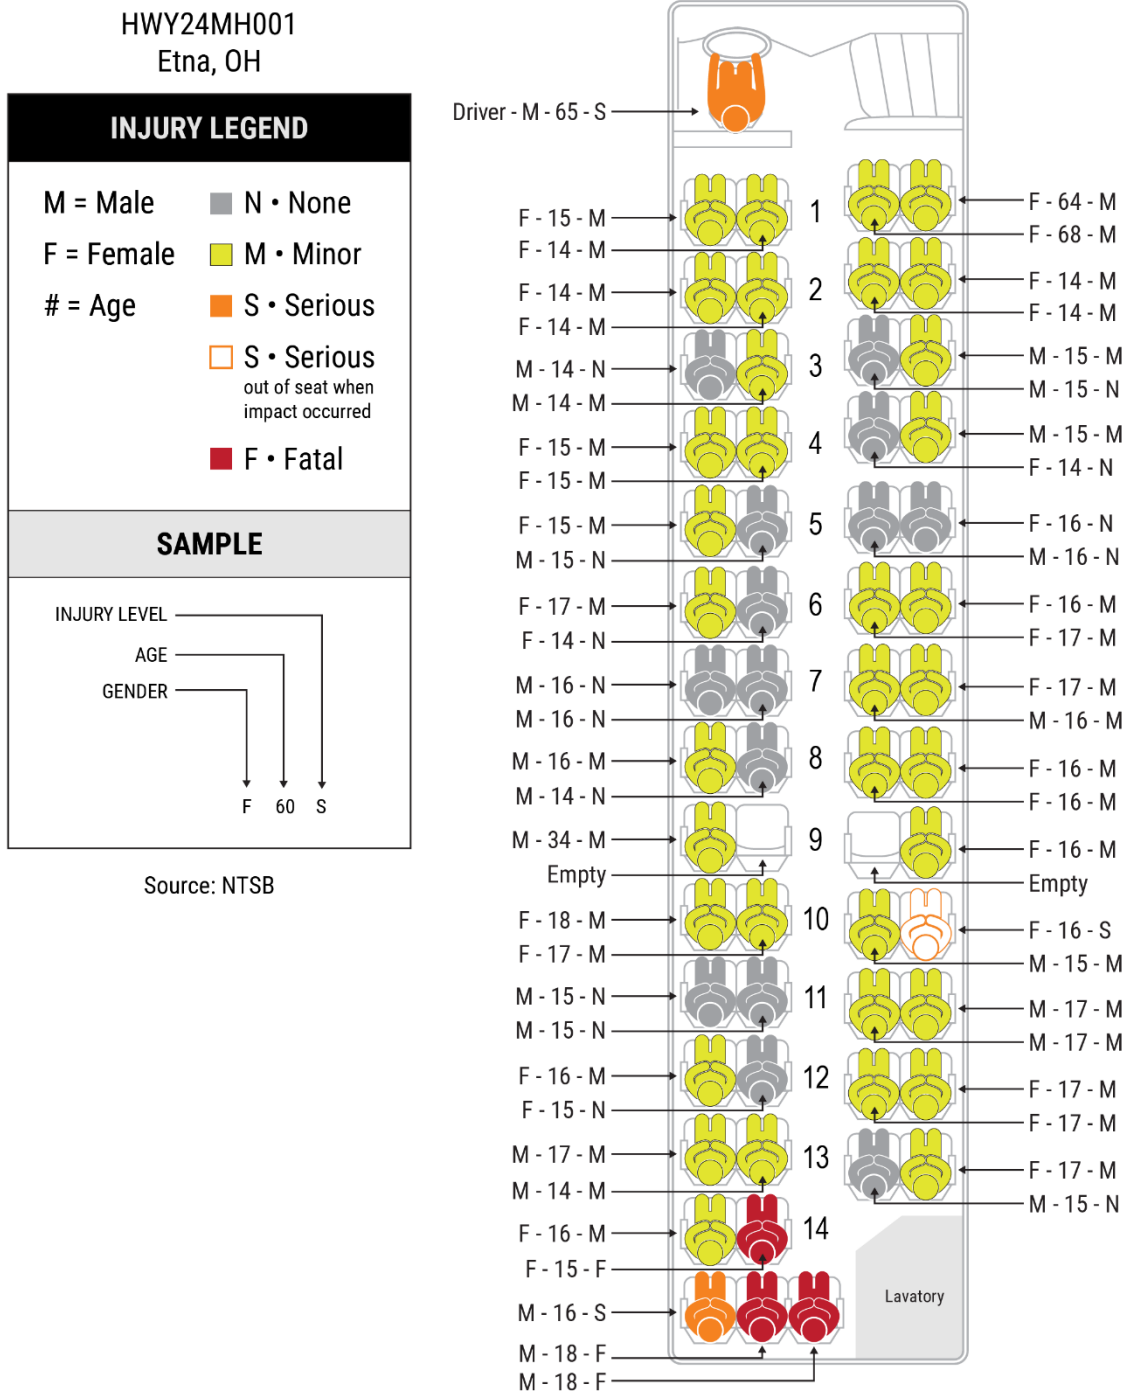
Figure 6. Motorcoach seating chart showing occupant injury severity.

One of the fatally injured motorcoach passengers, who was seated in the middle seat of row 15, sustained blunt force trauma to the torso and head. He was extricated from the motorcoach and given CPR. The other two fatally injured occupants, seated in rows 14 and 15, sustained blunt force trauma injuries to their

A head count of students who had evacuated the motorcoach indicated that two students were missing. According to the OSHP incident commander, an OSHP trooper entered the burning motorcoach through the front door to look for survivors. He went as far back as he could, but the flames prevented him from reaching the back. He deployed his fire extinguisher inside the vehicle but did not see any occupants (either deceased or surviving). Both missing students were extricated once the fire was suppressed, and both were deceased. These students had been seated in rows 14 and 15.

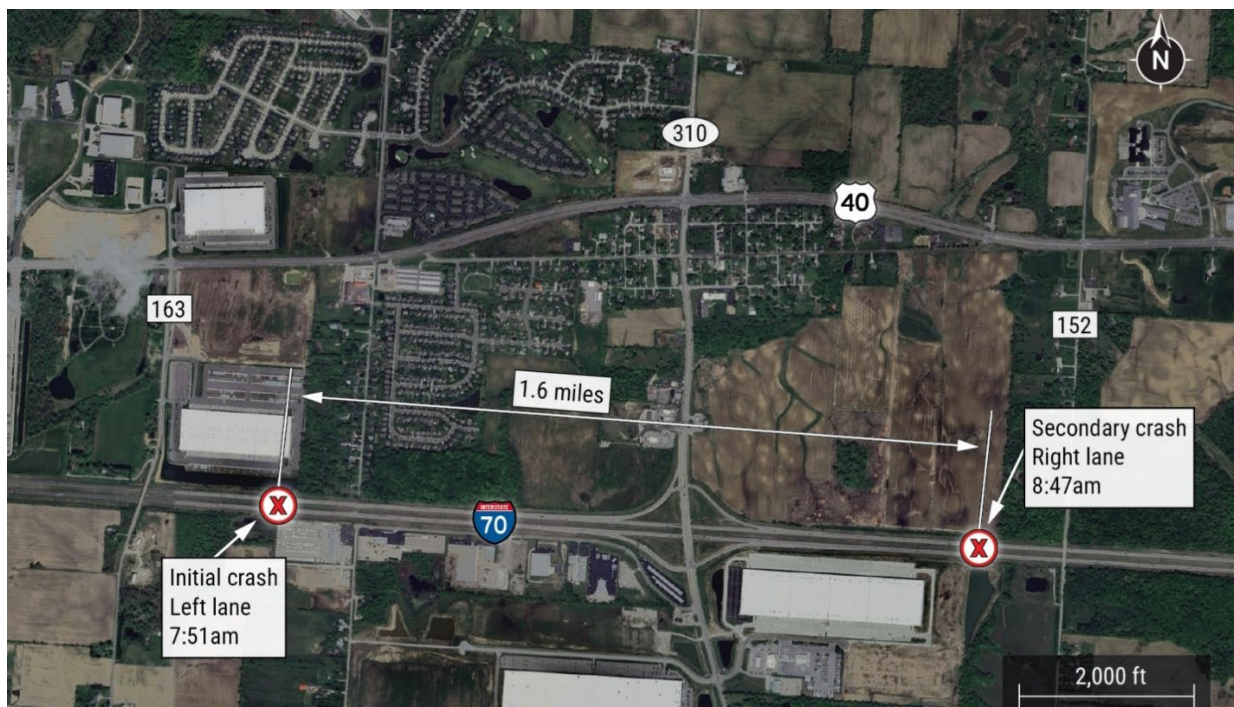
The 8:47 a.m. crash occurred at the end of a traffic queue that had formed due to an earlier crash involving only property damage that took place near milepost 117.2 (see figure 7). The initial crash, which occurred almost an hour earlier at 7:51 a.m., was a rear-end crash that involved four vehicles in the left lane, including one combination vehicle. All vehicles had been moved out of the travel lanes when an OSHP trooper arrived on scene at 8:14 a.m. Figure 8 shows the locations of the vehicles from the initial crash occupying the left shoulder and median. The vehicles were nearly on the solid yellow edge line and inches away from traffic traveling in the left lane of westbound I-70. Because all vehicles had moved out of the travel lanes before the OSHP trooper's arrival, the trooper pulled behind the vehicles in the median immediately after arriving at the scene and neither of the westbound lanes were blocked.

Figure 7. Locations of initial and secondary crashes on westbound I-70. (Source: Google Earth; annotated by NTSB)

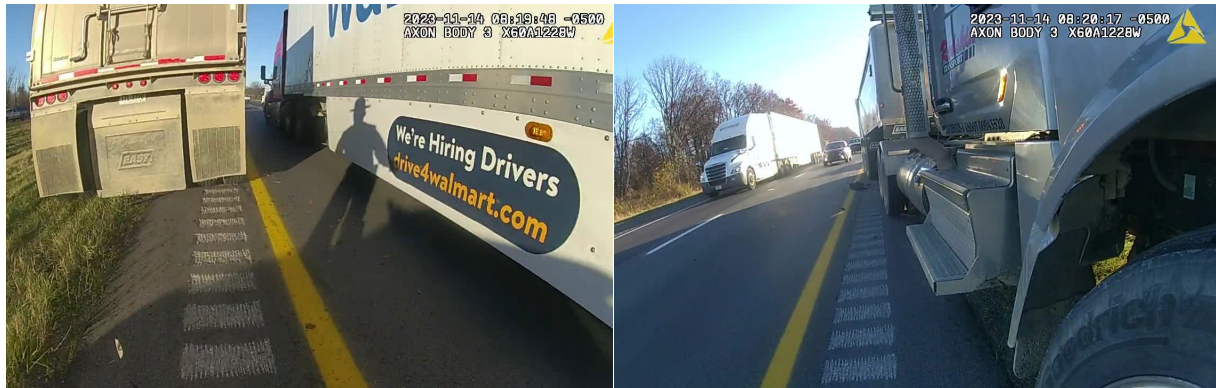
Figure 8. Trooper body camera images showing locations of vehicles from initial crash after they were moved to the median. The right rear of the trailer involved in the initial crash was nearly on the solid yellow edge line and inches away from traffic traveling in the left lane of westbound I-70. (Source: OSHP)

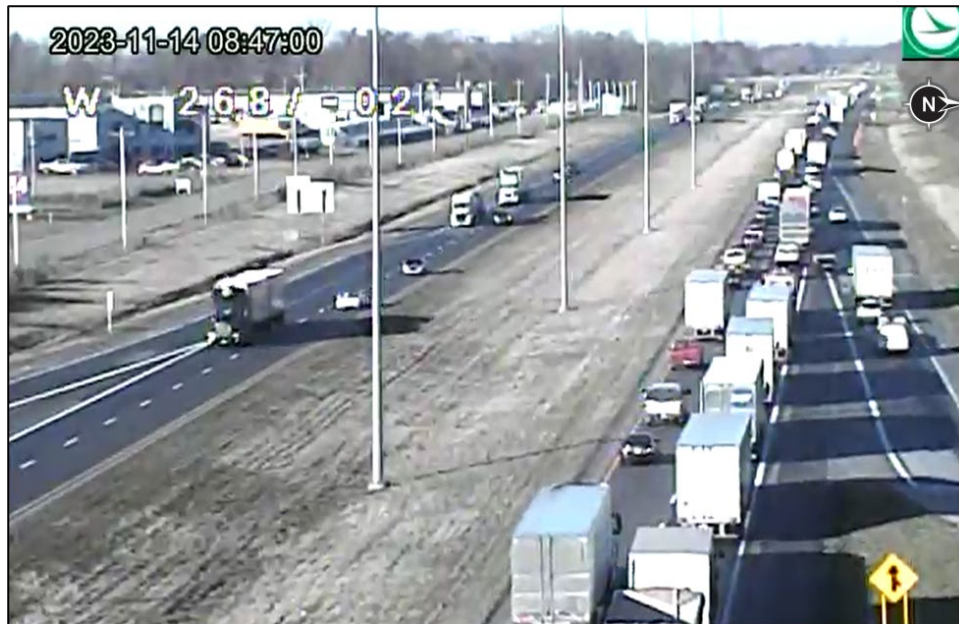
Although the vehicles involved in the initial crash were moved from the travel lanes in less than 30 minutes, a traffic queue formed. ODOT provided the NTSB with camera footage showing I-70 at the State Highway 310 interchange from 7:00 a.m. until 10:00 a.m. on November 14, 2023. (Figure 7 shows a map indicating the I-70-State Highway 310 interchange.) Figure 9 shows a still image of the camera footage at 8:47 a.m., looking west toward the location of the initial crash, which occurred about 1 mile west of State Highway 310. The 8:47 a.m. crash occurred about 0.6 miles east of State Highway 310.

Figure 9. Image from ODOT traffic camera footage, looking west and showing the traffic queue on I-70 at the State Highway 310 interchange at 8:47 a.m. on November 14, 2023. (Source: ODOT)
