HIR-26/04

Sport Utility Vehicle Roadway Departure, Overturn, and Submersion

Belle Glade, Florida
August 5, 2024

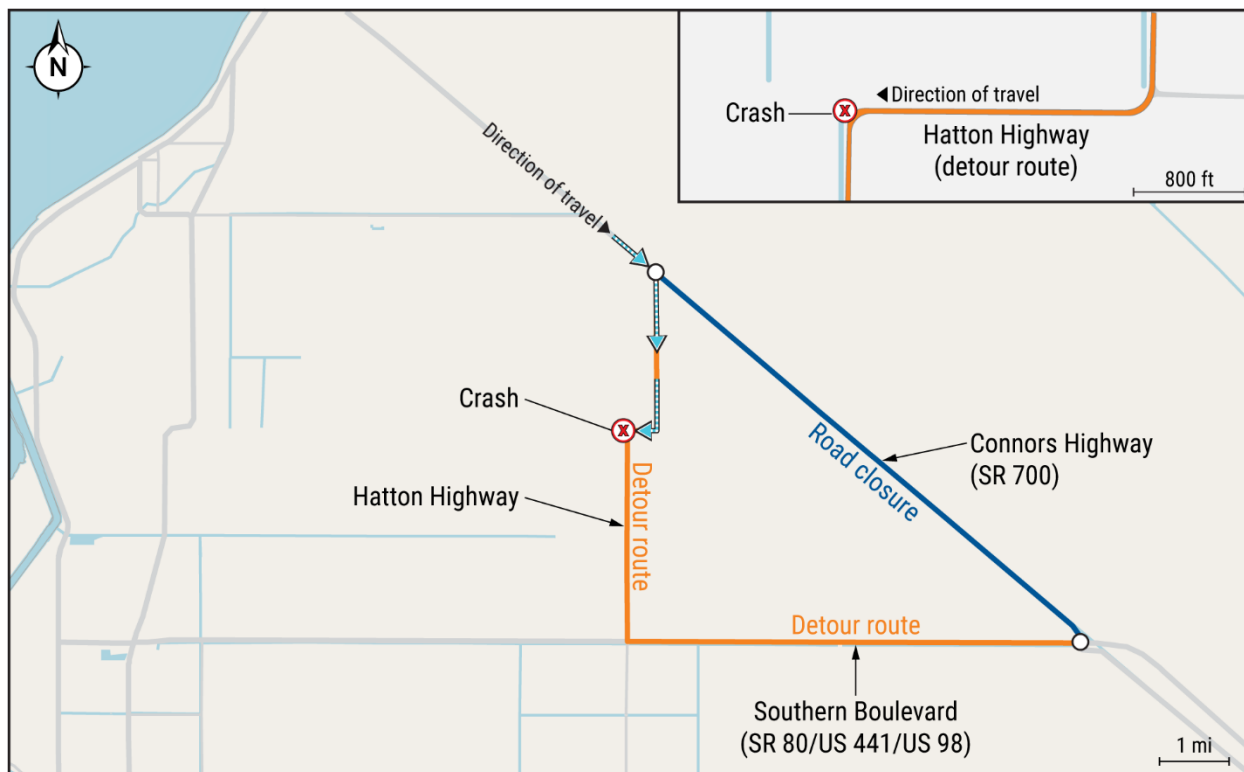
On the day of the crash, the SUV driver and nine passengers, five of whom were children aged 1 to 8, were traveling to Palm Beach International Airport to return their rental vehicle, a seven-seat 2023 Ford Explorer, before their flight. The driver's original route to the airport, southbound Connors Highway (State Route 700), was partially closed for road work, so the driver was detoured south on Hatton Highway, the first leg of the detour route. The detour route added about 4 miles to the driver's original route (see figure 2).

Figure 2. Map showing the detour route, the SUV's route, and location of the crash.
