HIR-26-06

# Multivehicle Collision with Combination Vehicle Parked on Shoulder, I-485

Charlotte, North Carolina  
July 26, 2025

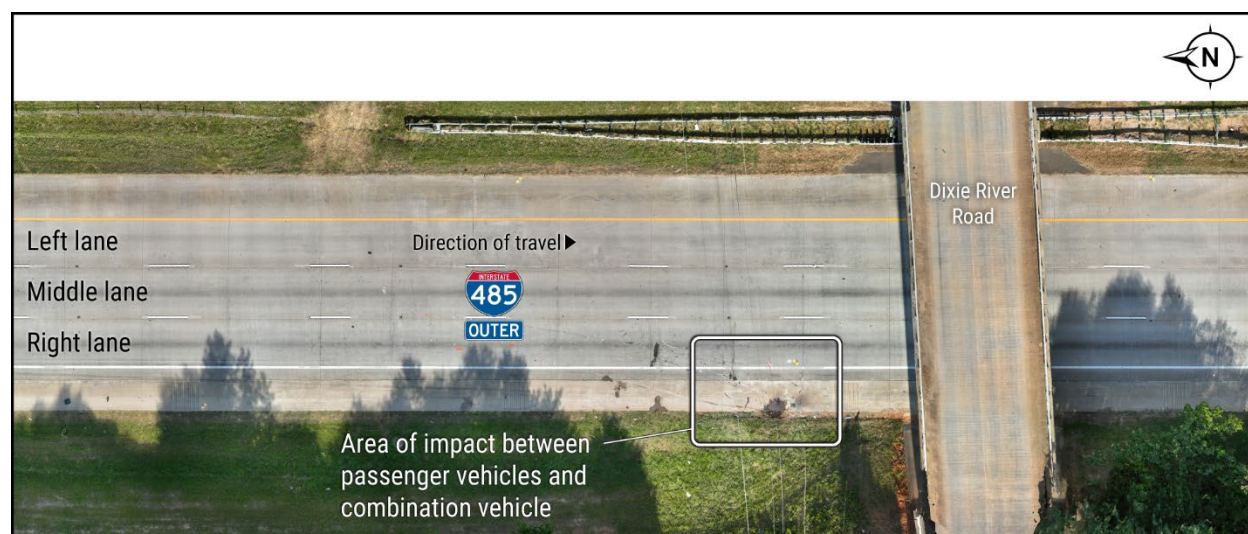
**Figure 2.** Aerial image of the crash location. (Source: North Carolina State Highway Patrol; compiled and annotated by NTSB)

| Location | Interstate 485 Outer Loop, about 134 feet north of the Dixie River Road overpass, Charlotte, Mecklenburg County, North Carolina (see figure 2) |
