Highway Investigation Report HIR-26-08

# Rear-End Collision Between Combination Vehicle and Sport Utility Vehicle on Interstate 80 — Swanton Township Toll Plaza

Swanton, Ohio  
August 15, 2024

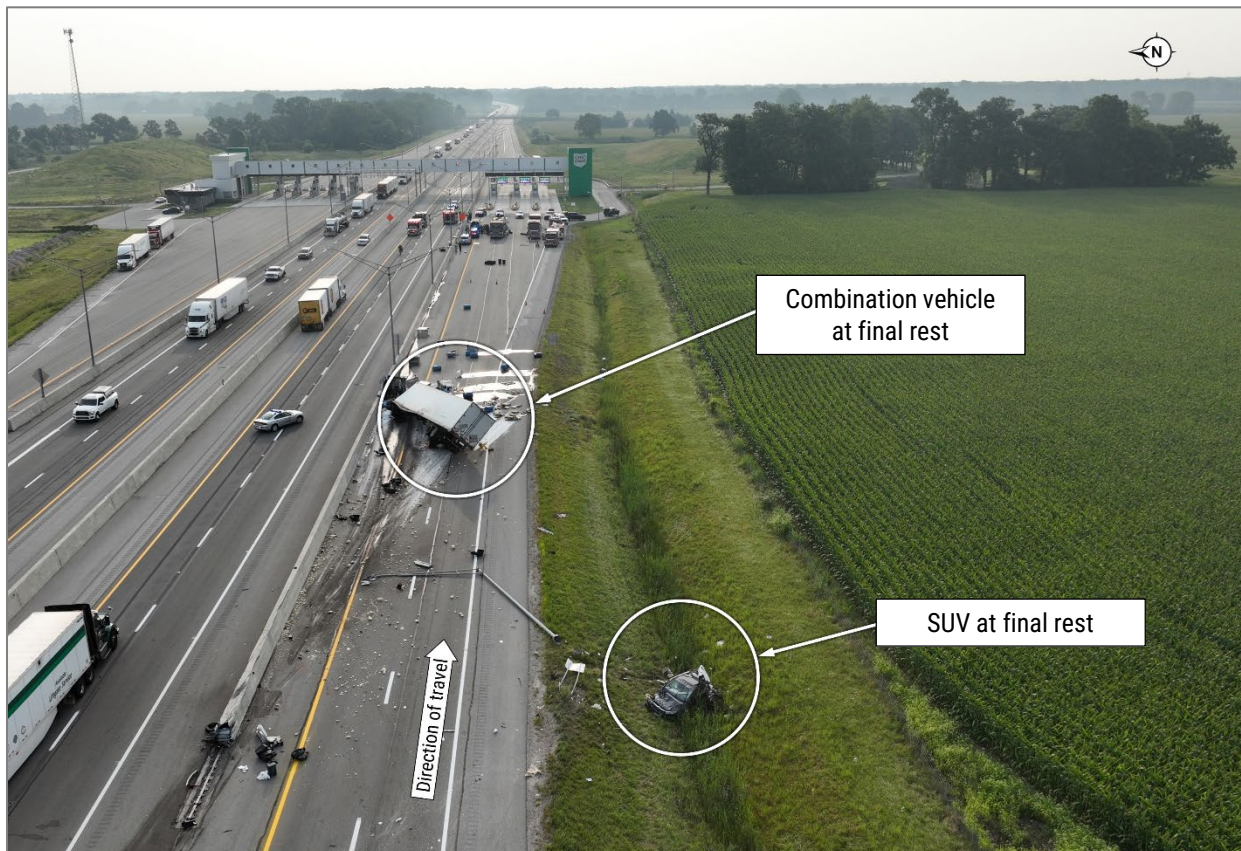
The area of impact, as determined by roadway evidence, was about 1,238 feet west of the toll plaza adjacent to the gore area and about 250 feet past the beginning of the gore area between the high-speed and low-speed toll lanes.<sup>4</sup> After impact, the SUV rotated clockwise and overturned; continued through the gore area, the two conventional toll lanes, and the right shoulder; and came to rest upright in a culvert adjacent to the right eastbound shoulder (figure 2). The combination vehicle also veered right and struck the crash attenuator and concrete barrier wall at the end of the gore area separating the high-speed toll lanes and low-speed toll booth access lanes. The truck-tractor then overturned, causing the release of its cargo.

**Figure 2.** Final rest positions of the combination vehicle and SUV. (Source: Ohio State Highway Patrol; annotations by NTSB)

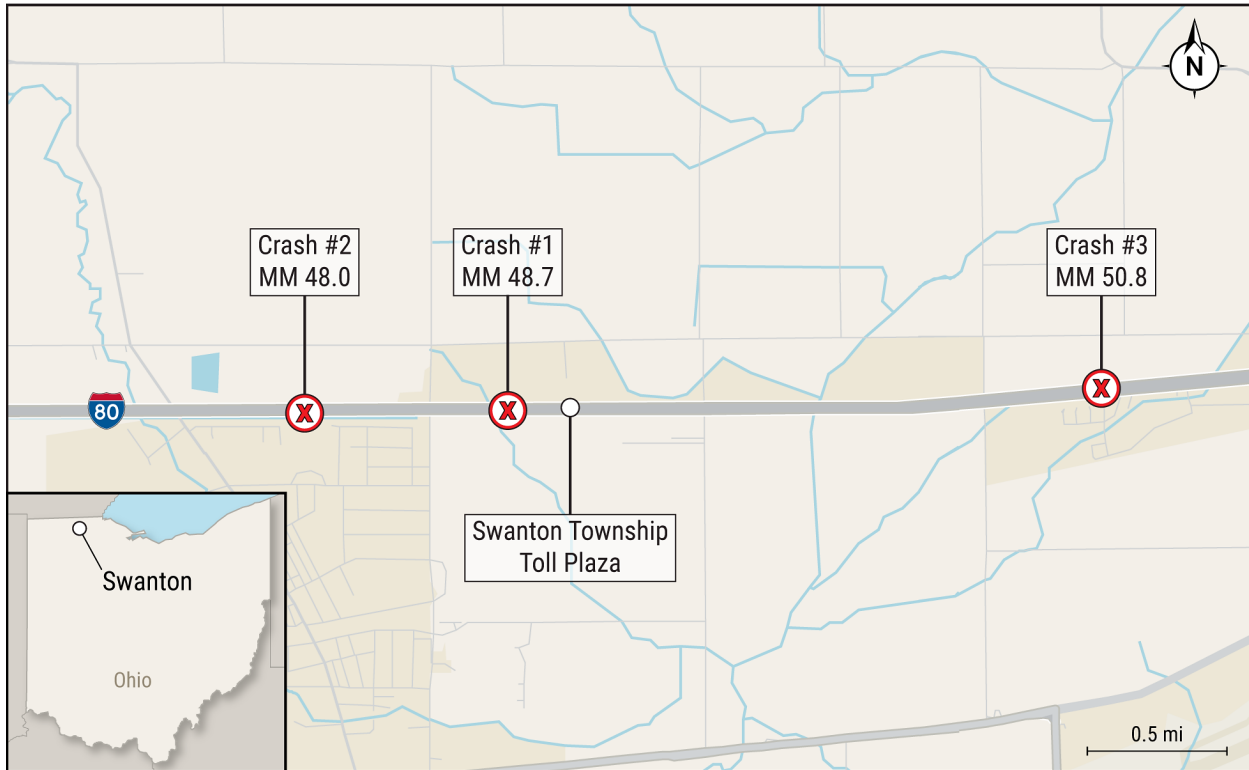
Following this collision, the I-80 east- and westbound lanes were closed due to the hazardous materials spill and to accommodate patient transport via helicopter and ambulance. A traffic queue began to form in the eastbound lanes of I-80 leading up to the crash site. At 5:54 a.m., a second crash involving five commercial motor vehicles and one passenger car occurred in the eastbound traffic queue near mile post 48, about a mile west of the initial crash. A third crash in the westbound lanes of I-80 occurred at 6:24 a.m. about 2 miles east of the toll plaza. Figure 3 shows the locations of all three crashes in relation to the toll plaza.

**Figure 3.** Diagram of the three crash locations in relation to the Swanton Township Toll Plaza.

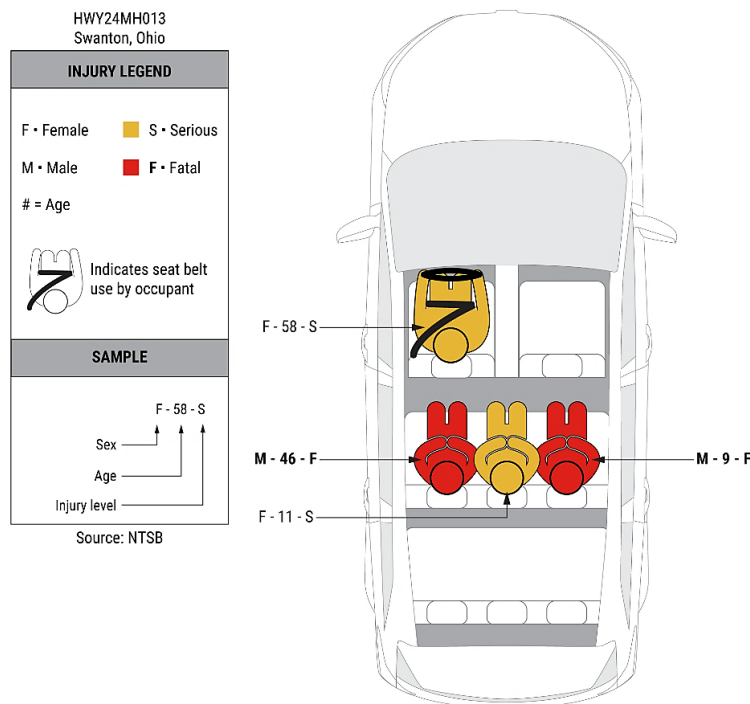
According to the recovered electronic data from the SUV, the driver was lap/shoulder-belted; she sustained serious injuries and was transported from the scene via ambulance. The driver's seat belt pretensioners and airbags did not deploy during the crash, which is consistent with their design not to activate in rear-end collisions.<sup>8</sup> The SUV driver told investigators that no passenger was seated in the front passenger seat leading up to the crash; all three passengers were seated in the second row of the SUV (figure 4). All of the seating positions in the SUV were equipped with lap/shoulder belts. The three rear-seated passengers were ejected as a result of the crash; none of them was belted. The left- and right-side rear-seated passengers died on scene, and the center rear-seated passenger sustained serious injuries and was transported by helicopter from the scene.

**Figure 4.** Diagram of the SUV occupants' seating positions, seat belt use, and injury severity.

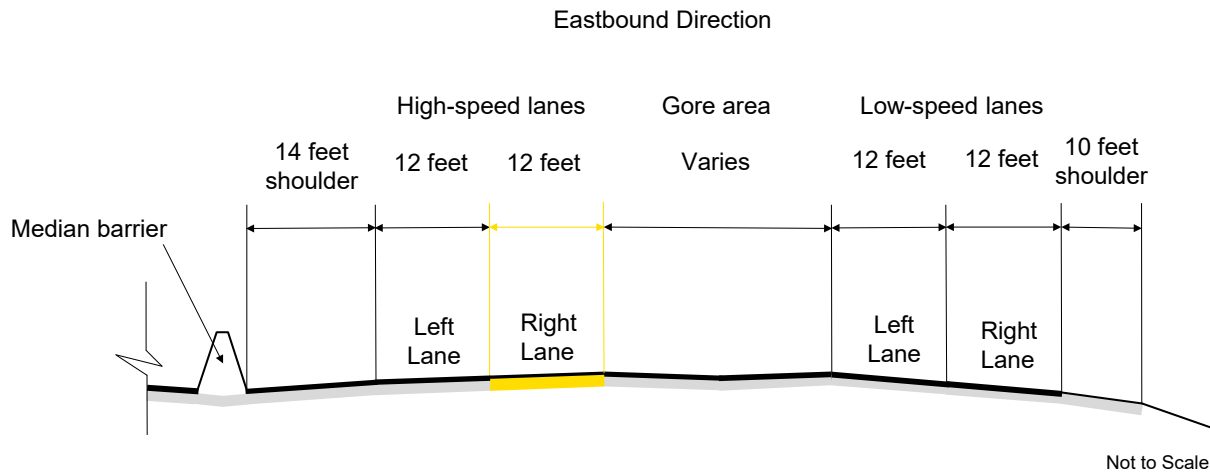
In the immediate vicinity of the toll plaza, the I-80 eastbound direction consisted of two high-speed lanes and two low-speed lanes separated by a painted gore area about 950 feet long. The gore area terminated into a 23-foot-long crash attenuator attached to a concrete barrier separating the high- and low-speed lanes and that extended 960 feet to the toll plaza (the crash attenuator was dislocated in the crash and therefore not shown in figure 5). Each of the high-speed and low-speed lanes was about 12 feet wide. A paved shoulder was adjacent to the low-speed lanes on the right side and was about 10 feet wide. Figure 6 illustrates the typical cross-section in the eastbound direction near the toll plaza.

**Figure 6.** Cross-section of the lanes approaching the Swanton Toll Plaza.

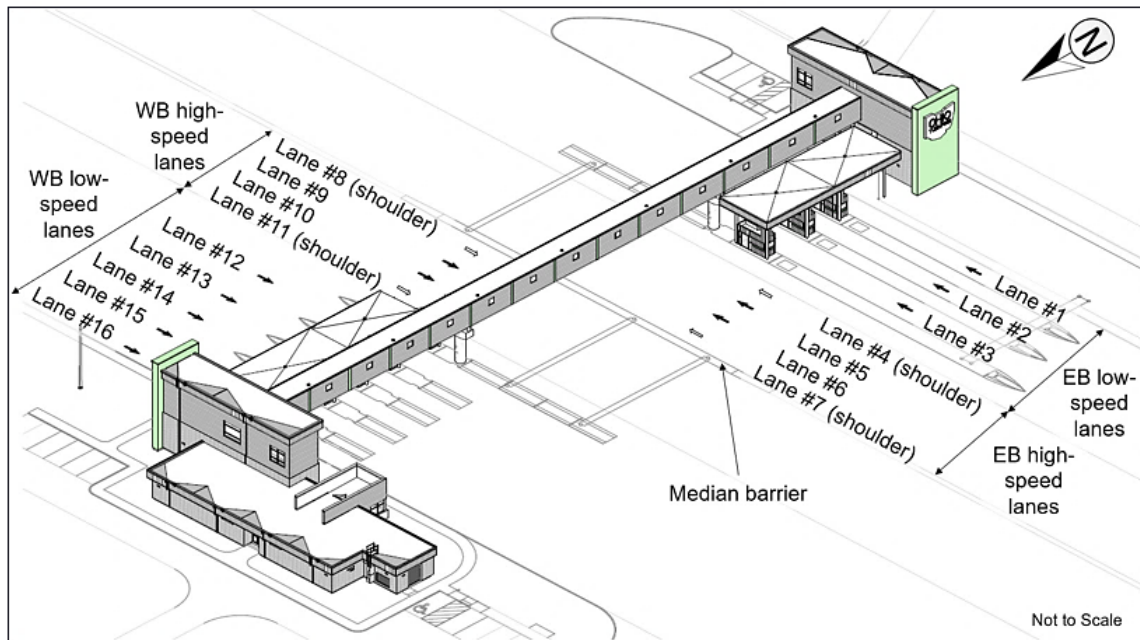
Figure 7 illustrates the Swanton Toll Plaza and the lane designations in the east and westbound directions of travel. The eastbound toll booth lanes are configured such that the two low-speed toll booth lanes expand to three low-speed toll lanes numbered 1-3. Toll lanes 5 and 6 are located to the left adjacent to the median

barrier in the high-speed lanes. The Ohio Turnpike and Infrastructure Commission (OTIC)—which handles all matters pertaining to the toll road, including maintenance, construction, toll plaza management, and traffic incident management—considers the shoulders open-road or high-speed tolling lanes.<sup>14</sup> OTIC has toll equipment above the shoulders identical to the travel lanes, and the shoulders are designated as lanes 4 and 7 in the eastbound direction. The westbound toll booth lanes (8–16) are configured in a similar manner with the numbering system ordered sequentially from south to north, and the shoulders numbered as travel lanes.

**Figure 7.** Swanton Toll Plaza and the lane designation in the eastbound and westbound directions of travel. (Source: Ohio Turnpike and Infrastructure Commission, revised)

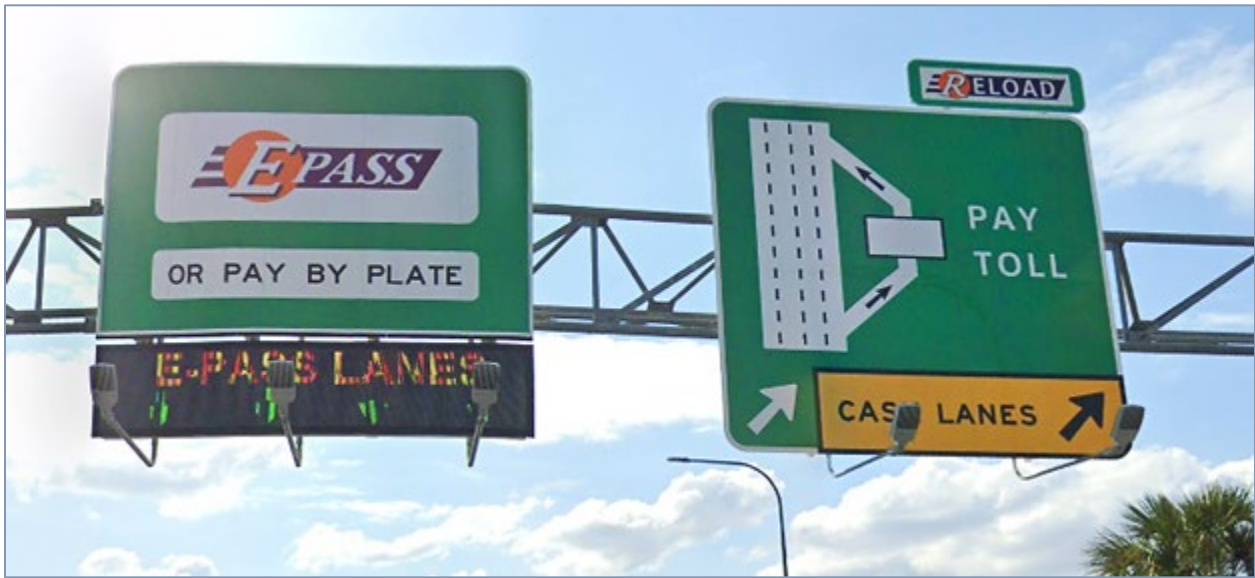
**Figure 12.** Overhead signage on the Central Florida Expressway that includes pay-by-plate designation for the high-speed lanes. (Source: Google Maps)

This lack of information about how to pay a missing toll may further encourage drivers to make last-minute lane changes to enter the low-speed lanes. OTIC could encourage use of the high-speed lanes by adding signage before the toll plaza, including modifying overhead signage to state that the tolls can be paid online and/or by mail. Informing drivers that they are not explicitly required to use the low-speed lanes might help reduce the number of last-minute lane changes (along with significant speed reduction in the high-speed lanes) and potentially reduce the overall number of conflicts and crashes near toll plazas. Other locations that use hybrid designs have adopted this type of signage, informing motorists of the payment options before reaching the toll plaza and using license plate readers to facilitate payment collection. Figure 12 shows overhead signage on the Central Florida Expressway that includes a “pay-by-plate” option in addition to the logo for the electronic tolling option. Based on documentation provided by OTIC and in discussions with the NTSB, no additional equipment is required to be installed at the Swanton Toll Plaza to accomplish this; open-road or high-speed tolling technology and equipment was installed at the turnpike plazas along the Ohio Turnpike in all lanes, including Swanton, during the recent upgrade completed in 2024.<sup>52</sup>

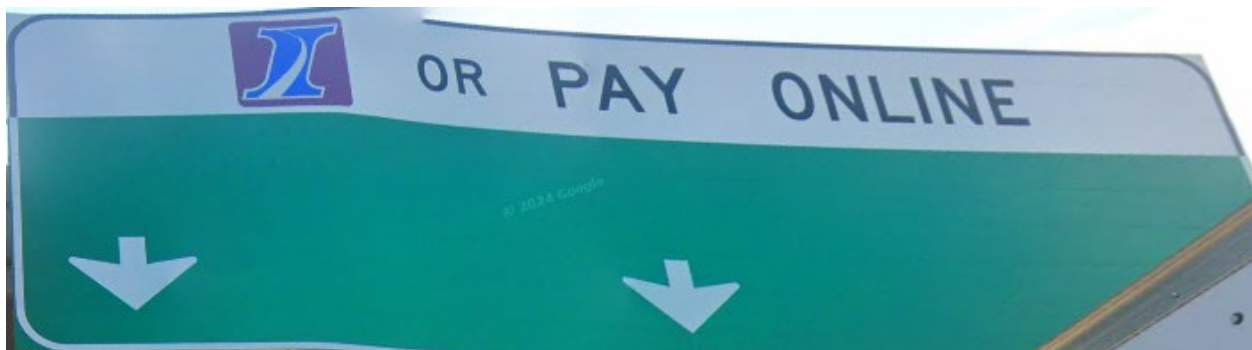
This more informative signage would also be consistent with other signage along the turnpike corridor. Figure 13 shows an overhead sign that was present when the SUV approached the Hampshire-Marengo Toll Plaza in Hampshire, Illinois, with the “pay online” option clearly indicated in addition to the transponder-based toll option (for more information about the Hampshire-Marengo Toll Plaza, see section 2.4.2.2). Figure 14 shows a similar image from the Pennsylvania Turnpike, displaying a “toll-by-plate” payment option.

**Figure 13.** Signage approaching the Hampshire-Marengo toll plaza in Illinois, traversed by the SUV driver. (Source: Google Maps)

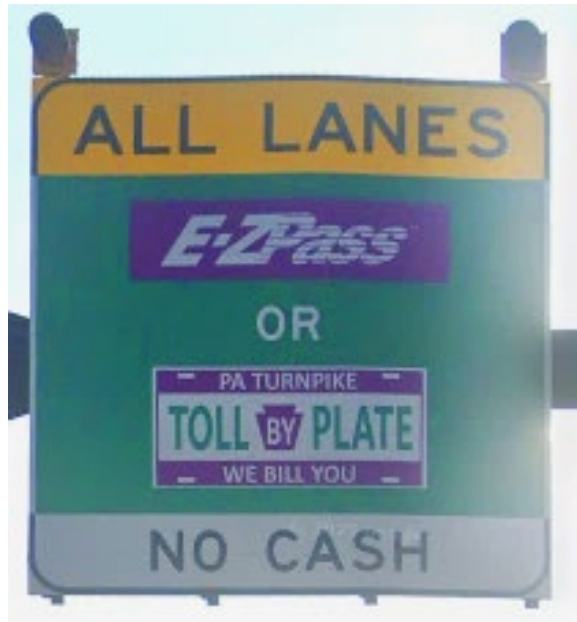
**Figure 14.** Signage on the Pennsylvania Turnpike, displaying a pay-by-plate option. (Source: Google Maps)
