National Transportation Safety Board Washington, D.C. 20594

Hazardous Materials Accident Brief

Accident No: DCA02MZ001
Location: South Charleston, West Virginia
Date of Accident: January 5, 2002
Time: 11:36 a.m. eastern standard time
Carrier: Dana Transport, Inc.
Vehicle: MC-307 Cargo Tank
Injured: No injuries
Evacuated: None
Property Damage: In excess of \$18,000
Materials Involved: 5,152 gallons of polypropylene glycol
Type of Accident: Catastrophic structural failure of cargo tank

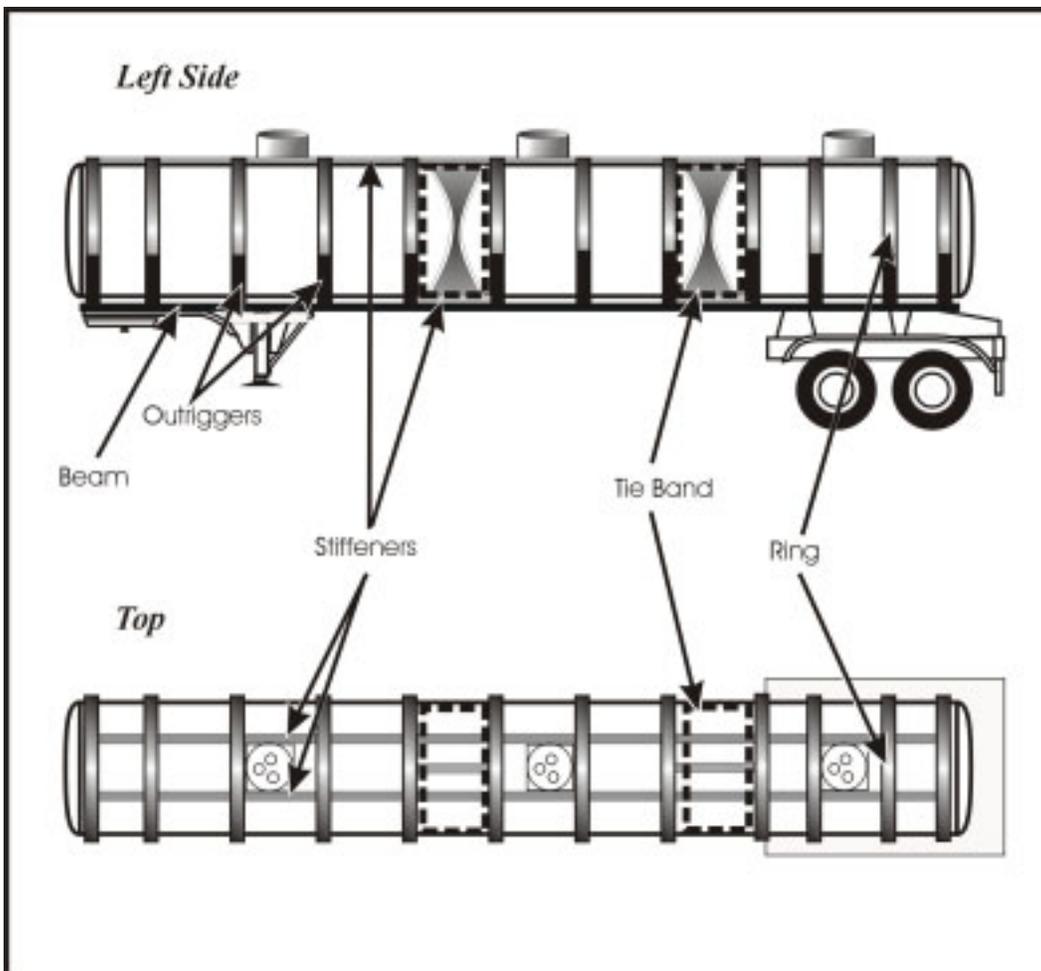
Figure 2. Side and top view of cargo tank (without exterior jacket).

The tanks were Department of Transportation (DOT) specification MC-307 cargo tanks and were made of T316 stainless steel. The shell material was specified as 12 gauge (nominally 0.105 inches thick), and the head material was specified as 10 gauge (nominally 0.140 inches thick). Each tank had circumferential stainless steel stiffeners (rings) that had been welded around it to provide structural support. (See figures 2 and 3.)

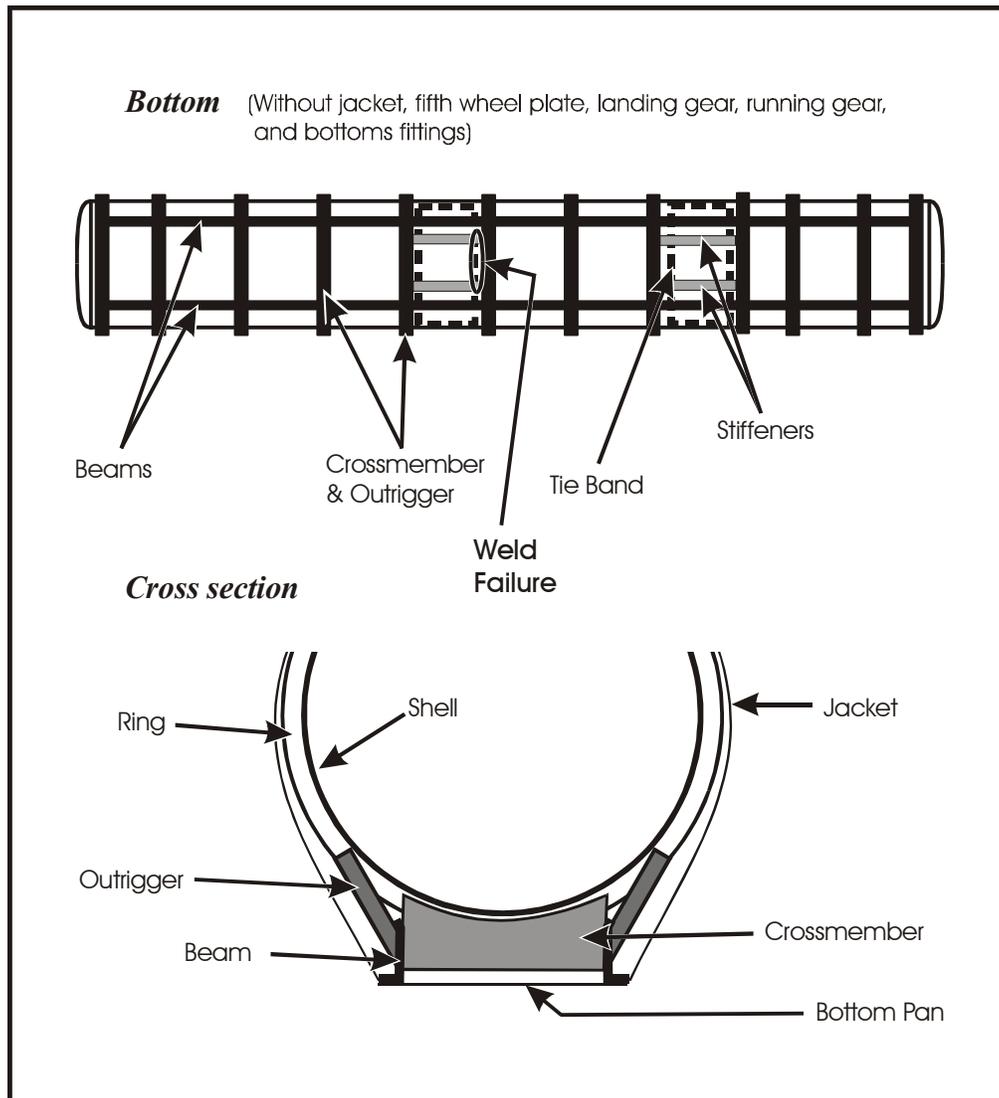
Figure 3. Bottom view and cross section of cargo tank.

The three tanks had been made into a unified structure by welding 2-foot-wide stainless steel bands, called “tie bands,” over the facing heads of adjacent tanks. (The tie bands were made of the same material as the tank shell: 12-gauge stainless steel.) According to the design specifications, the welds were to have complete penetration and to be fully circumferential. Longitudinal stainless steel stiffeners (stiffeners) had been welded along both sides of the top and bottom of the cargo tank to provide structural support.
