# National Transportation Safety Board

## Hazardous Materials Accident Brief

Accident No.:	DCA04MZ001
Transportation Mode	Air
Location:	Memphis, Tennessee
Date:	August 7, 2004
Time:	3:51 a.m. central daylight time
Carrier:	Federal Express Corporation
Shipper	AC Propulsion, Inc.
Vehicle:	Boeing MD-11
Injuries:	None
Property Damage:	About \$20,000
Hazardous Material:	Lithium-ion batteries
Type of Accident:	Cargo fire

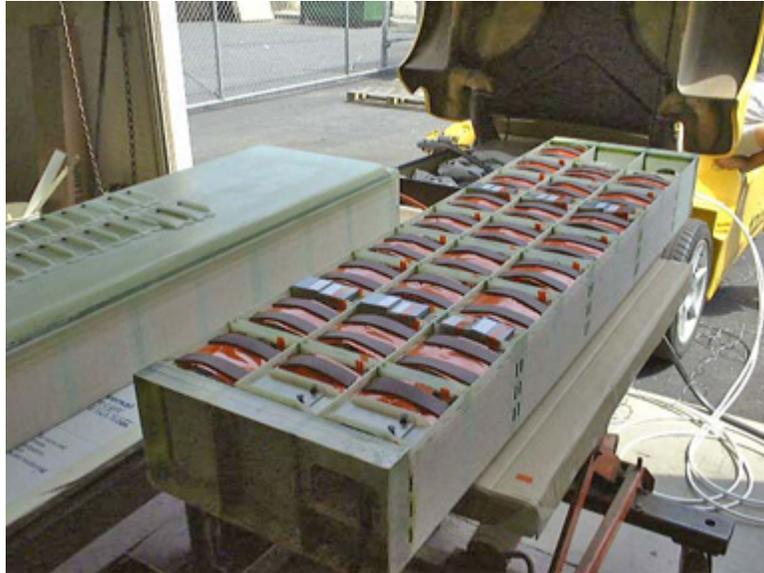
AC Propulsion had stated in its application for the DOT approval that the prototype battery pack would measure approximately 62 inches by 17 inches by 9 inches and weigh about 350 pounds. Each battery pack was to consist of 25 modules that had been individually secured within an insulating fiberglass case. To prevent an inadvertent short circuit of the battery, the fuses were to be removed from the external electrical connections built into the fiberglass case. The battery pack was to be enclosed by a wooden box and bolted to the base of the box; the gross weight of the package was to be 530 pounds. (See figures 1 and 2.)

**Figure 1.** Approved battery pack in fiberglass case. The battery pack is without its cover and shows the modules secured in the fiberglass case.

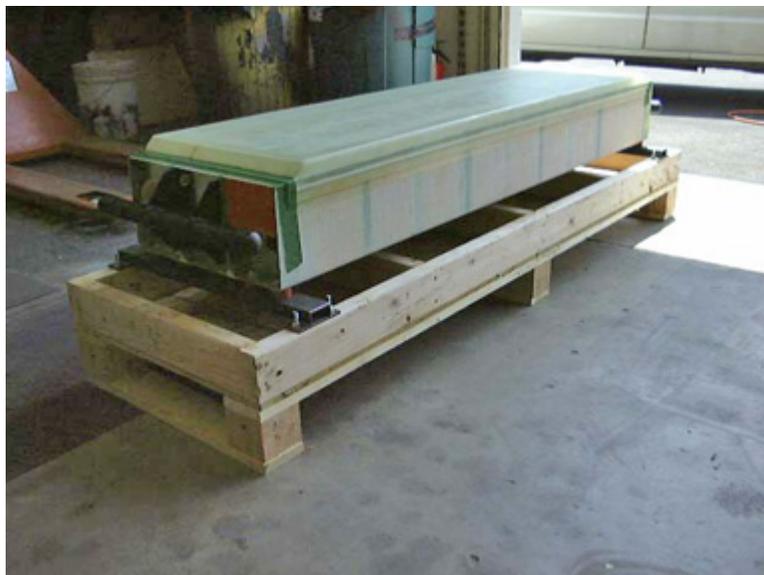
**Figure 2.** Approved battery pack in covered fiberglass case that is bolted to wooden base. (A wooden box that covers the fiberglass case is then secured to the wooden base.)

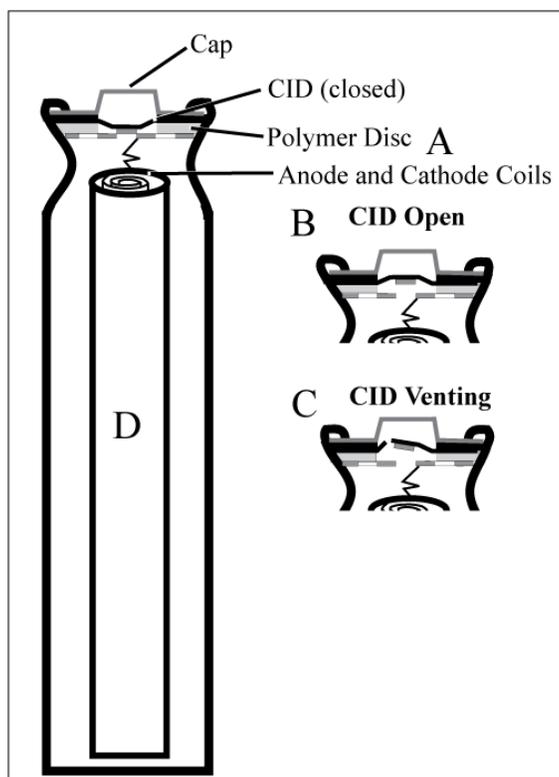
The lithium-ion cells involved in the incident had been constructed with four safety features designed to prevent short circuits and violent ruptures. (See figure 6.) The features were meant to satisfy Federal regulations (49 *Code of Federal Regulations* [CFR] 173.185[e]).

2. A current interrupter device (CID) was between the polymer disc and the cap. (The CID has an inward-facing dimple that electrically connects the cathode foil to the top cap. Excess gas generated during an uncontrolled reaction within the cell causes the dimple to pop outward, breaking the connection between the cathode foil and the cap and stopping the reaction.)

3. The CID was responsive to excessive pressure. (If the pressure within the cell is great enough, the CID fractures, releasing the gas into vent holes in the top cap and preventing a burst of the cell.)

**Figure 6.** Lithium-ion cell with safety devices. (A: The disc is a temperature-sensitive polymer that resists electron flow as the temperature increases. B: The CID opens with internal pressure breaking the cell circuit. C: Increased pressure causes the CID to vent to the cap. D: A polymer sheet between the anodic and cathodic foils melts at a given temperature, stopping the electron flow.)
