Hazardous Materials Accident Report

**Hazardous Materials Release
From Railroad Tank Car With
Subsequent Fire at
Riverview, Michigan
July 14, 2001**

**NTSB/HZM-02/01
PB2002-917002
Notation 7400A
Adopted June 26, 2002**

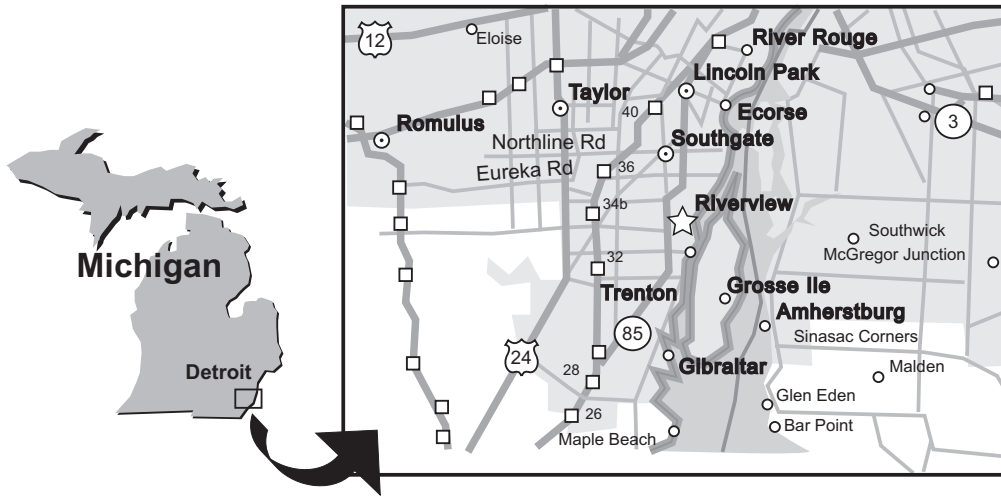
Figure 1. Accident site.

From 2:00 until 3:00 a.m. on July 14, 2001, employees at the ATOFINA plant in Riverview, Michigan, (see figure 1) removed three empty¹ tank cars from the Process 46² loading area and replaced them with three full tank cars. Two of the loaded tank cars were filled with chlorine, a poisonous gas, and one was filled with methyl mercaptan, a poisonous and flammable gas. In the Process 46 area, the tank cars were to be used to feed the chlorine and methyl mercaptan into the production process for the production of several other materials. (See figure 2.)

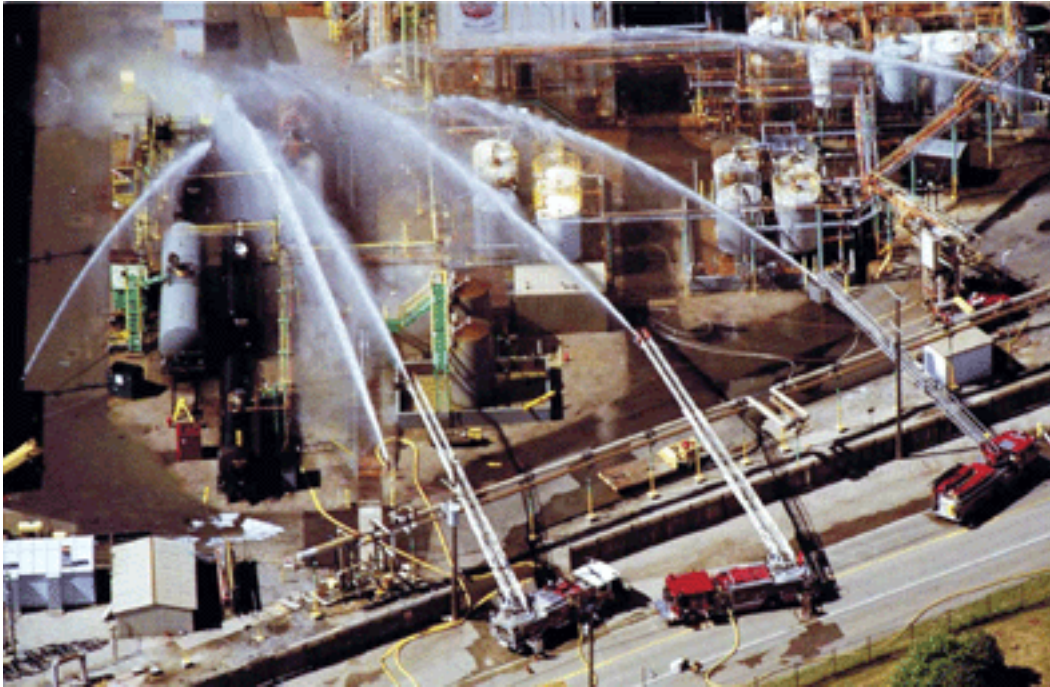
Figure 3. Overview of accident site and emergency response.

resulted in a fireball that extended an estimated 200 feet into the air. When the fireball occurred, the Riverview fire chief requested mutual aid from the surrounding communities. Riverview Fire Department responders began applying water to the tank cars involved in the fire and to the adjacent tank cars to keep them cool. (See figure 3.) Units from the Wyandotte, Trenton, and Brownstown Fire Departments, and the Downriver Mutual Aid HAZMAT Team⁶ responded.
