Marine Accident Brief

Collision Between Bulk Carriers *Mary Ann Hudson* and *Star Grip*

Accident no.	DCA-12-LM-019
Vessel names	Bulk carriers <i>Mary Ann Hudson</i> and <i>Star Grip</i>
Accident type	Collision
Location	Houston Ship Channel, Texas (City Dock 23)
Date	June 6, 2012
Time	0530 central daylight time (coordinated universal time – 5 hours)
Injuries	None
Damage	> \$500,000
Environmental damage	None
Weather	Clear; unrestricted visibility; calm winds; air temperature 82°F
Waterway information	The Houston Ship Channel extends from the city of Houston, Texas, to Galveston Harbor at the Gulf of Mexico, and is a busy shipping lane.

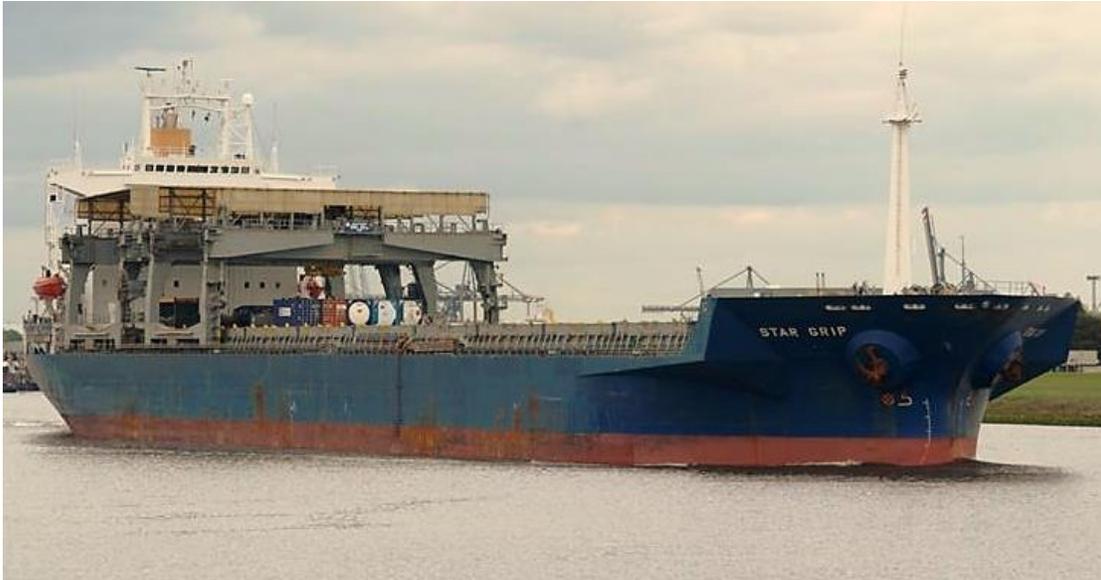
The *Star Grip* under way. Visible immediately forward of the superstructure at the stern of the ship are two gray-colored gantry cranes. In this photo, the cranes' cantilever arms are folded inward toward the center of the ship. (Photo by Frank Katzer, available at www.marinetraffic.com)

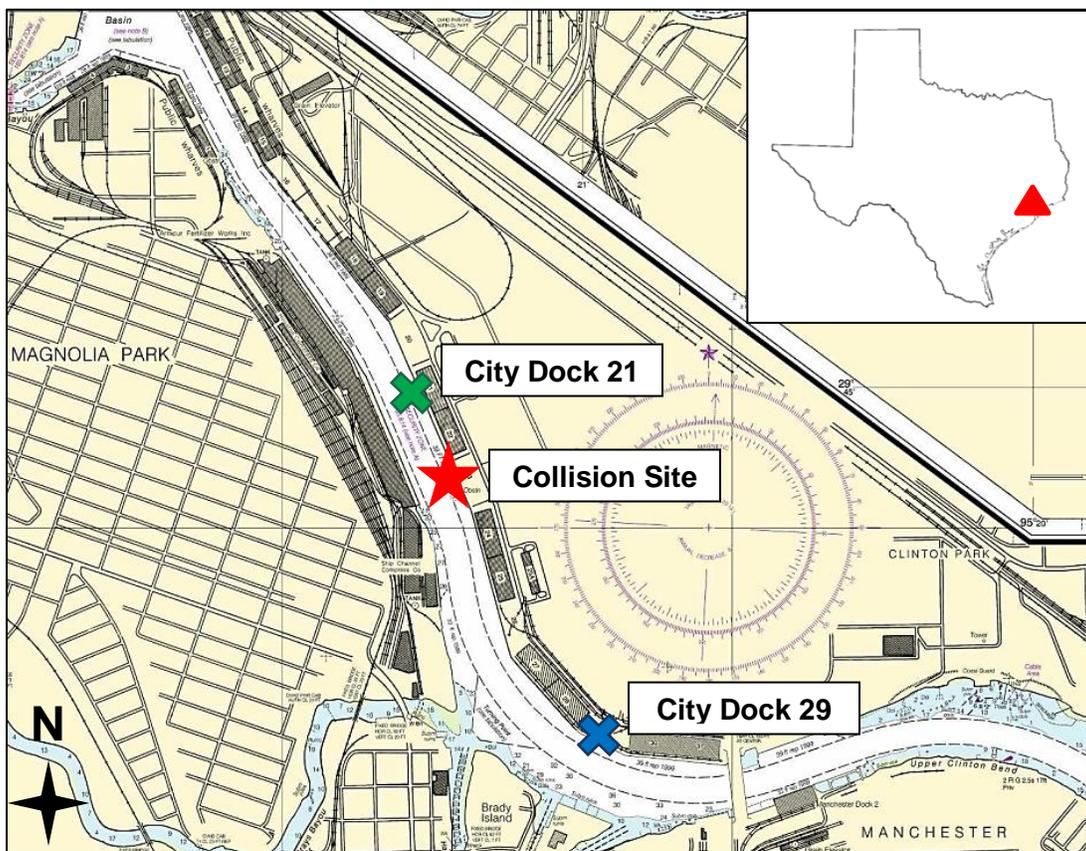
Extract of NOAA chart 11325, showing the section of the Houston Ship Channel where the collision occurred. The *Mary Ann Hudson* departed from City Dock 21, marked by the green X. The approximate collision location is marked by the red star. When the accident occurred, the *Mary Ann Hudson* was being moved to City Dock 29, marked by the blue X.

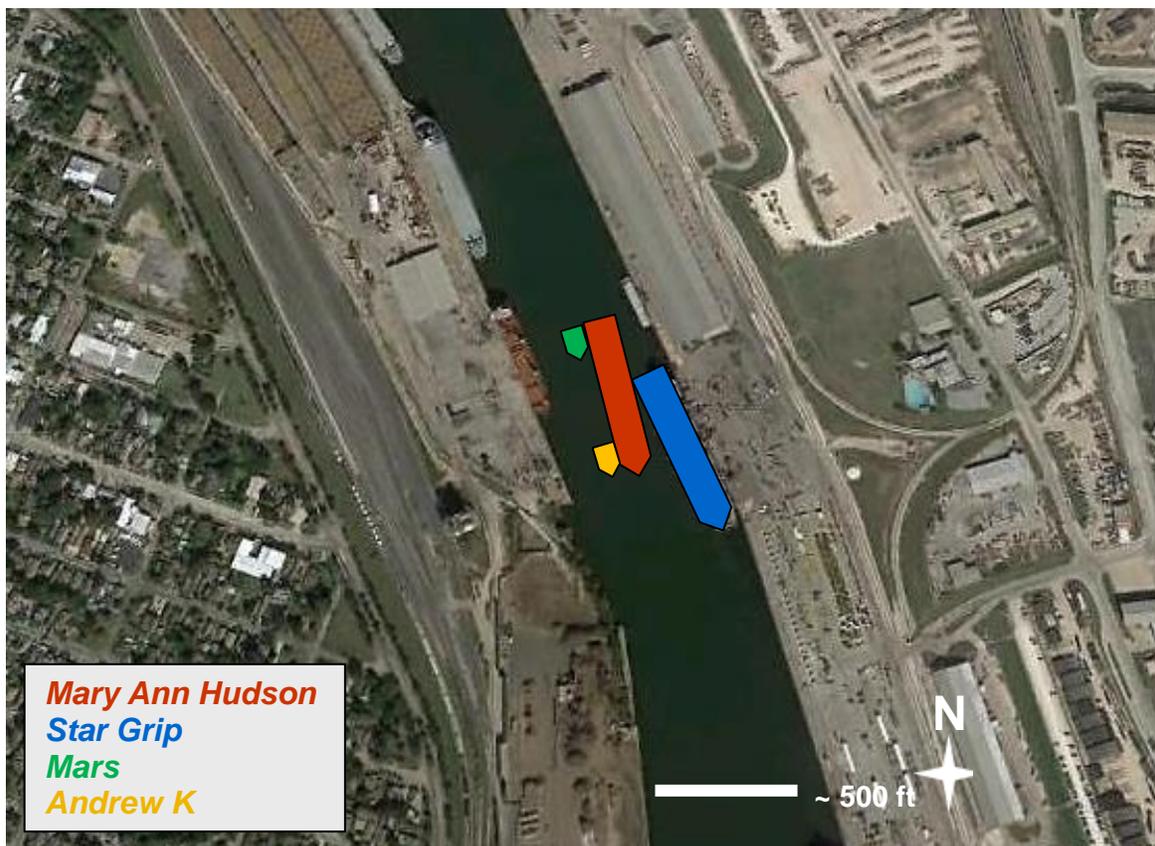
Aerial image of the waterway where the two vessels collided. Icons representing the vessels are overlaid in the image. (Background by Google Earth)
