# National Transportation Safety Board

## Marine Accident Brief

### Bollard Failure Causing Breakaway of Cruise Ship *Carnival Triumph* from its Moorings, and Subsequent Collision with Dredge *Wheeler* and Towing Vessel *Noon Wednesday*

<b>Accident no.</b>	DCA-13-LM-015
<b>Vessel names</b>	<i>Carnival Triumph</i> , <i>Wheeler</i> , and <i>Noon Wednesday</i>
<b>Accident type</b>	Bollard failure; breakaway from moorings; subsequent collision
<b>Location</b>	BAE Systems shipyard, Mobile River, Mobile, Alabama 30°40.659' N, 88°1.975' W
<b>Date</b>	April 3, 2013
<b>Time</b>	1328 central daylight time (coordinated universal time –5 hours)
<b>Injuries</b>	1 fatal, 1 injured (both BAE Systems employees)
<b>Damage to vessels</b>	<i>Carnival Triumph</i> , \$2.7 million; <i>Wheeler</i> , \$200,000; <i>Noon Wednesday</i> , \$3,000
<b>Environmental damage</b>	None
<b>Weather</b>	Heavy rain with limited visibility. Air temperature 59°F. The National Weather Service had issued a Special Weather Statement at 1251 CDT, warning of possible wind gusts of up to 50 mph in the vicinity of the accident.
<b>Waterway characteristics</b>	The Mobile River, located in southern Alabama, is about 45 miles in

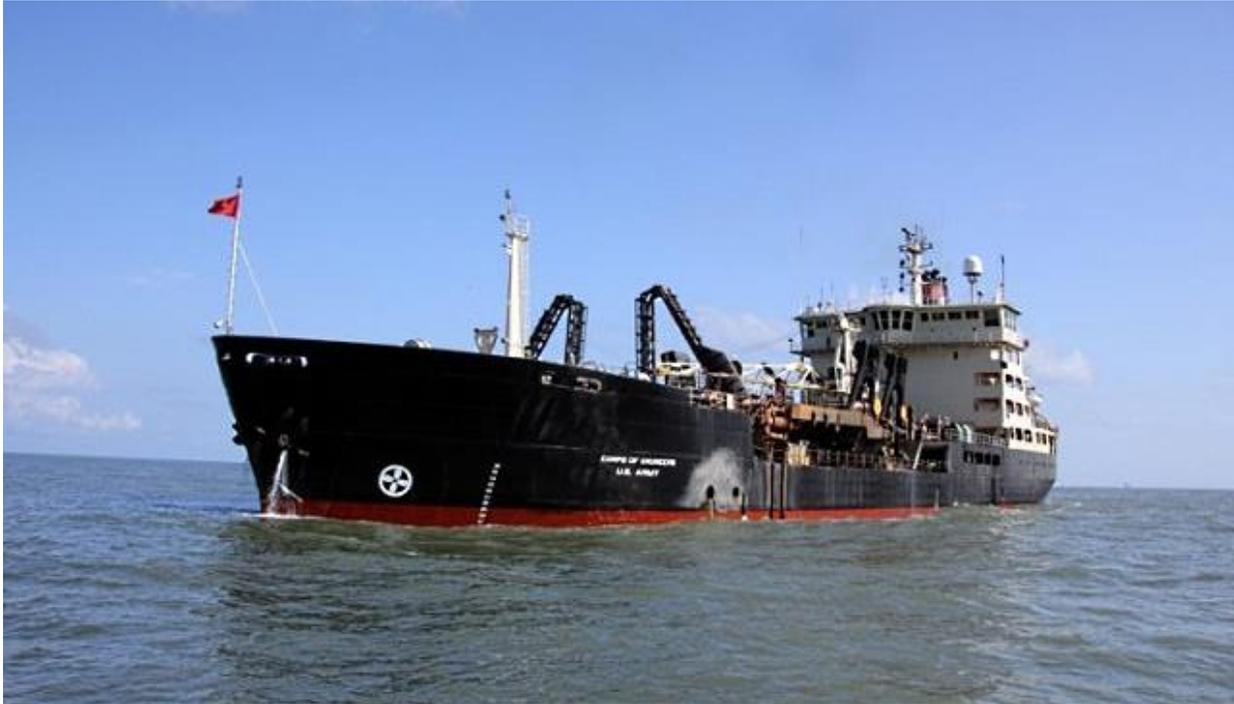
**The dredge *Wheeler*. (Photo provided by the US Army Corps of Engineers)**

On the dredge *Wheeler*, which was moored port side to across the river at the Signal Ship Repair facility, the master and crew had become aware of the situation by monitoring the VHF radio and hearing sound signals from the *Carnival Triumph*. As the *Carnival Triumph* approached the *Wheeler*, the master of the dredge ordered all crew and shipyard personnel to abandon ship.
