National Transportation Safety Board

Marine Accident Brief

Grounding and Sinking of Towing Vessel *Stephen L. Colby*

Accident no.	DCA14LM002
Vessel	<i>Stephen L. Colby</i>
Accident type	Grounding and sinking
Location	Upper Mississippi River, near mile 497, LeClaire, IA 41°35.8' N, 90°20.6' W
Date	November 25, 2013
Time	1555 central standard time (coordinated universal time – 6 hours)
Injuries	None
Damage	\$3.9 million
Environmental damage	US Coast Guard estimated 2,096 barrels of petroleum product recovered from vessel and river Vessel carried est. 2,156 barrels of petroleum product when it sank—2,128 barrels of diesel and 28 barrels of lube oil
Weather	Mostly cloudy, winds southwest 12 mph and gusting to 29 mph, visibility 10 miles, air temperature 35°F
Waterway information	The Upper Mississippi River is upstream of Cairo, IL. Pool 14, location of the accident, is a body of water between US Army Corps of Engineers Lock & Dam 13 and Lock & Dam 14. The Coast Guard noted shallowest water depth was 9.88 ft, water temperature 37°F at time of accident

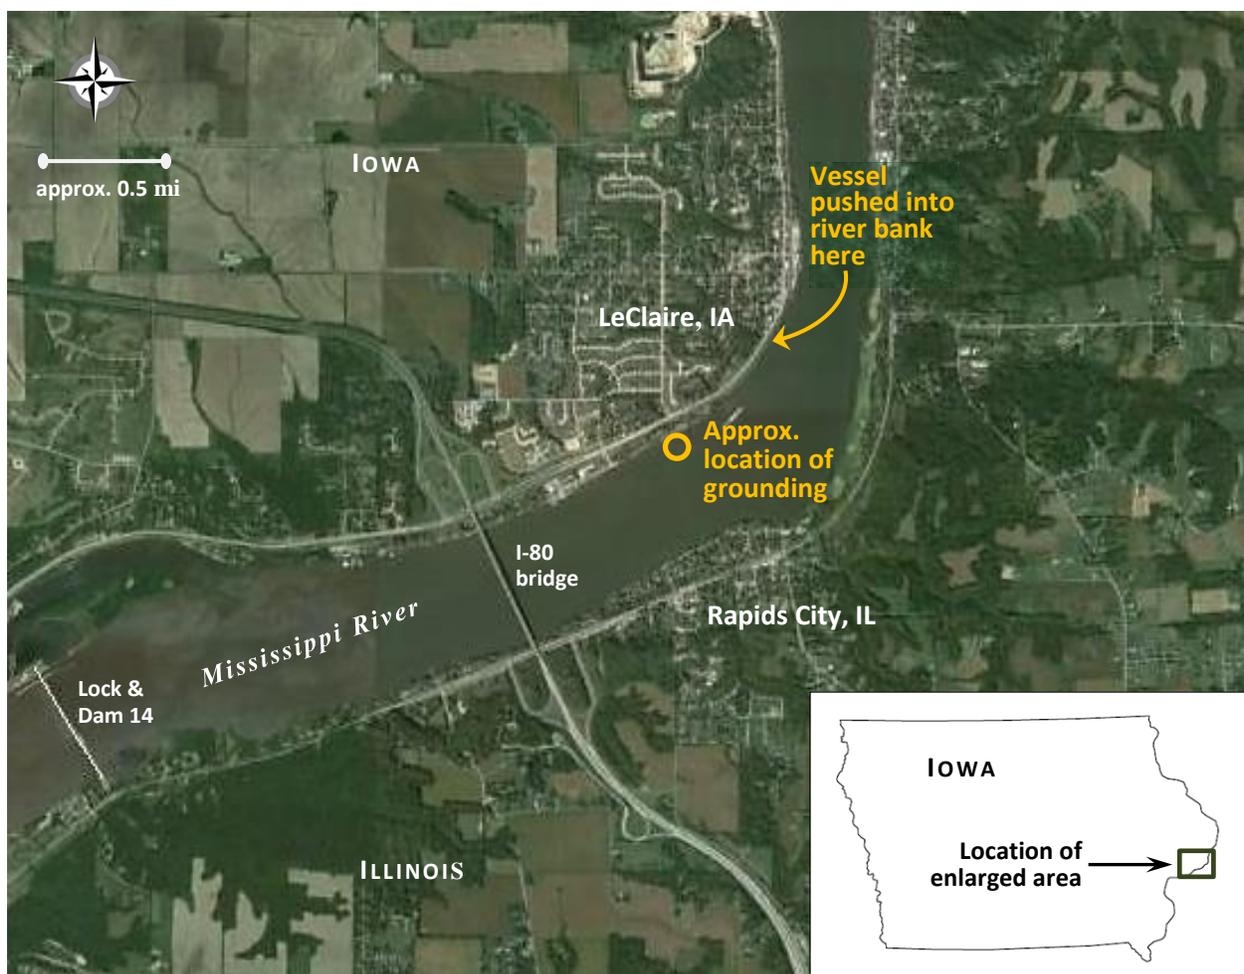
The *Stephen L. Colby* was ahead of the *Aaron F. Barrett* as it passed under the Interstate 80 bridge at UMR mile 494.5 about 1545 and proceeded upriver at 6.3–6.6 mph. At 1555, as the *Stephen L. Colby* approached mile 497, the mate, who was on watch in the wheelhouse, heard and felt the hull strike something near the bow area. He pulled back the throttles to slow the vessel and directed the engineer to check the engine room for damage. The engineer reported a significant amount of water spraying up through the deck plating. The mate sounded the general alarm signal and maneuvered toward the right descending riverbank to ground the vessel in shallow water. Using VHF marine radio, the mate also requested support from the *Aaron F. Barrett*, which was about 1 mile downriver at the time.

Location of the grounding and sinking of the towing vessel *Stephen L. Colby*. (Background by Google Earth)

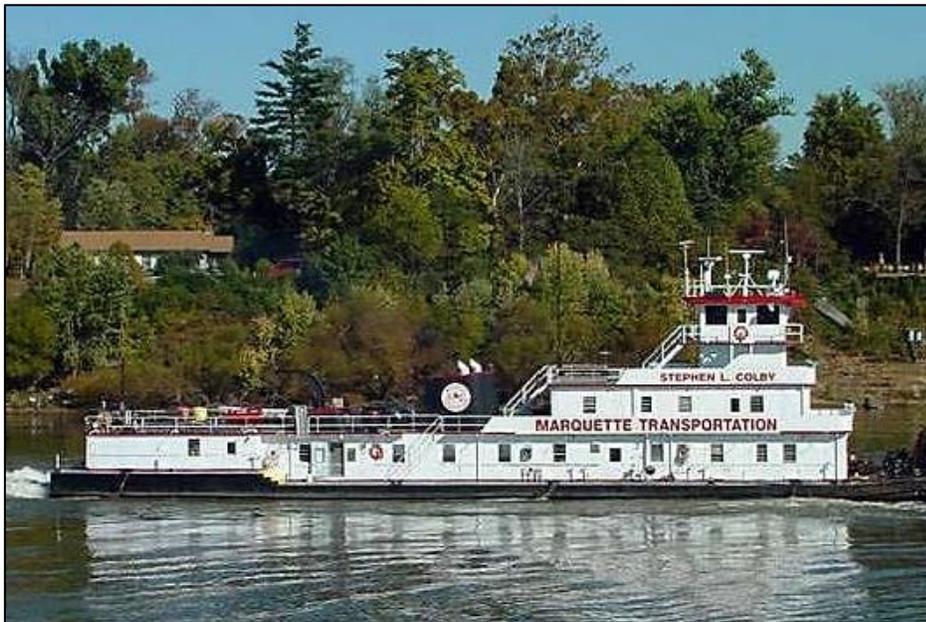
Uninspected towing vessel *Stephen L. Colby* on the Ohio River before the accident. (Photo from www.towboatgallery.com)
