National Transportation Safety Board

Marine Accident Brief

Allision of the ITB Krystal Sea/Cordova Provider with US Coast Guard Cutter Sycamore

| Accident no. | DCA13PM031 |

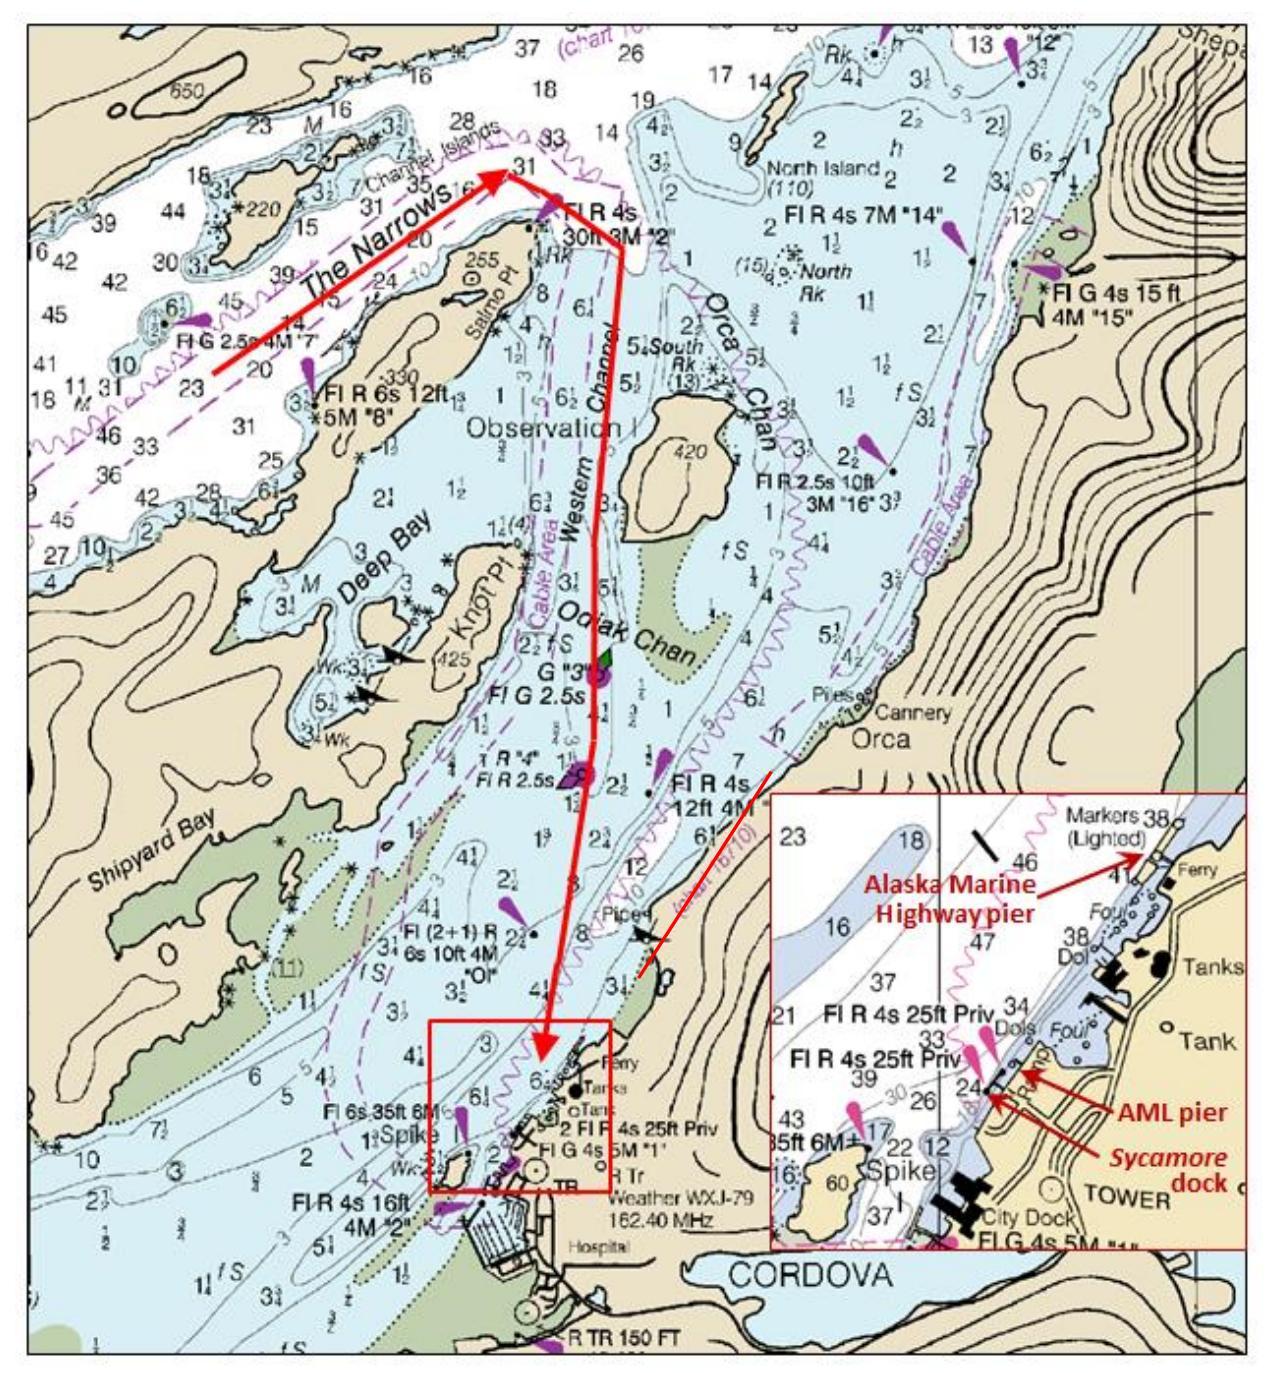
Approximate course of the *Krystal Sea* based on AIS data (background from NOAA chart 16709). Inset shows details of Cordova Harbor, the *Sycamore* dock, the ITB's intended dock at AML pier, and the Alaska Marine Highway ferry pier where the captain began to disengage autopilot (excerpt from NOAA chart 16710).

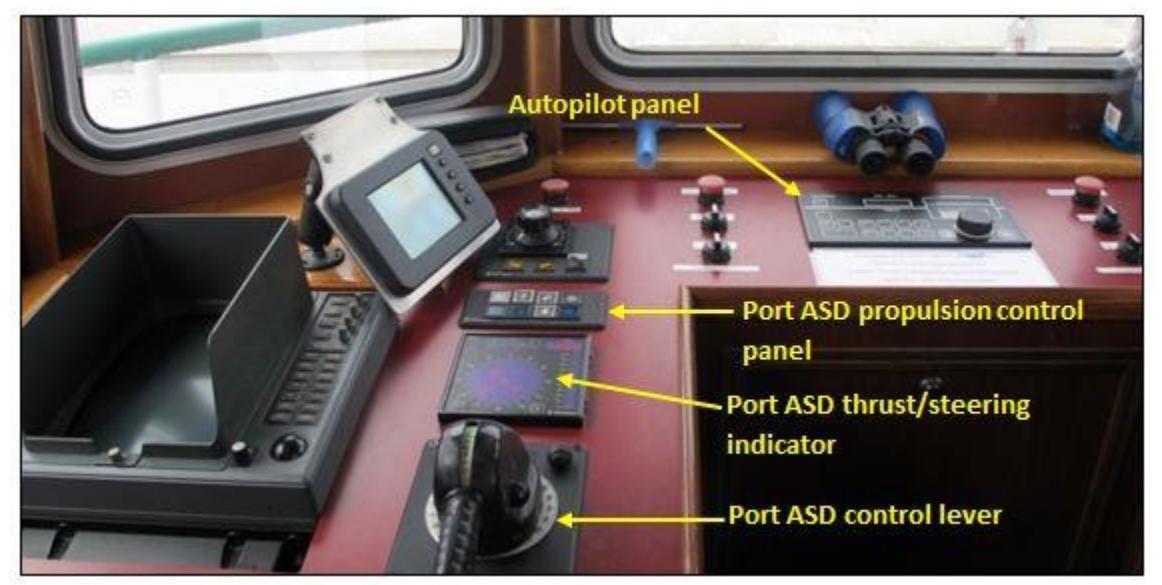
In manual mode, the autopilot is passive and manual steering commands are carried out using the separately mounted port and starboard ASD control levers (see photo below). These levers combine rotation and thrust in a single control—rotating the levers changes the direction of thrust, while moving the levers up and down controls the amount of thrust by changing the engine throttle. Each ASD is also fitted with a thrust indicator panel that shows the thrust direction and propeller rpm for the ASD.

Krystal Sea bridge console, port side, looking forward. Starboard side ASD controls are similar.

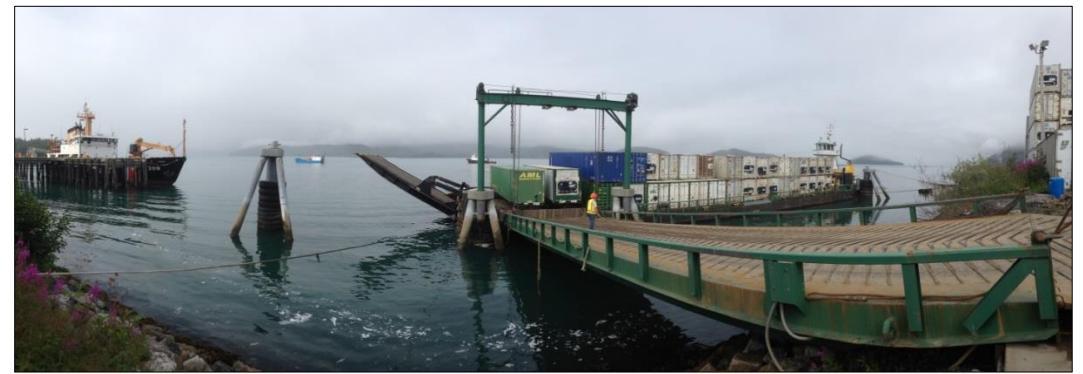
The ITB docks directly north of the *Sycamore* at the AML barge facility. Site plans show that the distance between the AML dock's southern dolphin and the north end of the *Sycamore's* pier is 137 feet. Investigators estimated that, when docked, the distance between the bow of the *Cordova Provider* and the bow of the *Sycamore* was about 150 feet.

View of the moored Sycamore and the docked Krystal Sea/Cordova Provider at the AML dock a few days after the allision.

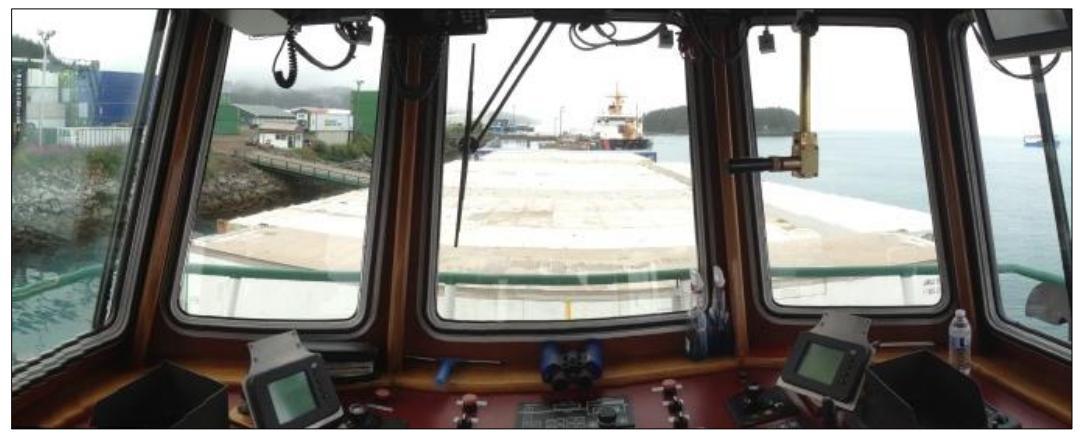
View of the Sycamore from the Krystal Sea wheelhouse looking over containers on the Cordova Provider a few days after the allision.

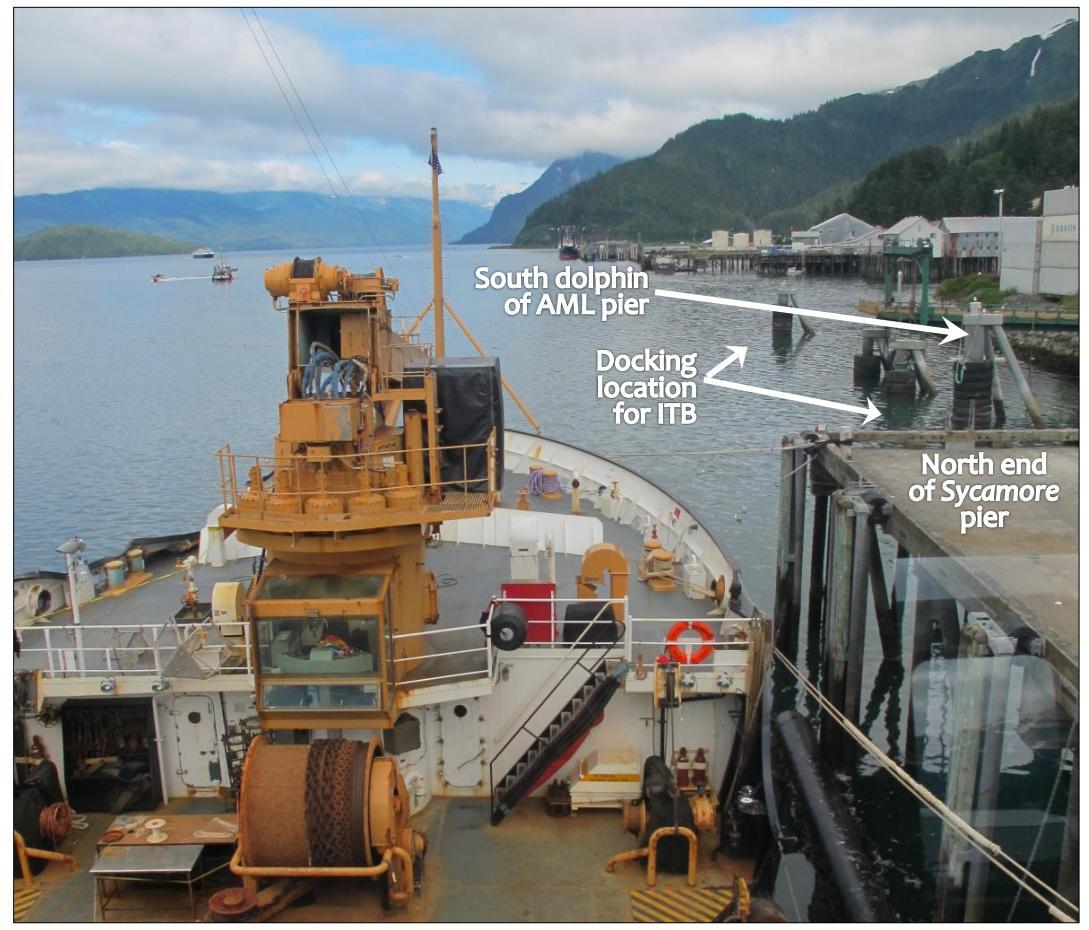
The AML dock was constructed in 2002 and designed for the larger 400-foot-long *Whittier Provider*. The port manager stated he did not have a specific concern with the distance between the two docks. The *Whittier Provider* was a rail barge of greater size and capacity (300 containers and 45 rail cars), which, in his opinion, was more subject to the effects of winds and currents than the *Krystal Sea/Cordova Provider*. The *Alaska Mariner/Whittier Provider* was a traditional tug-barge rather than a paired ITB such as the *Krystal Sea/Cordova Provider*, which is highly maneuverable and was built specifically for the docks it services. The senior captain stated that, compared to Valdez and Whittier, the Cordova docking was "probably the easiest" as the tide is parallel to the dock and the winds are seldom a problem.

View from the Sycamore bridge of the AML pier's dolphins and ramp where the ITB docks in Cordova.
