National Transportation Safety Board Marine Accident Brief

Breakwater Pier Collapse in Eastport, Maine

Accident no.	DCA15LM006		
Vessel names	Ada C. Lore, Double Trouble 2, Medric II		
Accident type	Pier collapse and subsequent damage to moored vessels		
Location	Eastport, Maine		
Date, time	December 4, 2014 0158 eastern standard time (coordinated universal time – 5 hours)		
Injuries	None		
Damage	Ada C. Lore, \$480,000; Double Trouble 2, \$110,000; Medric II, \$120,000		
Environmental damage	Slight oil sheen		
Weather	Low tide, clear, calm		
Waterway information	Cobscook Bay, at the mouth of the Bay of Fundy, west of Deer Island and Campobello Island, Canada

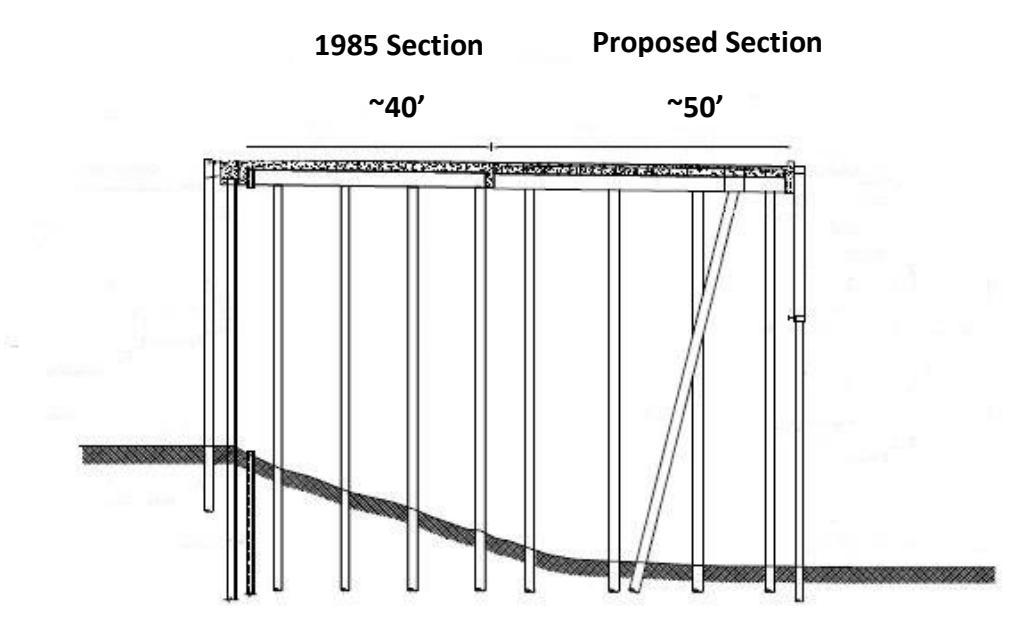
Cross-section of proposed pier design after demolition of 1962 breakwater. (Drawing by Childs Engineering Corp.)

Due to the breakwater's age and deteriorated state, in August 2013, the Maine Department of Transportation (Maine DOT) engaged Childs Engineering Corp. from Bellingham, Massachusetts, to design a replacement structure for the original pier. Reconstruction plans included demolishing the original section and replacing it with a new 400-foot by 50-foot piece to be built on concrete-filled steel pilings located outside the 1985 section. A single layer of sheet pile was designed to form a new breakwater inside the 1985 section. Relocating the pier would enlarge the inner part of the harbor by 20,000 square feet. The construction project called for the use of composite materials in place of steel in some parts to mitigate deterioration. The cost of the reconstruction project was estimated at \$14.95 million, to be funded by the US Government, state of Maine, and Eastport Port Authority.
