# National Transportation Safety Board

## Marine Accident Brief

### Sinking of Tank Barge *Nash*, Towed by Towing Vessel *Calvin*

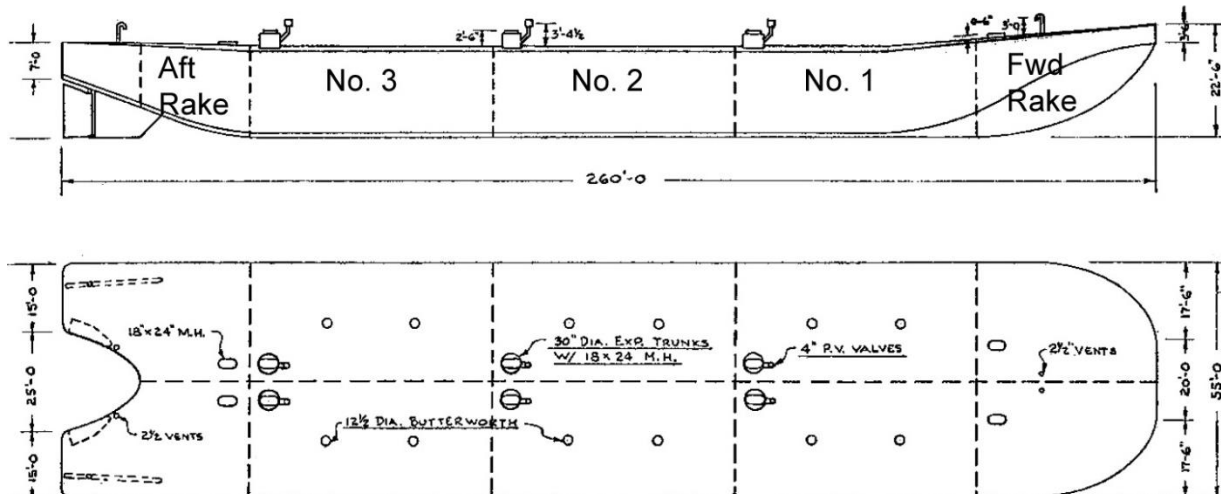
The *Nash* was a single-hull tank barge built in 1969 and operated as a bunker barge by Foss Maritime, its previous owner. Salmon Bay Barge Line Inc. (SBBL) purchased the barge in December 2013 to carry magnesium chloride from Mexico to Canada. The barge had six cargo tanks—nos. 1, 2, and 3, port and starboard—and four void (rake) tanks located at the forward and aft ends of the barge.

Original general arrangement of barge *Nash*, showing location of cargo tank nos. 1, 2, and 3 and void (rake) tanks forward and aft. Not shown in the drawings are a 1,500-pound boom crane and two small deckhouses. (Drawing from Foss Maritime, previous operator of the *Nash*.)

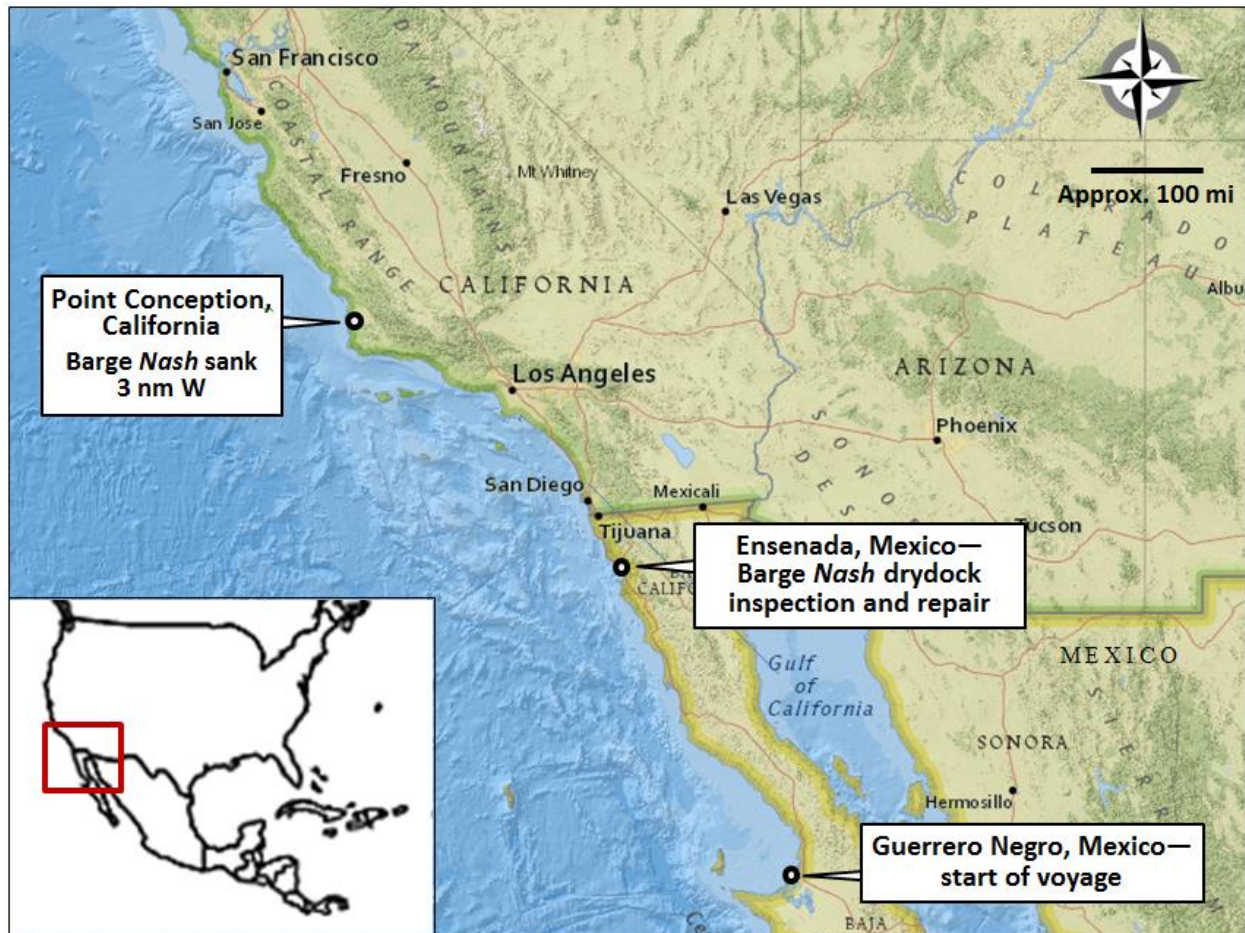
Following repairs to the *Nash* in Ensenada, Mexico, barges *Nash* and *Kenny* were loaded in Guerrero Negro, Mexico, and then began the voyage to British Columbia, Canada, towed by the *Calvin*. After the *Nash* took on a starboard list, the Coast Guard directed the tow to anchorage near Point Conception, California.

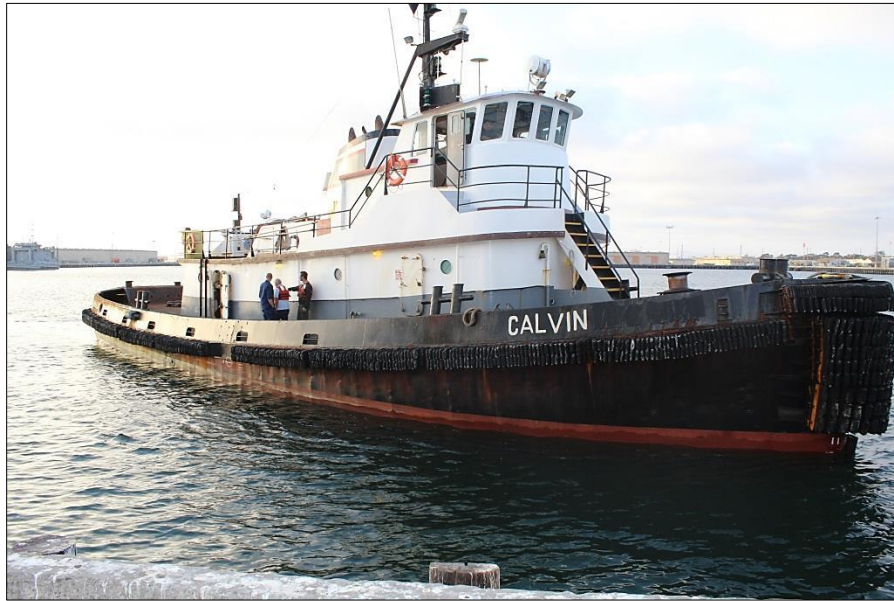
Towing vessel *Calvin* after the accident.
