National Transportation Safety Board

Marine Accident Brief

Launch Capsizing of the Yacht *Baaden*

Accident no.	DCA14LM009
Vessel name	Recreational yacht <i>Baaden</i>
Accident type	New build capsizing at launch
Location	Fidalgo Marina ramp, Anacortes, Washington
Date, time	May 18, 2014 2050 Pacific daylight time (universal coordinated time – 7 hours), twilight
Injuries	3 minor injuries
Damage	Total constructive loss, estimated at \$10 million
Environmental damage	None
Weather	Clear, visibility 10 miles, no wind, air temperature 60° F, water temperature 54° F
Waterway information	Fidalgo Marina Harbor, Fidalgo Bay, a sheltered recreational boat harbor; calm surface, minimal flood current, near high tide (about 2158)

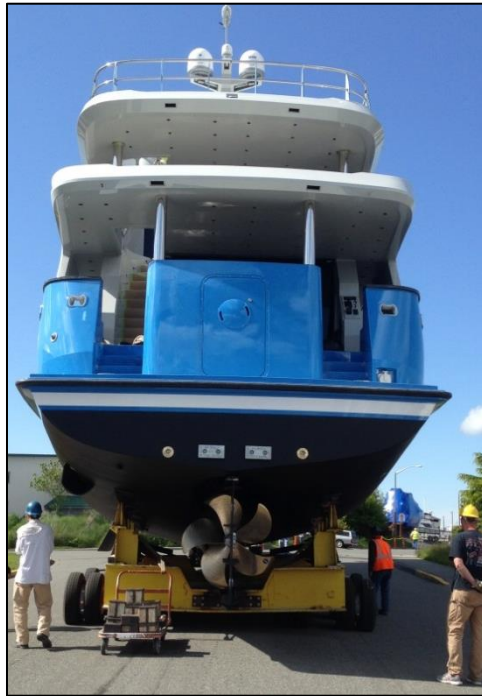
Stern view of *Baaden* and aft dolly during the vessel's tow toward the launch ramp. (Photo by New World Yacht Builders)

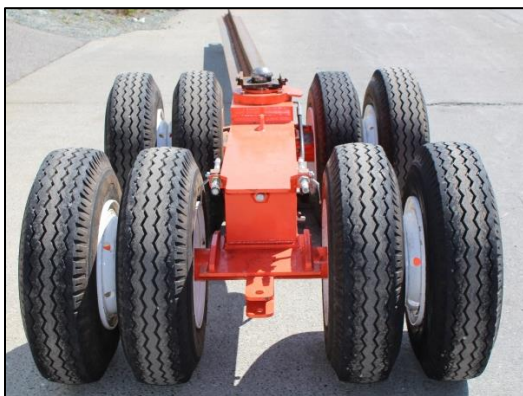
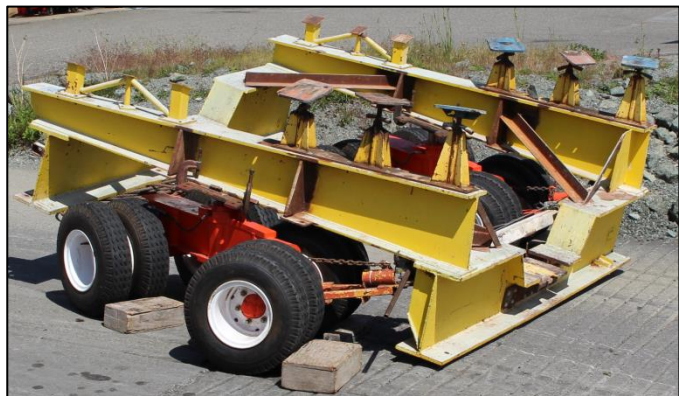
Front dolly with connecting bar (left) and the two rear dollies and aft cradle assembly (right). (Photos by Coast Guard)

Launch team members inspected the launch cradles, dollies, and equipment after the incident and noted that one of the tires on the forward dolly was flat, and witnesses said they saw bubbles coming from the forward dolly at the time of the launch. The tire likely was damaged during the initial port roll at 2037.

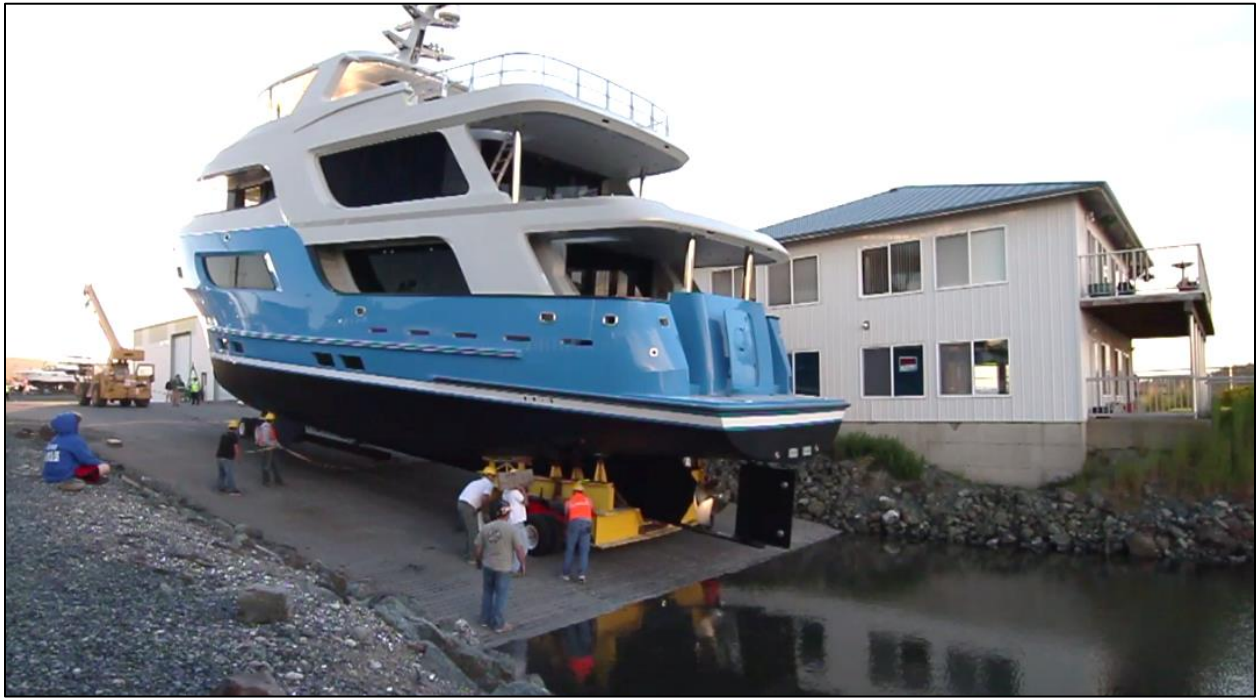
The *Baaden* on its front and rear dollies on the upper ramp prior to final launching. (Photo from YachtVid video)

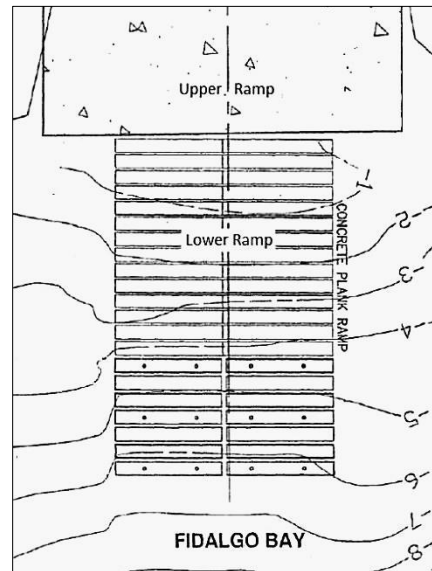
The Fidalgo Marina ramp consisted of a 40-foot-wide concrete upper ramp with about a 6.5 degree downslope and a more recently installed narrower lower ramp of 24-foot-wide concrete planks that extended about 37 feet beyond the end of the upper ramp. The lower ramp was offset about 4 inches below the end of the upper ramp.

Fidalgo Marina ramp in plan view.
(NTSB annotated excerpt from drawing provided by Fidalgo Marina)

During previous Northern Marine/New World launches, the Fidalgo ramp did not have the lower ramp extension and the dollies rolled off the upper ramp into the mud. The last two launches, however, required directing the vessel down the center of the lower ramp while the dollies were completely underwater and obscured from view.
