# National Transportation Safety Board

## Marine Accident Brief

### Sinking of Towing Vessel *Nalani*

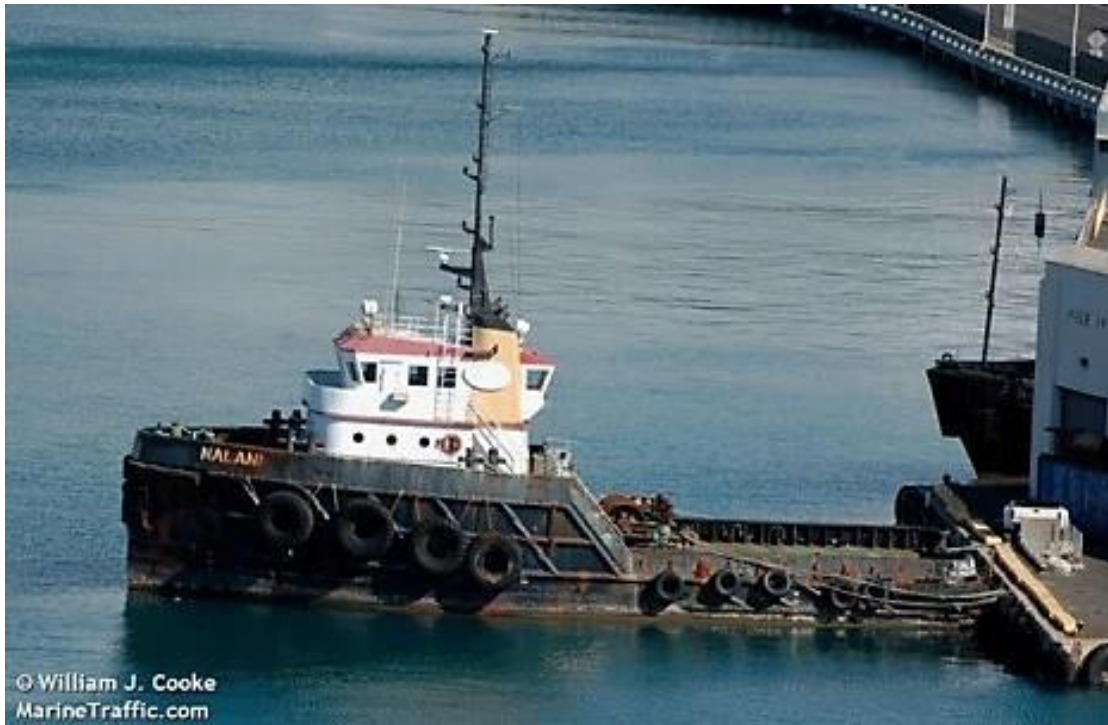
Photo of the *Nalani* before the sinking. (Photo by William J. Cooke, [www.marinetraffic.com](http://www.marinetraffic.com))

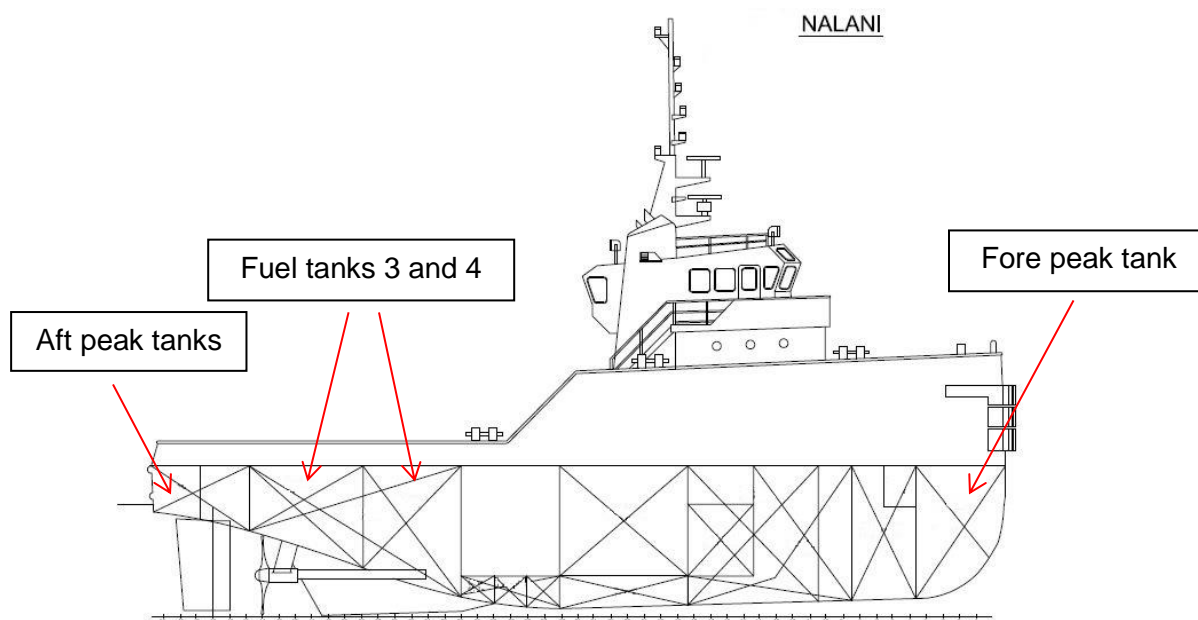
**Profile drawing of the *Nalani*. (Drawing provided by Remolcadores de Altura)**

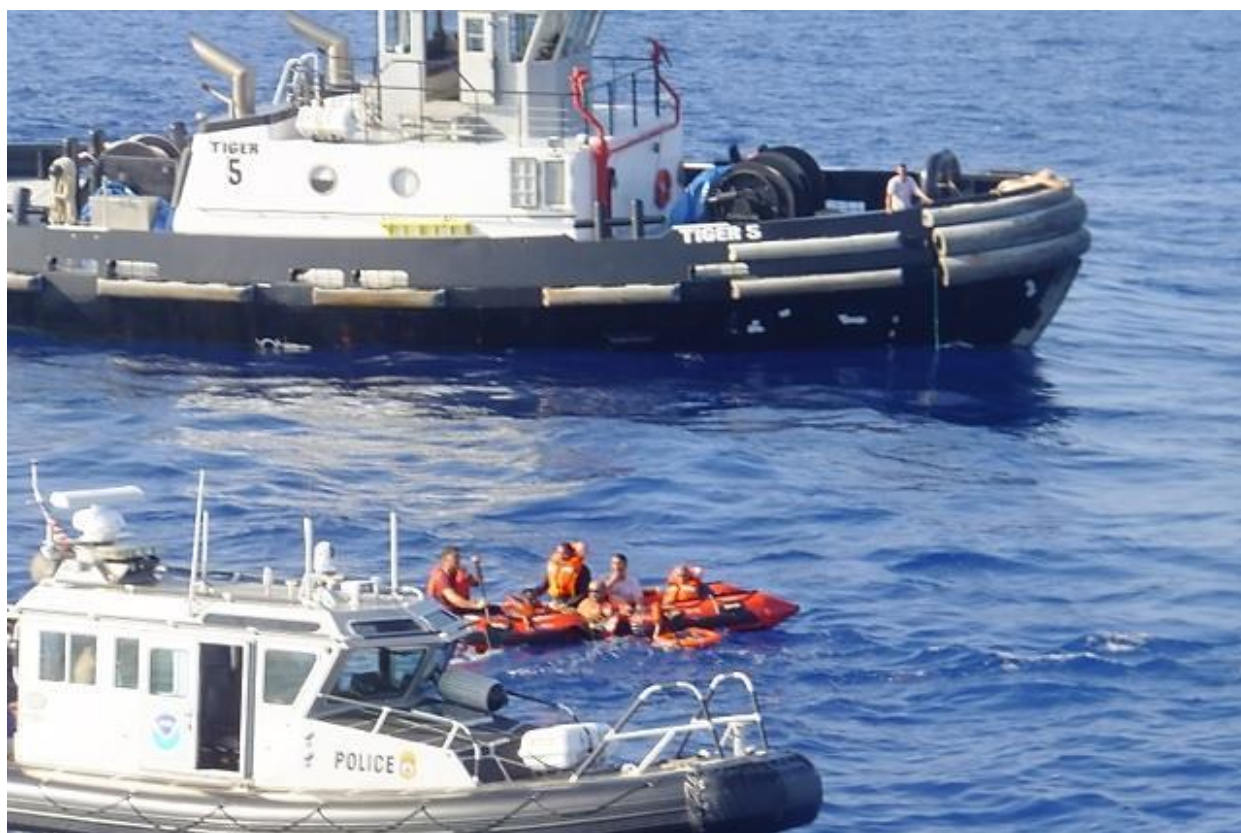
People from the *Nalani* in the newly installed inflatable boat before being rescued by assist vessels. (Photo by *Clean Islands* crewmember)

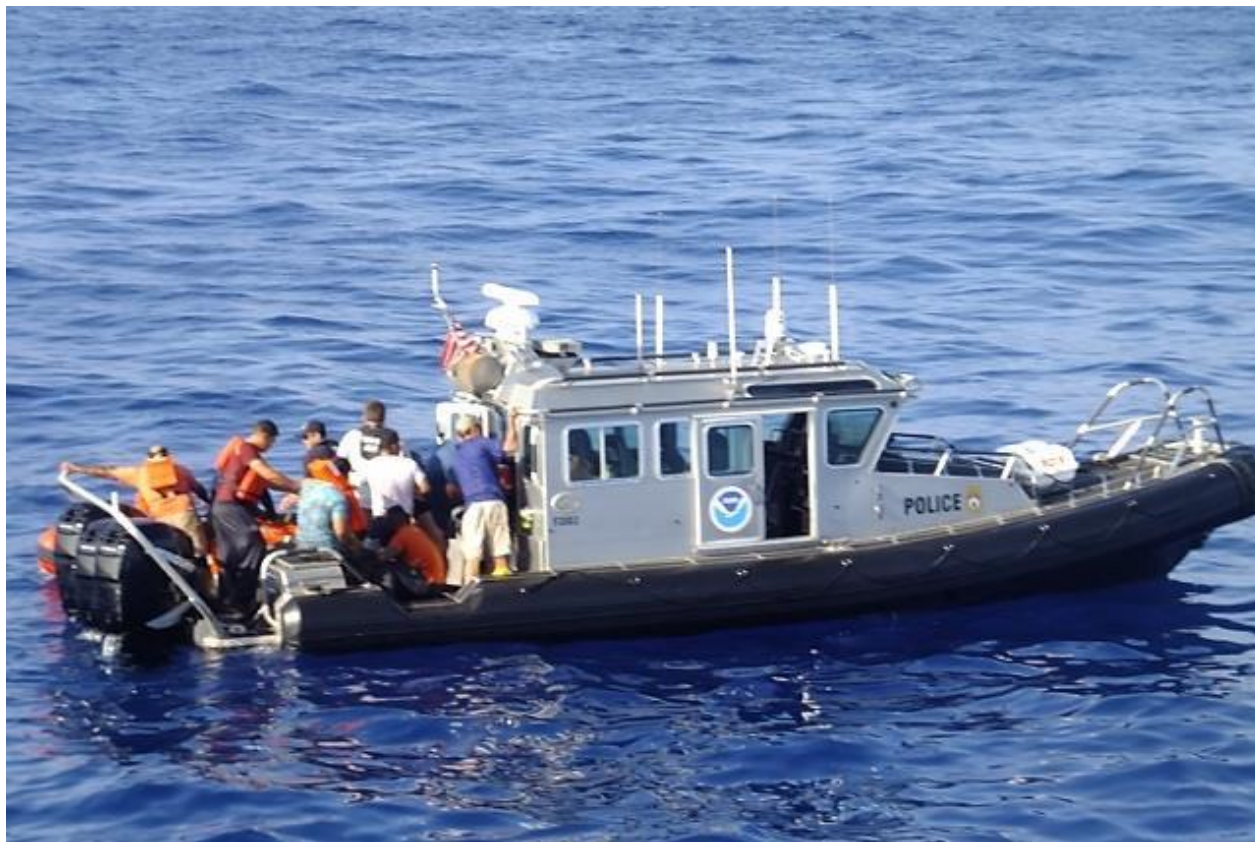
Rescued people from the *Nalani* on board NOAA patrol boat F3503. (Photo by *Clean Islands* crewmember)
