National Transportation Safety Board

Marine Accident Brief

Collision between Tanker *Chembulk Houston* and Container Ship *Monte Alegre*

Issued: February 23, 2016

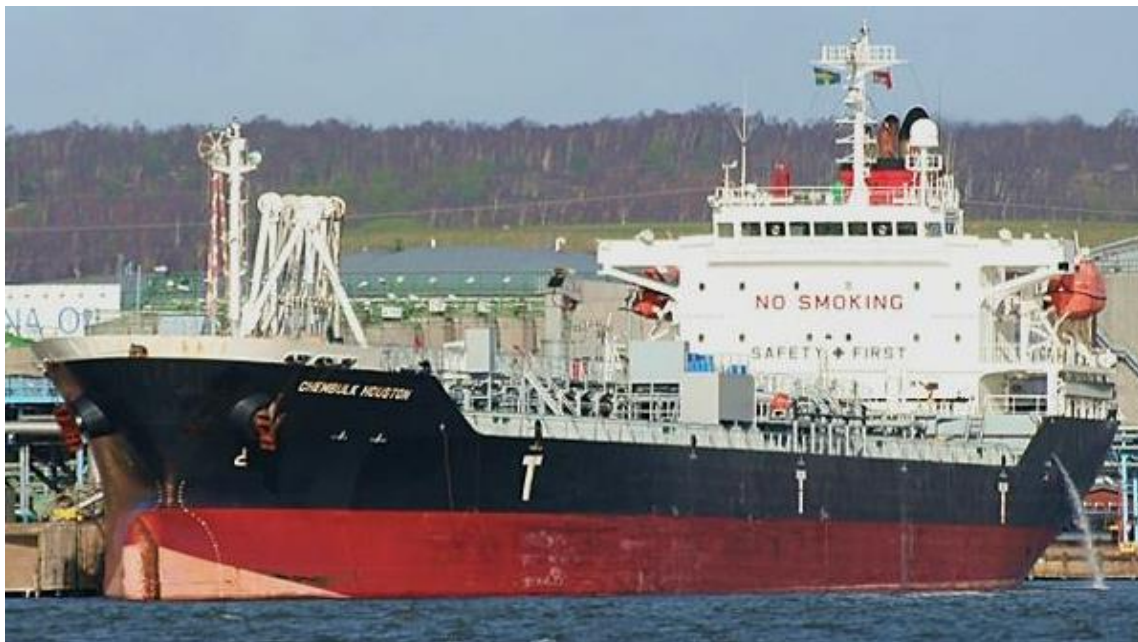
Tanker *Chembulk Houston*. (Photo by Peter Langsdale, at photo-forums.net)

Damage to the *Chembulk Houston* totaled \$729,600 and extended about 216 feet between frames 106 and 182 on the starboard side. The damage included distorted internal structural framing, bent railings, and inset and punctured main deck and hull.

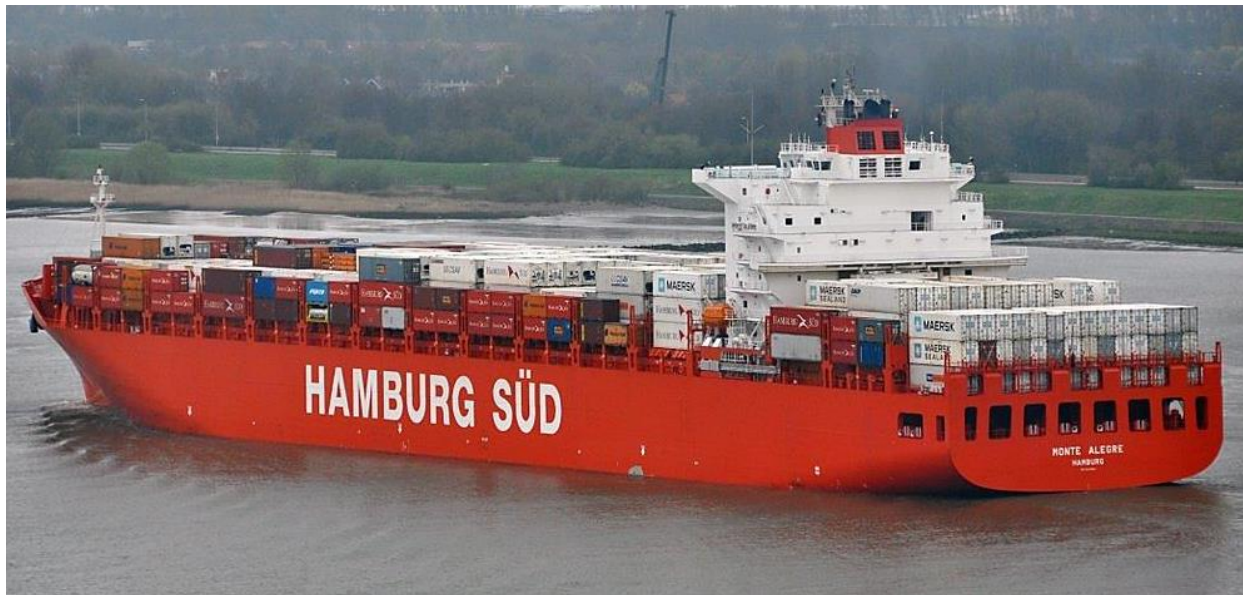
Container ship *Monte Alegre*. (Photo by Ria Maat, at panoramio.com)

Damage to the *Monte Alegre* totaled about \$997,700 and included distorted internal structural framing and hull inset along a distance of about 660 feet on the port side between frames 40 and 110, about 53 to 65 feet above the waterline. The hull was punctured in several places along this 660-foot-long damage section.

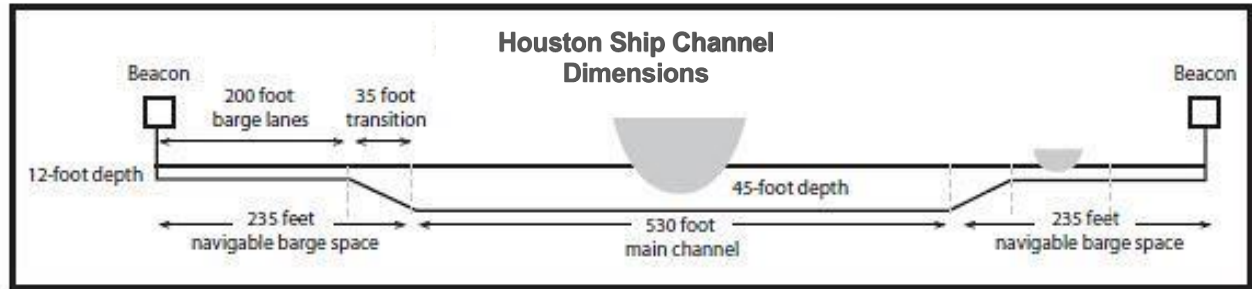
Two vessels transiting in close proximity to each other in the channel can create even more intense hydrodynamic forces, acting on one or both of the vessels. Overtaking maneuvers, such as the one attempted by the deputy pilot on the *Chembulk Houston*, are inherently higher risk than vessel-meeting situations because of the longer length of time during which the hydrodynamic forces can affect each vessel. (The NTSB performed motion and kinematics parameter extraction studies, using VDR and other data from both vessels, to determine the forces acting on each vessel during the overtaking attempt. Both studies are available in the public docket for this accident.)

Cross-sectional view of the Houston Ship Channel in the accident area. (Image provided by the Houston Pilots Association)
