National Transportation Safety Board Marine Accident Brief

Collision of Articulated Tug and Barge *Lucia/Caribbean*, Assisted by Tugboat *William S*, with Multiple Barges

NTSB/MAB-16/11

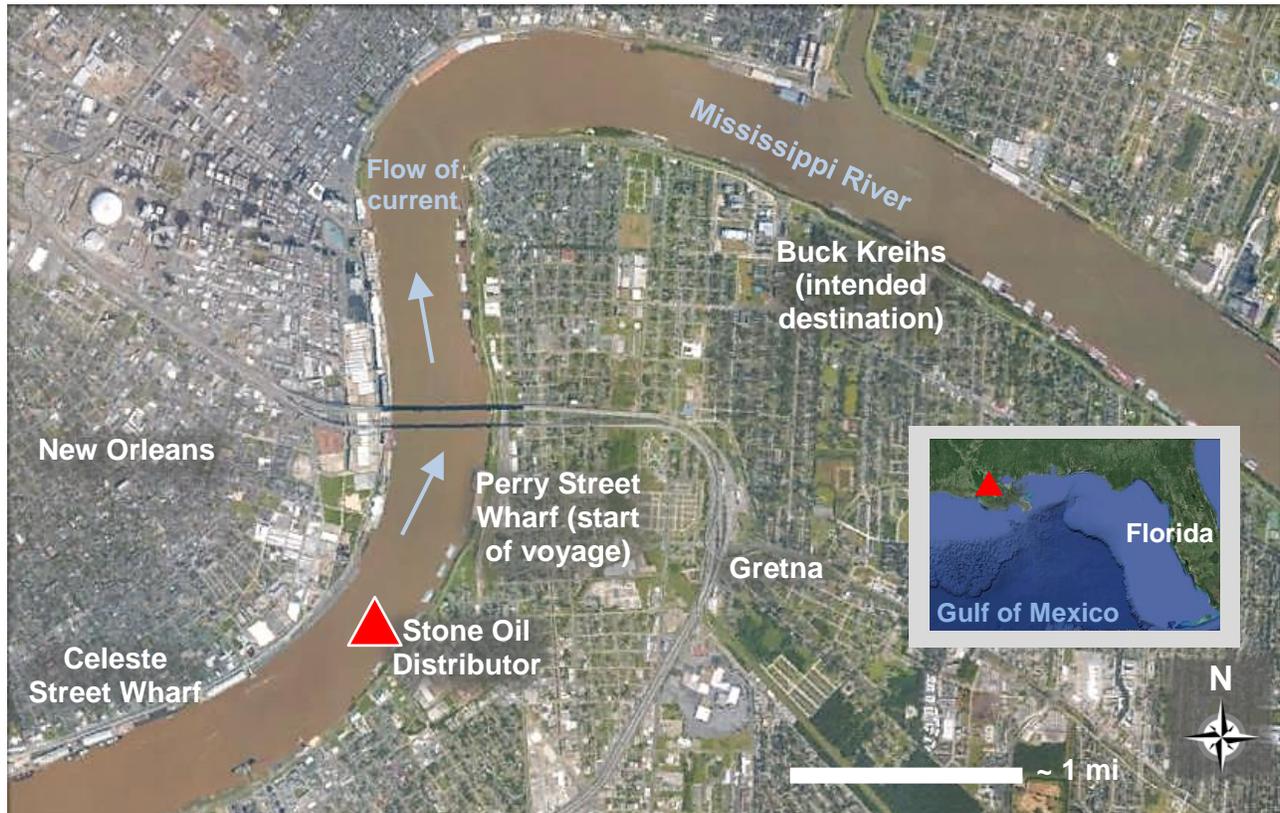
Satellite image of the Mississippi River in the accident area. The ATB was being moved about 3 miles downriver (to the northeast) from the Perry Street Wharf to the Buck Kreihs marine repair berth when the ATB collided with barges at the Stone Oil Distributor facility.

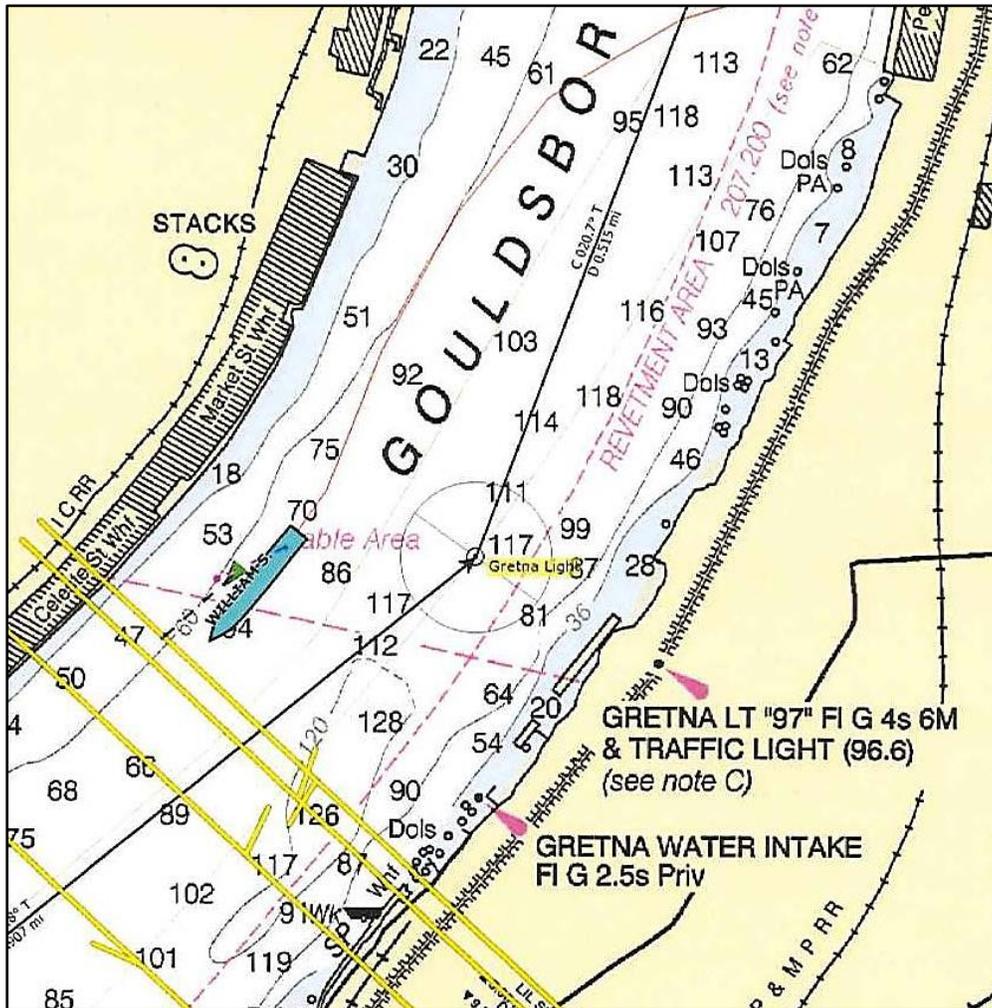
Still image extracted from playback of the electronic chart system on board the *Lucia* at 0011. The ATB is identified as one unit, light blue in color. *William S* is the green triangle to the left. (Source: Kirby Offshore Marine)

In preparation for the turning maneuver, the mate on the *William S* repositioned the tugboat so that it was once again about perpendicular to the centerline of the ATB. At 0011, the chief mate on the *Lucia* put the rudders to full port and the throttle at half astern, and then ordered the mate on the *William S* to push full ahead (100-percent throttle) on the *Caribbean*'s hull. The mate on the *William S* verbally acknowledged the full-ahead command.
