National Transportation Safety Board

Marine Accident Brief

Collision between Towing Vessel *William E Strait* and *Margaret Ann* Tow

Accident no.	DCA16FM010
Vessel names	<i>William E Strait</i> and <i>Margaret Ann</i> tow
Accident type	Collision
Location	Lower Mississippi River (LMR), mile marker 727.4
Date	December 14, 2015
Time	1122 central standard time (coordinated universal time – 6 hours)
Injuries	None
Property damage	Estimated \$2 million
Environmental damage	Approximately 700 gallons of oil and diesel released
Weather	Clear, visibility 10 miles, winds 13 mph with gusts to 23 mph from the southwest, air temperature 45°F
Waterway information	LMR near Memphis, Tennessee; river stage 17.7 feet and falling, current running between 1.5 and 2 knots

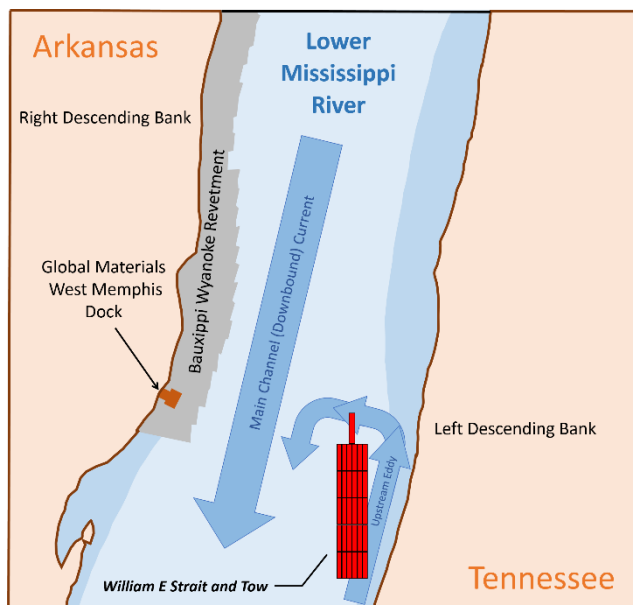
PortVision AIS data playback image showing the river contour and the positions of the downbound *Margaret Ann* and *William E Strait* at 1045 on the morning of the accident.

In that section of the river, the US Army Corps of Engineers maintains a 300-foot-wide navigation channel dredged to a 9-foot depth at low water. From mm 732 to 727, downbound vessels must navigate a bend in the river that requires the vessel to make a wide port turn and transition gradually from a course over ground of roughly 300 degrees to 199 degrees. The river current flows more rapidly along the right bank and in the center channel than it does along the left bank. This is based upon several factors, including the geological aspects of the river bottom, bank contour, shoaling, and the volume of water moving in the river at any given time. During certain conditions, an upstream eddy—a short reverse current—was known to develop in the

southernmost section of the bend along the left bank where the *William E Strait* was holding position. The eddy, when present, flowed upstream close to the bank and then westerly toward the center of the river to a point where it was influenced by the stronger downbound current.
