# National Transportation Safety Board

## Marine Accident Brief

### Allision of Fishing Vessel *Ferrigno Boy* with Ventura Harbor Boatyard Travel Lift Pier

<b>Accident no.</b>	DCA15LM029
<b>Vessel name</b>	<i>Ferrigno Boy</i>
<b>Accident type</b>	Allision
<b>Location</b>	Ventura Harbor, California, 34°15.0' N 119°16.0' W
<b>Date</b>	July 29, 2015
<b>Time</b>	1030 Pacific daylight time (coordinated universal time – 7 hours)
<b>Injuries</b>	None
<b>Damage</b>	Estimated \$850,000 to the Ventura Harbor Boatyard travel lift pier
<b>Environmental damage</b>	No pollution reported
<b>Weather</b>	Clear, visibility 6.5 nautical miles, winds east-southeast at 11.4 mph, calm seas, air temperature 71°F
<b>Waterway information</b>	Ventura Harbor is a 274-acre multiple-use recreational and commercial fishing small craft harbor.

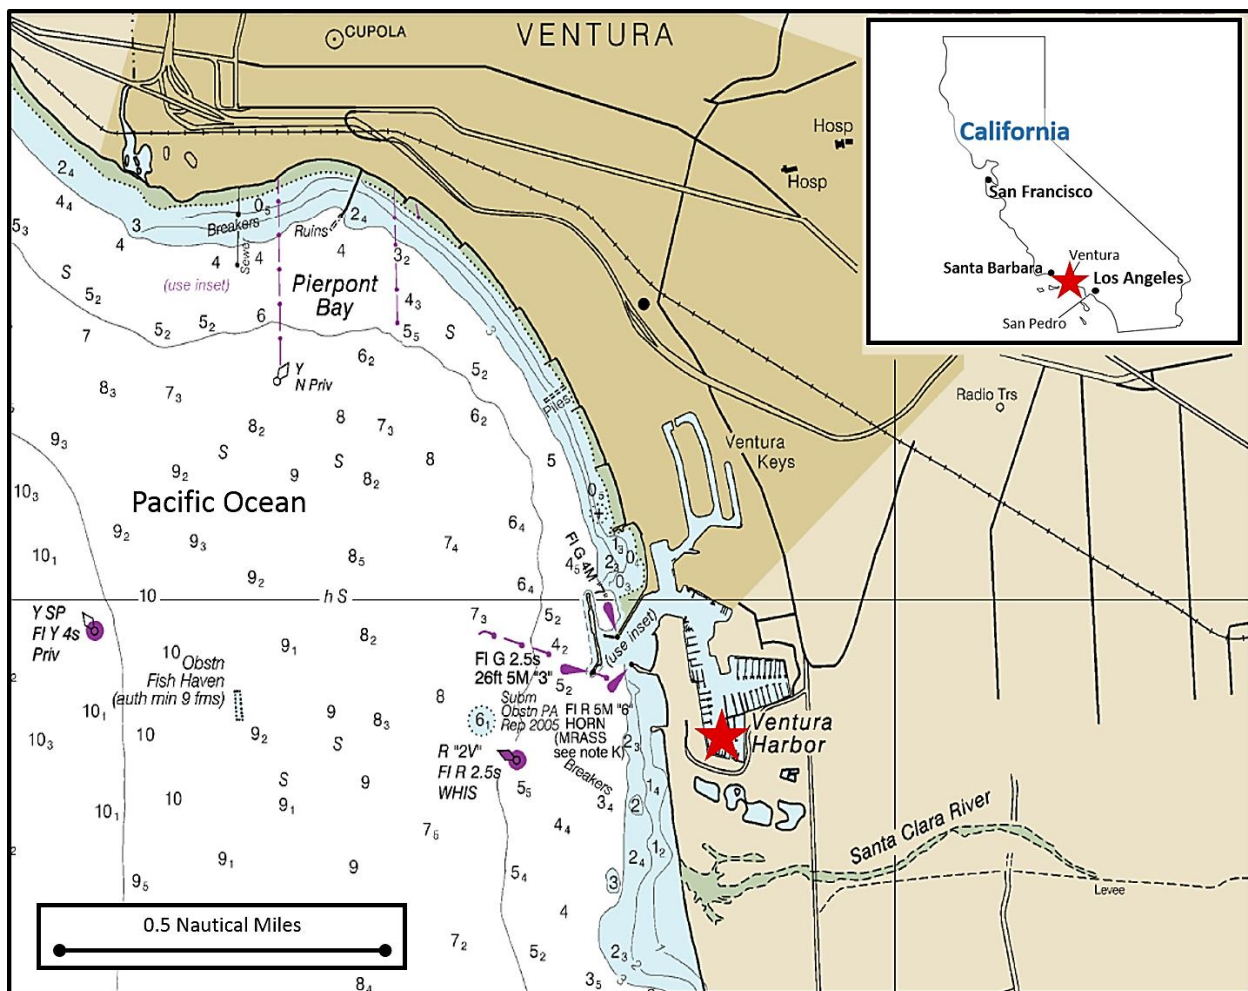
**Accident location, Ventura Harbor, California. (Background NOAA Chart 18725)**

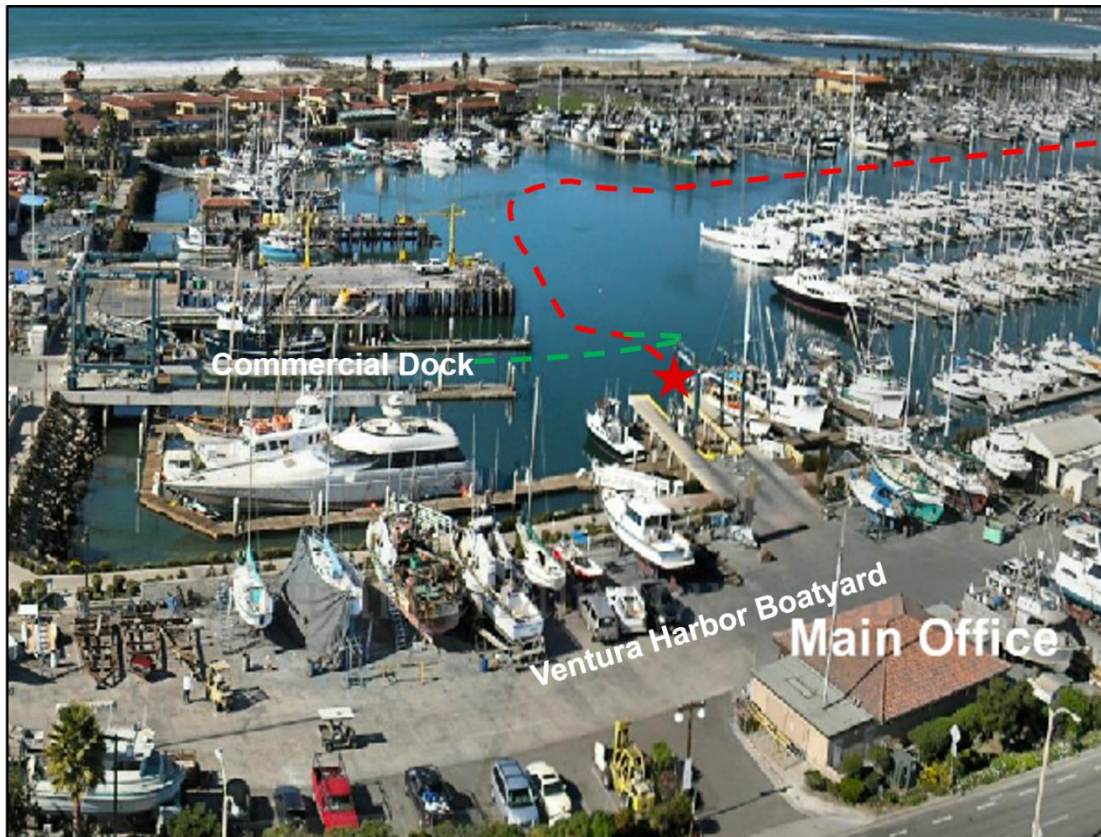
Photograph of Ventura Harbor with the *Ferrigno Boy* trackline depicted in red. The green line represents the intended maneuver of backing into the commercial fish dock, port side to the pier.

The captain navigated the vessel from the port bridge wing while maneuvering inside the harbor. He stated that he always backed the vessel into the commercial dock and moored port side to the pier to facilitate the offload due to the configuration of equipment on the pier and vessel. As the captain made his approach to the pier, he made a wide turn in order to pass near the end of the pier and thus provide enough maneuvering room to turn the bow away from the berth before backing down. The captain positioned the throttle in reverse and increased the main propulsion engine RPMs to slow the forward movement of the vessel as it continued to turn to port.

After making this maneuvering change, the captain instantly realized something was wrong because the vessel accelerated in the forward direction, and there was a lack of prop wash along the side of the hull that would have been produced by the astern thrust from the propeller. He immediately shut down the main engine and turned hard to starboard to avoid colliding with a sailing vessel and private sport fishing vessels moored in the slips directly ahead of the *Ferrigno Boy*'s projected course. The vessel continued forward at a speed of approximately 3 knots until its starboard bow struck the concrete deck, pilings, and floating docks of the travel lift pier at the Ventura Harbor Boatyard. About 1030, the fishing vessel came to a stop on floating docks that
